Orleans Old Firehouse Project – Part A

Historic Building Survey

April 2014

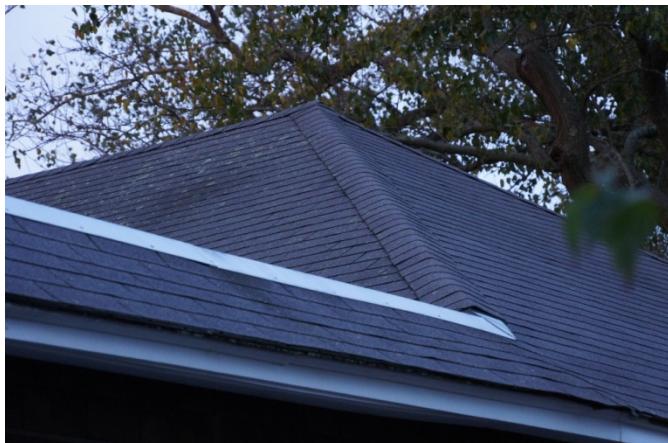
Fig. 4.1. Asphalt shingles at hipped roof.

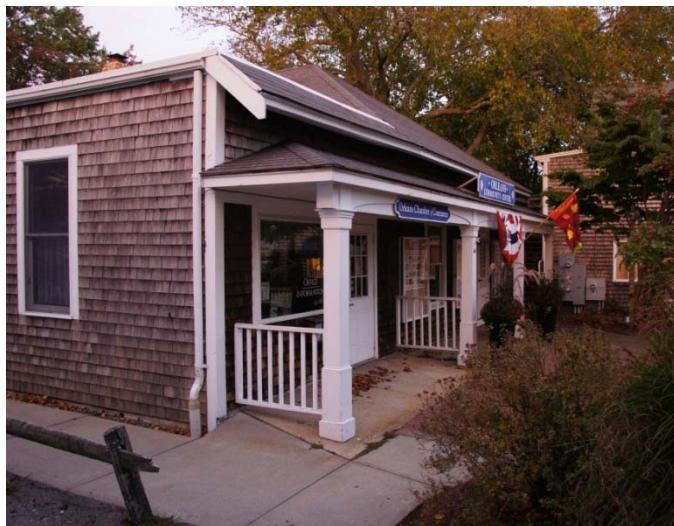
The hip-roofed porch or canopy added to the building lends human scale and provides cover for the existing entrances. However, in its present form, the canopy conceals part of the façade and appears to limit opening up the façade to Main Street and/or restoring the historic façade, a character-defining feature.

Fig. 4.3. Front porch.

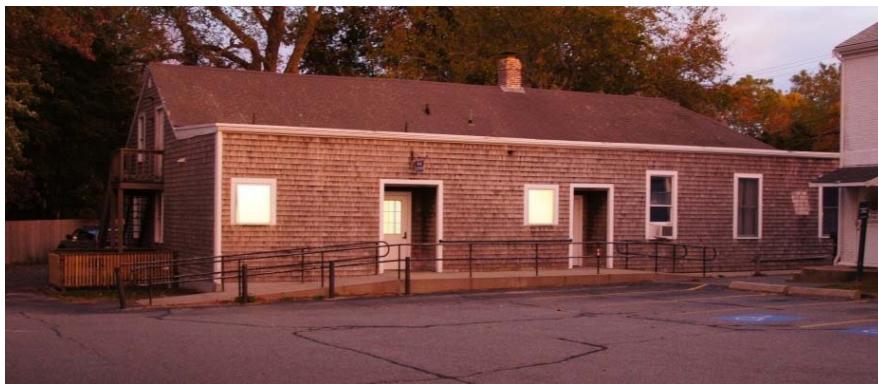
The original building is believed to have had regularly-spaced windows. The west addition also featured simple and ordered fenestration, but the existing restroom entrance and fenestration is not as austere and attractive. The east elevation is even more jumbled in composition, with a disturbing number of different window sizes and head heights for a relatively small building.

Fig. 4.5. West elevation, showing alterations for public restrooms and accessible entrance.

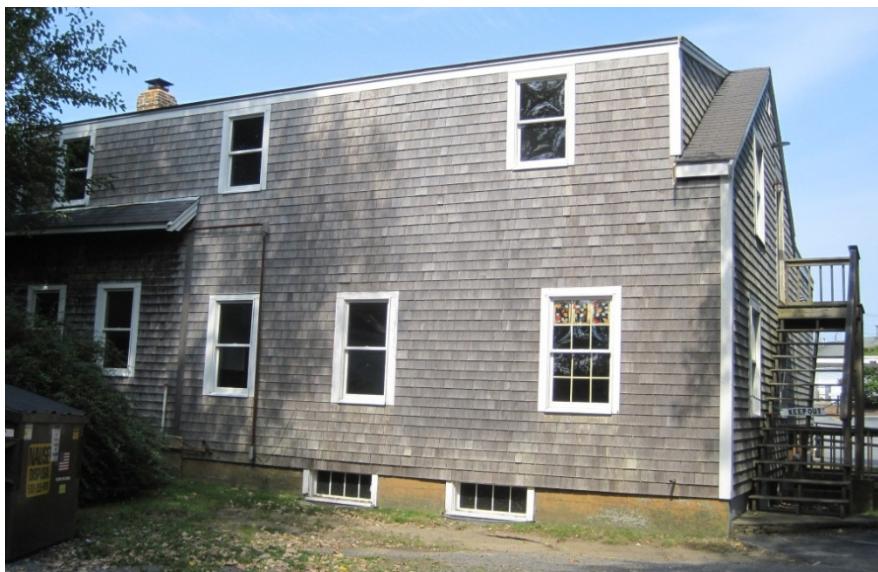
Fig. 4.6. East elevation; note variety of window sizes, types and locations.

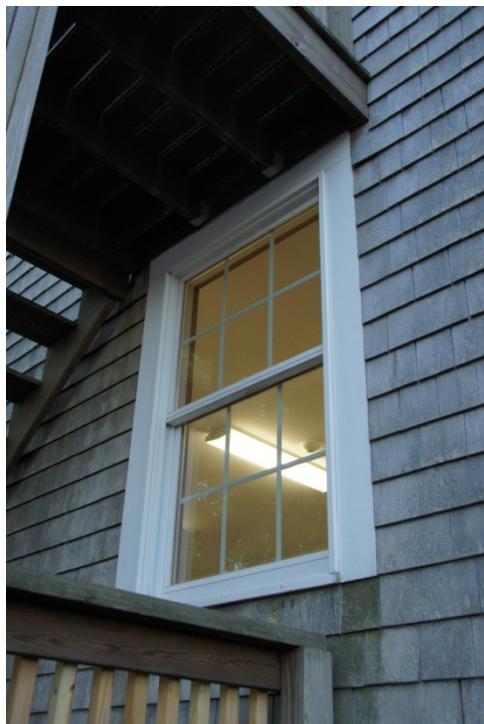
Fig. 4.7. Replacement window with fake muntins.

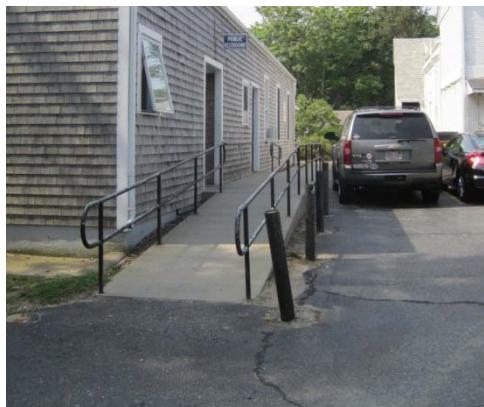
The existing wheelchair ramp provides access to a vestibule shared by the public restrooms and the facility's internal corridor. The stair/ramp assembly is in fair condition and the handrails are not in full compliance with current MAAB regulations.

Fig. 4.8. Existing wheelchair ramp.

The existing wheelchair ramp at the west side of the building provides access to the building from the parking lot; however, the handrails are non-compliant. As noted in the TLCR report, the existing restrooms should also be upgraded for full MAAB compliance. The existing Main Street entrances are not code-compliant, due to the steep slope of the approaches, the lack of level landings and the non-compliant door threshold height and profile). Potential accessibility solutions include upgrade of the existing concrete ramp, construction of one or more new ramps or wheelchair lifts and/or re-grading portions of the site to facilitate direct entrance and exit.

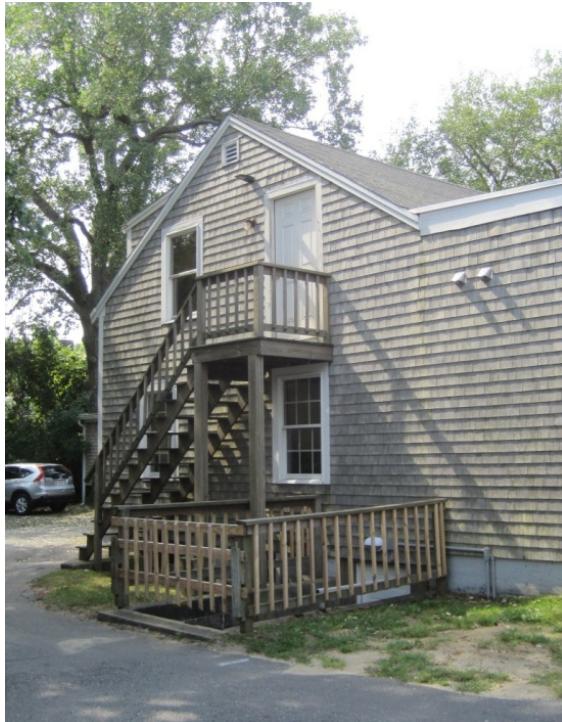
The pressure-treated wood stairs connecting the second floor "apartment" to the ground have open risers and do not comply with current requirements for new construction. A guard and gate of similar materials and construction has been erected around the poured-in-place concrete stairs down to the basement.

Fig. 4.9. Existing rear stairs.

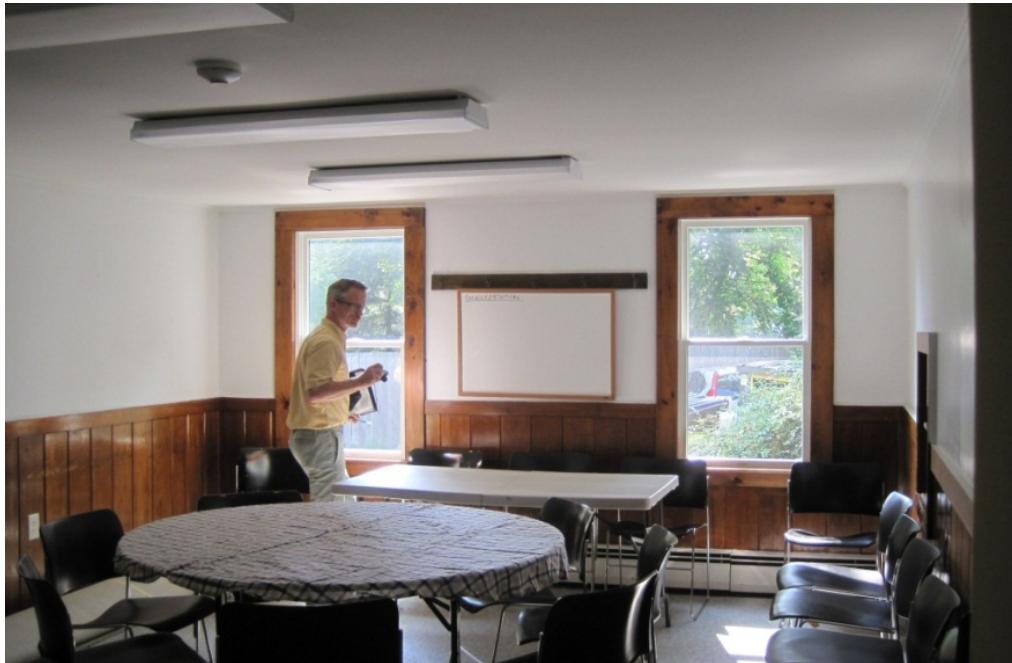
The meeting rooms at the rear of the building occur beneath the "low second floor" of the former upstairs apartment and, accordingly, are very low. Refer to the structural analysis for the structural engineer's concerns about the existing second floor capacity.

Fig. 5.5. Meeting room interior.

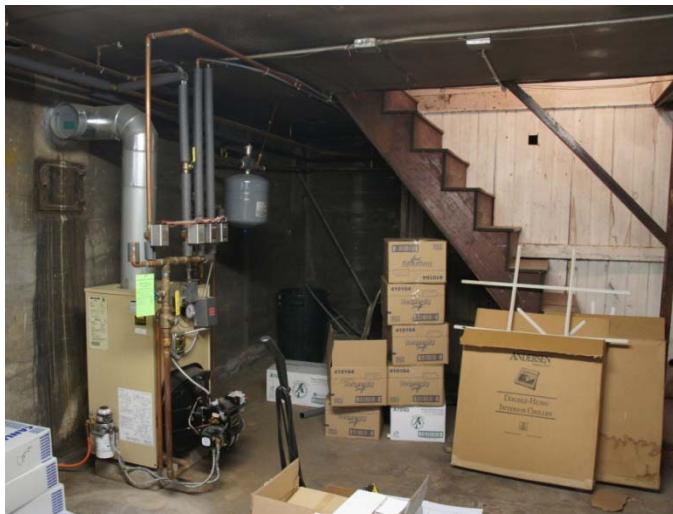
Fig. 5.8. Steep, non-conforming basement stairs.

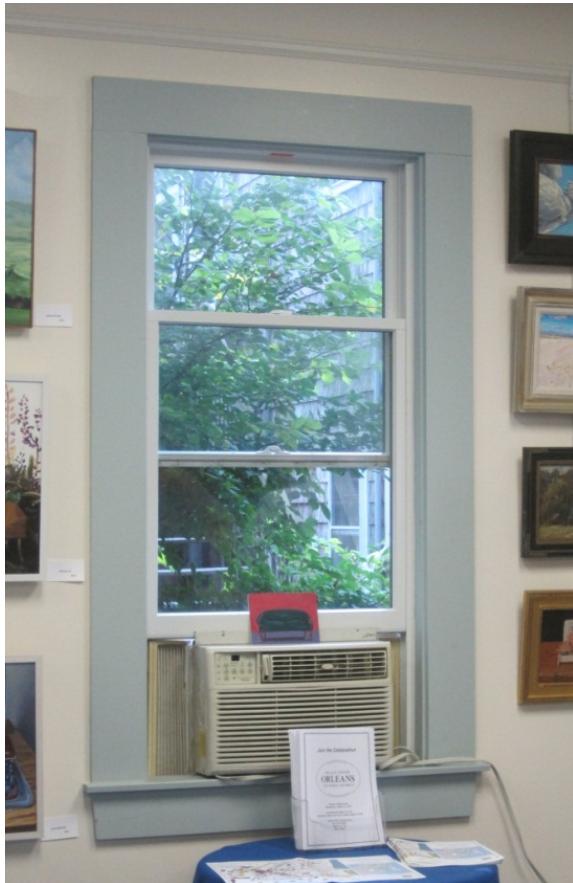
The original 12-over-12-light, weighted double-hung windows were removed at an unknown time and have been replaced with modern 1-over-1 double-hung units with spring balances. The replacement windows at the rear meeting room sport false muntins in a 6-over-6 pattern. In both cases, the windows appear to have been sized to fit the original openings, but the extant sash materials and muntin configurations represent a significant loss of historic character. Flat interior window trim appears to be original to the building or the early additions.

Fig. 5.11. Typical 1/1 window, with air conditioner; flat trim and skirt may be original.

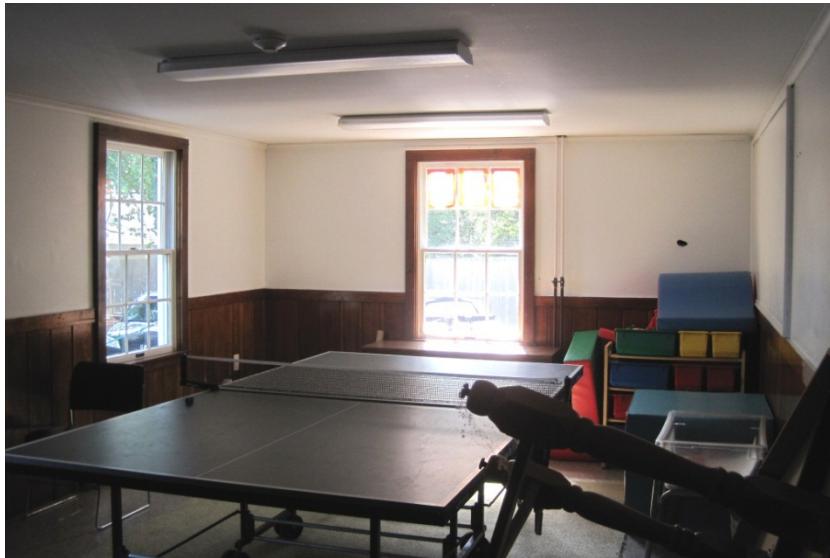
Fig. 5.17. The rear meeting room has a low ceiling which, together with the knotty-pine dado, begins to lend the room a "den" character. However, the flush-mounted fluorescent lights and vinyl windows detract from the building's historic character.
