Memorandum

Subject **Town of Orleans, MA**
Water Quality and Wastewater Planning
Task 2.a. Tri-Town Transition Requirements, Interim Use Option
Deliverable 2.1 – Extend Facility Life

From Thomas Parece, P.E., AECOM Project Manager

Date 10/22/15

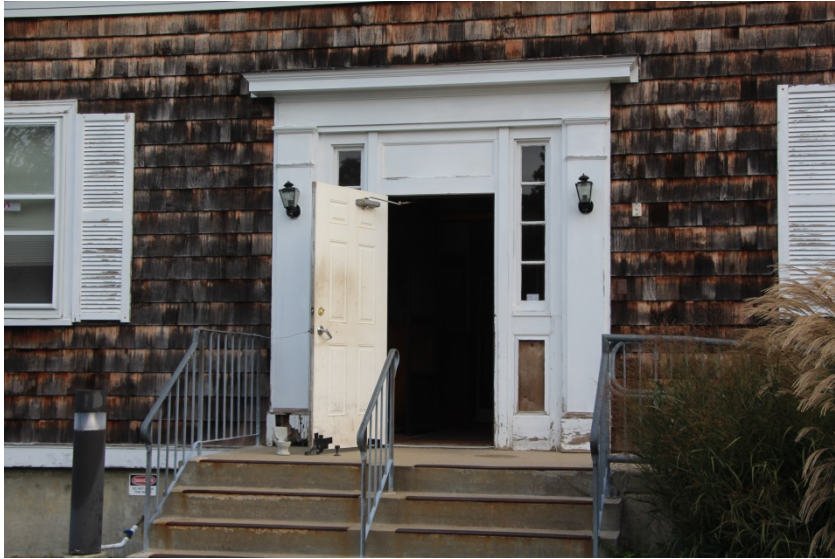
The Administration Building exterior appears weather worn with trim in some areas in need of replacement. AECOM understands that the wooden shingle and trim exterior is a façade for what is concrete block construction underneath. Any work on the wooden exterior would therefore be considered aesthetic only and not necessary to keep the facility operational through 2021. The roof however has some areas where roofing shingles have lifted. Facility staff have completed temporary repairs, however, a more permanent roofing repair is needed to prevent water intrusion and damage to electrical/instrumentation systems within the building.

Admin Building Siding and Trim

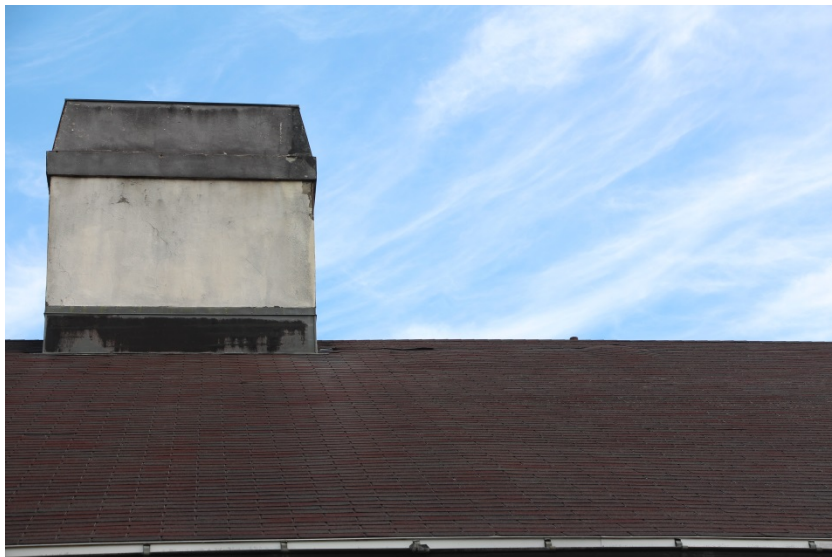
Admin Building Roof
(Bulge to right of vent)

| Recommendation | Description | Total Installed Cost | Probability of Needing to Be Done Prior to 2021 | Prorated Cost |
|---|---|---|--|---|
| Building Roof (30' x 30' patch) | Bldg roof over admin area needs replacment soon to prevent water damage to electrical equipment housed below | \$ 25,000 | 100% | \$ 25,000 |

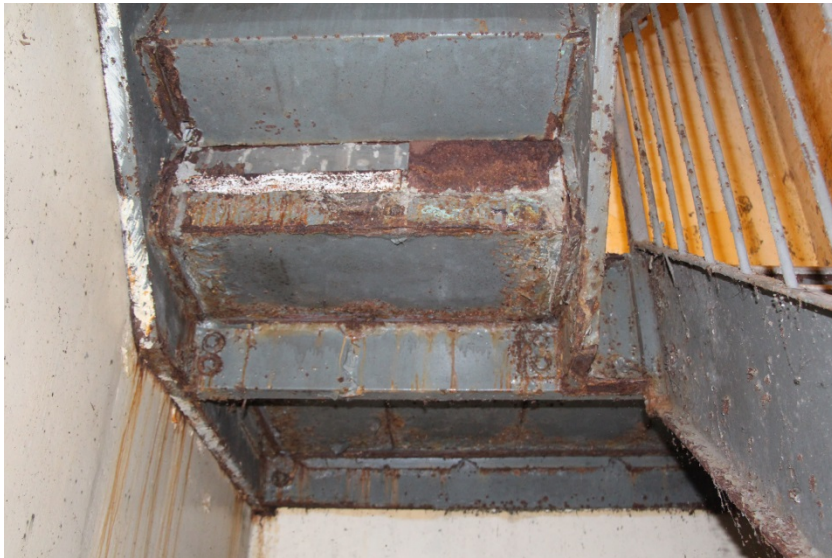
Housekeeping in the facility is generally quite good, and it's apparent that facility staff strives to maintain the facility and its systems. There are some areas, however, where the corrosive nature of off-gasses from septage processing have taken their toll. One area that has risen to the level of a safety concern is the stairwell leading down to the grit feed pumps. The stairwell has corroded to the point where facility staff has had to make temporary repairs, however, it's clear that a full replacement is warranted. Facility staff indicates that MassDEP inspectors have stated that they will require this issue be addressed prior to any approval for the facility to operate beyond December 2016.

Severe Corrosion in Grit Wetwell Staircase

| Recommendation | Description | Total Installed Cost | Probability of Needing to Be Done Prior to 2021 | Prorated Cost |
|---|---|---|--|---|
| Grit Pump Stairwell Replacement | Stairwell corroded to point of being safety issue. DEP mandate | \$ 25,000 | 100% | \$ 25,000 |

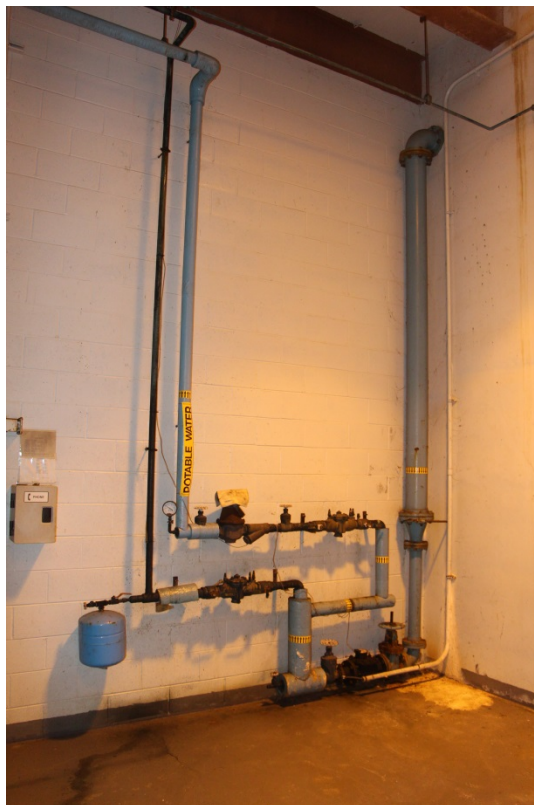
Another issue that was noted in the MassDEP inspection is the condition of the incoming potable water piping to the facility. An inspection of this piping reveals a coating failure and evidence of moderate to severe H₂S induced corrosion. The location of the piping, meter, and back-flow preventer up close to the wall of the building make maintenance of the coating system difficult and AECOM agrees with MassDEP's assessment that at this point, the piping and associated fittings need to be replaced. Facility staff suggests that if/when it is replaced, that it be slightly rerouted to provide better access for maintenance of the system.

Corrosion in Potable Water Piping

| Recommendation | Description | Total Installed Cost | Probability of Needing to Be Done Prior to 2021 | Prorated Cost |
|---|---|---|--|---|
| Potable water piping | DEP mandate | \$ 6,500 | 100% | \$ 6,500 |

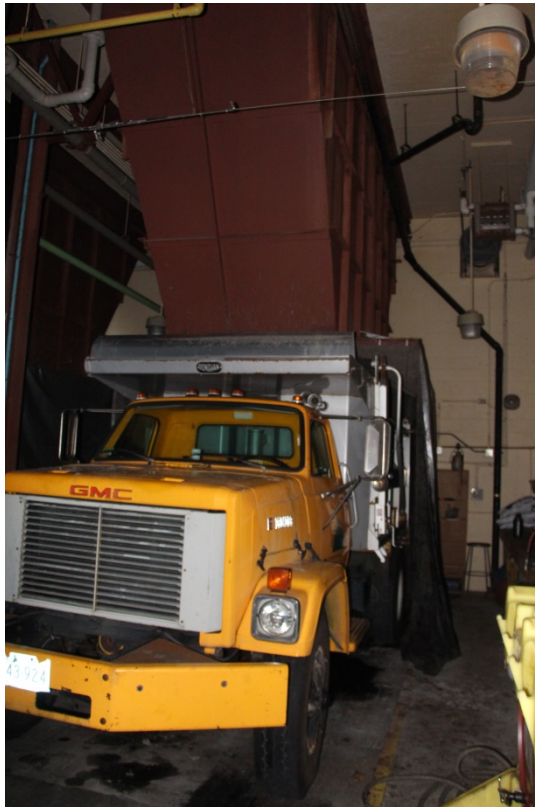
The facility uses an aging 10-wheel dump truck to transport dewatered biosolids ("cake") to a transfer station in Yarmouth for ultimate disposal "off-Cape". Without a detailed mechanical inspection of this vehicle, it's unclear whether it could be relied on through 2021, however, it would seem doubtful. A contingency plan for another solids removal mechanism should be explored (i.e. contract dumpsters). This would affect Operation and Maintenance expenses, however, it's likely this could be achieved with little to no expenditure in capital funds.

10-Wheel Dump Truck for Dewater Solids ("Cake") Transport

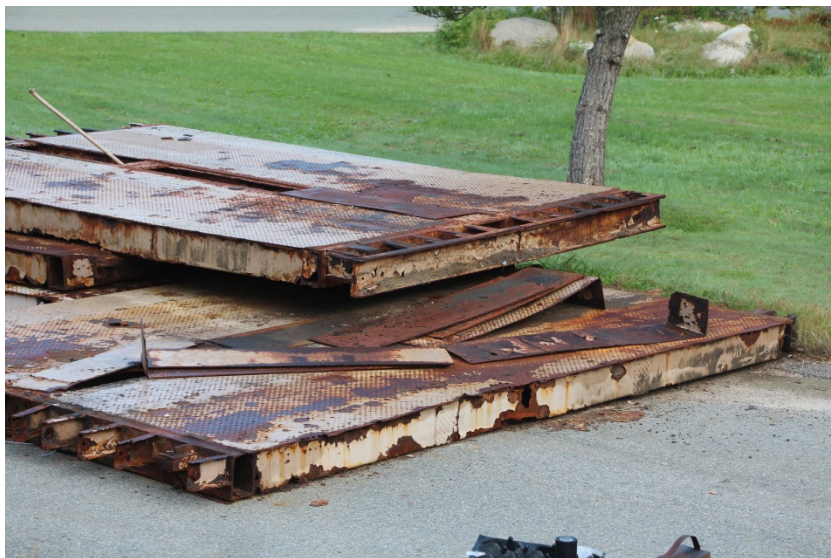
Septage Receiving Bays - The facility was designed with two receiving bays where septage can be received. Each bay was originally equipped with a drive on/off scale, to provide a mechanism for quantifying the septage brought to the facility; however one has since corroded to the point of failure and has been removed by facility staff. Facility staff indicates that limiting access to one bay can result in a back-up of pumper trucks waiting to offload at the facility. The remaining scale appeared to be in fair condition however, its failure would provide no way for facility staff to quantify septage received, leaving staff with no recourse but to charge haulers for the full capacity of their trucks. Haulers carrying partial loads would likely go elsewhere resulting in a loss of revenue. A previous evaluation in 2014 estimated the cost of a replacement scale to be approximately \$75,000. AECOM believes a more cost effective interim solution would be to install a metering station with magnetic flow meter and flow totalizer. This should be able to be installed within an existing bay and might be accomplished at an installed cost closer to \$20,000 to \$25,000.

Failed Receiving Area Floor Scale Panels

| Recommendation | Description | Total Installed Cost | Probability of Needing to Be Done Prior to 2021 | Prorated Cost |
|---|---|---|--|---|
| New metering station | Only one scale operational. Metering station to provide redudancy. | \$ 25,000 | 66% | \$ 16,500 |

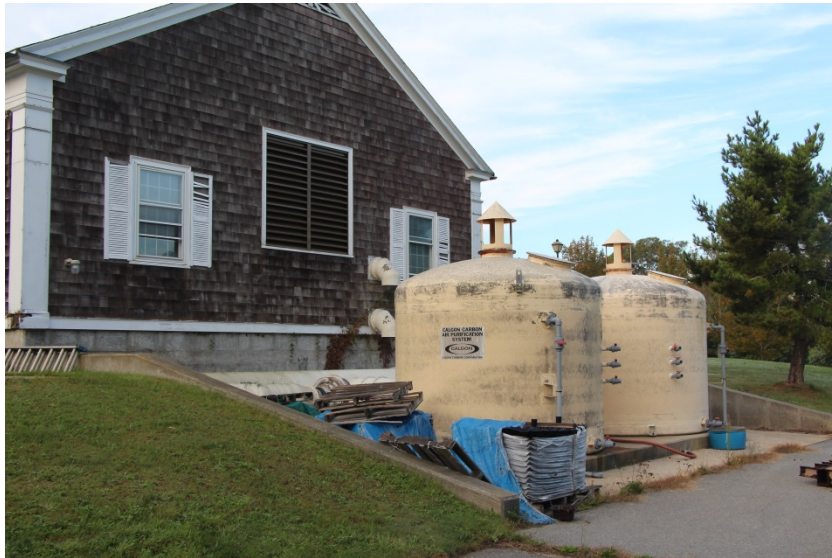
Main Odor Control Carbon Canisters

| Recommendation | Description | Total Installed Cost | Probability of Needing to Be Done Prior to 2021 | Prorated Cost |
|---|---|---|--|---|
| Odor Control Carbon | Carbon is spent | \$ 30,000 | 100% | \$ 30,000 |

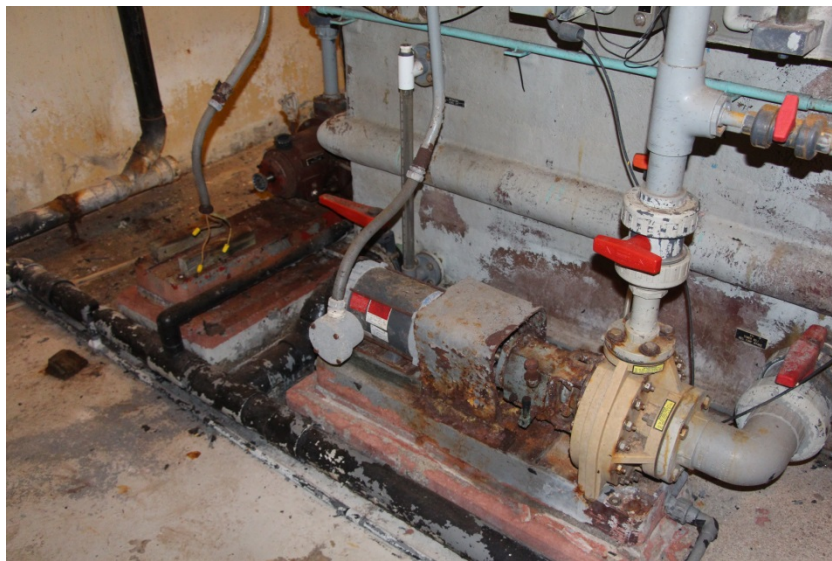
Odor Control System - The odor control system for the receiving area consists of wet scrubbers followed by carbon adsorption. This equipment, while aging, appeared to be functioning adequately as there were no noticeable odors on the day of the visit. However facility staff report that there have been recent instances of odor break-thru during periods of heavy receiving and/or processing. The carbon in at least one of the canisters will need to be replaced to mitigate odors over the interim period. Only one of three chemical recirculation pumps is operable for the wet scrubber system. Replacement of at least one pump should be considered to provide reliable redundancy.

Main Odor Control Wet Scrubber Recirc Pump

| Recommendation | Description | Total Installed Cost | Probability of Needing to Be Done Prior to 2021 | Prorated Cost |
|---|---|---|--|---|
| Odor Control Chem Circ Pump | Only one pump operational. Buy new pump for redudancy. | \$ 12,500 | 75% | \$ 9,375 |

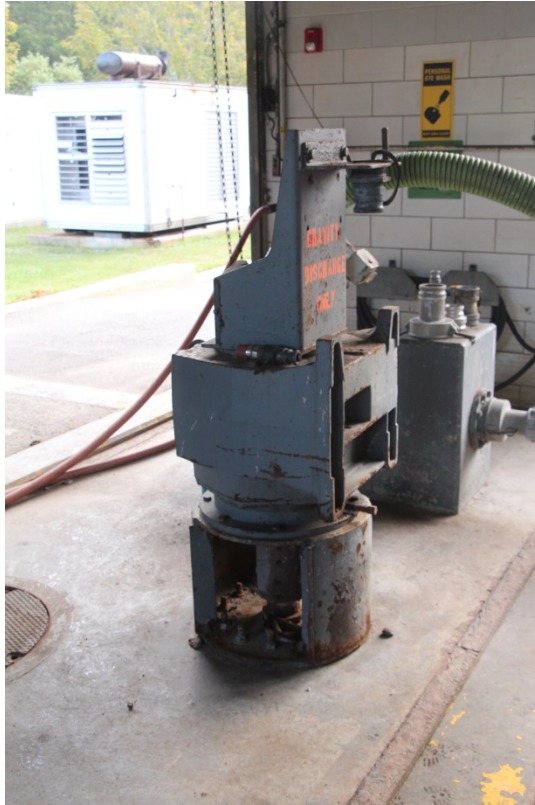
Septage/FOG Receiving Tanks - The tanks appear to be in good condition, as does the air mixing system. The mechanical mixer is out of service on one of the tanks, but the facility staff indicates that the air diffuser system does a reasonable job with mixing. There is some indication of grit/grease buildup within the tanks. Cleaning out of these tanks is a significant effort and beyond the resources of in-house staff and will need to be done in order to keep the facility online for an additional five years.

Septage Equalization Tank Mixer

| Recommendation | Description | Total Installed Cost | Probability of Needing to Be Done Prior to 2021 | Prorated Cost |
|---|---|---|--|---|
| Receiving tank mixer | Mixer on one tank is out, however diffuser system still keeps tank mixed. | \$ 30,000 | 50% | \$ 15,000 |

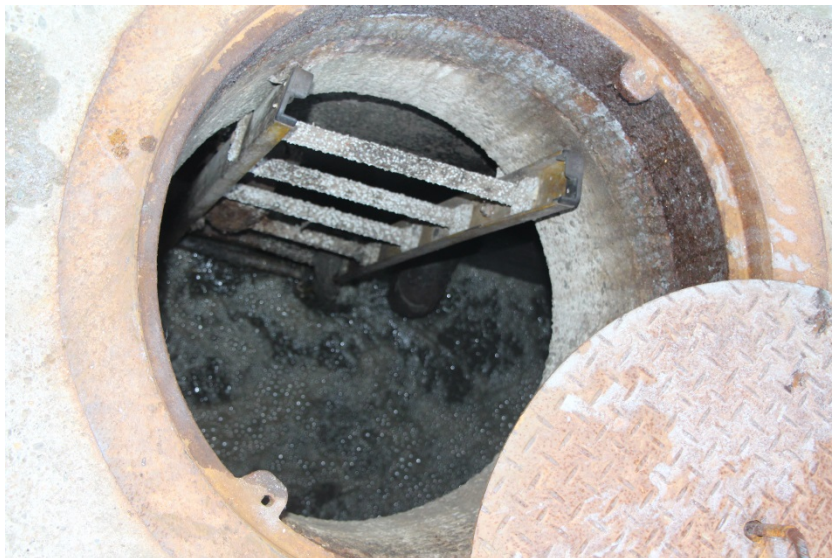
Septage Equalization Tank Diffused Air Mixing

| Recommendation | Description | Total Installed Cost | Probability of Needing to Be Done Prior to 2021 | Prorated Cost |
|---|---|---|--|---|
| Receiving tank cleanout | Tanks full of grease/grit. Need to be cleaned to avoid damage to diffusers and potential clogs in downstream systems | \$ 30,000 | 100% | \$ 30,000 |

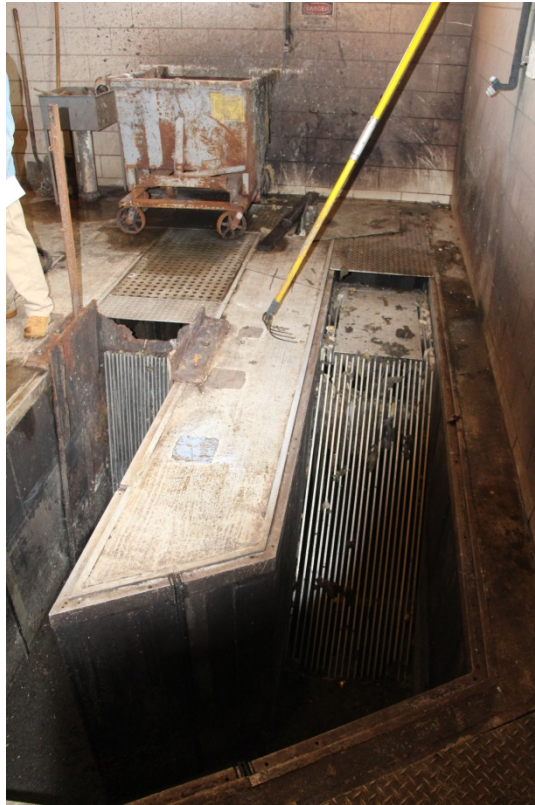
Screening - The original mechanically operated screen was inoperable and has been demolished and replaced with a manual bar rack. This requires the facility staff to clean the screenings off the bar rack manually. In addition to being a physically intensive operation, there is evidence of corrosion, to the point of impending structural failure of the main screen frame. While it is not recommended to do a complete upgrade of this area, some repair/replacement work will be necessary to keep this operation viable for an additional five years.

Severe Corrosion on Receiving Area Screen

| Recommendation | Description | Total Installed Cost | Probability of Needing to Be Done Prior to 2021 | Prorated Cost |
|---|---|---|--|---|
| Screening | Screen close to structural failure. Repace with manual unit, repair channel as needed | \$ 20,000 | 100% | \$ 20,000 |

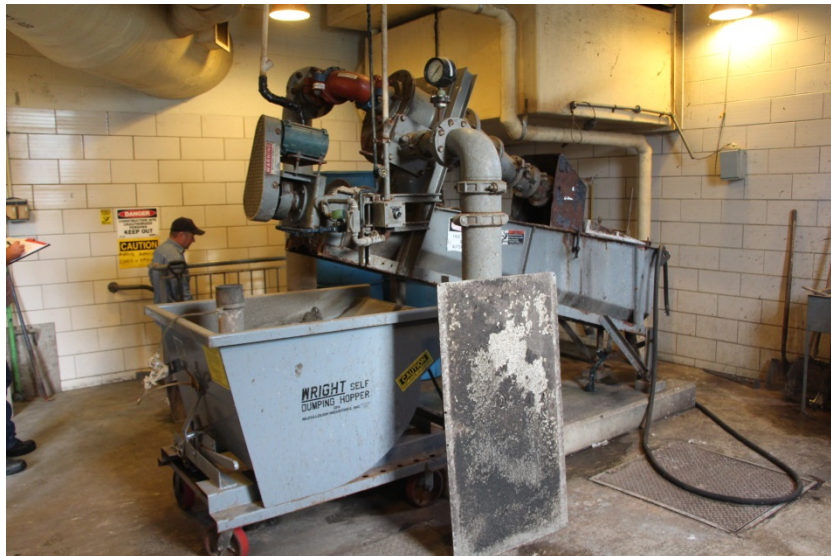
Degritting System - The degritting system is original and is working marginally. In addition, there is some evidence of the feed pumps suffering from abrasion within the volute. Both systems require some attention. It is feasible to avoid wholesale replacement, but some capital money will be needed to keep this important system operable for the interim period.

Aging Receiving Area Degritter

| Recommendation | Description | Total Installed Cost | Probability of Needing to Be Done Prior to 2021 | Prorated Cost |
|---|---|---|--|---|
| Degritter | Only one unit operating with no redundancy, showing signs of decreased performance. Carry allowance to replace components as necessary. | \$ 45,000 | 50% | \$ 22,500 |

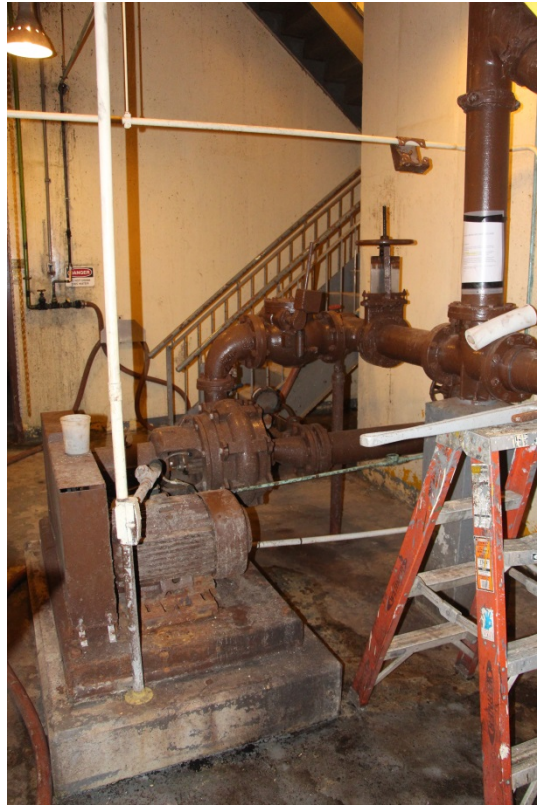
Grit Feed Pump – Corrosion and Abrasion Issues

| Recommendation | Description | Total Installed Cost | Probability of Needing to Be Done Prior to 2021 | Prorated Cost |
|---|---|---|--|---|
| Grit Feed Pumps | Grit feed pumps subject to grit abrasion. Likely to fail. Replace one unit. | \$ 45,000 | 100% | \$ 45,000 |

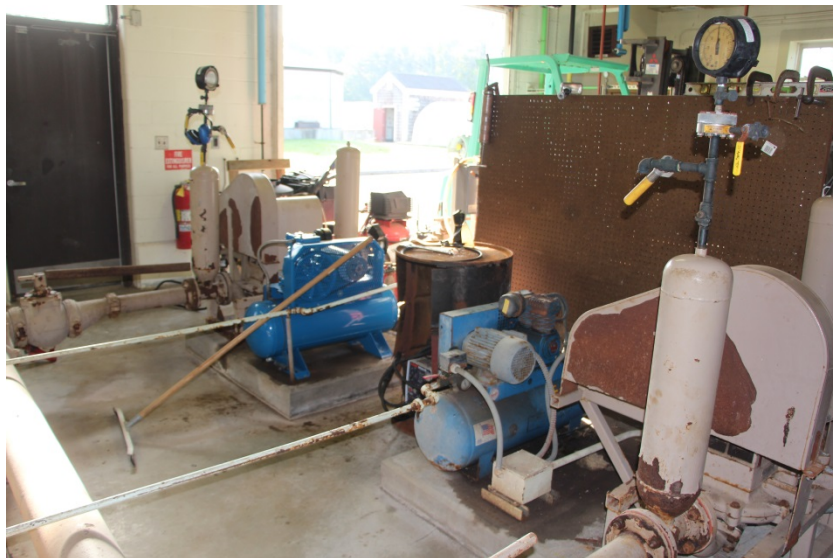
Thickening Systems - Solid processing consists generally of thickening in gravity belt thickeners (GBTs), and dewatering in plate and frame presses. At the time of the visit, one of two GBTs was online and operating well. The other was in the process of maintenance, but there didn't appear to be any major issues with either. The thickened sludge pumps were both operable, but both are original and it's reasonable to assume they will require some capital repair/replacement work during the interim period.

Thickened Sludge Pumps in Need of Component Repair/Replacement

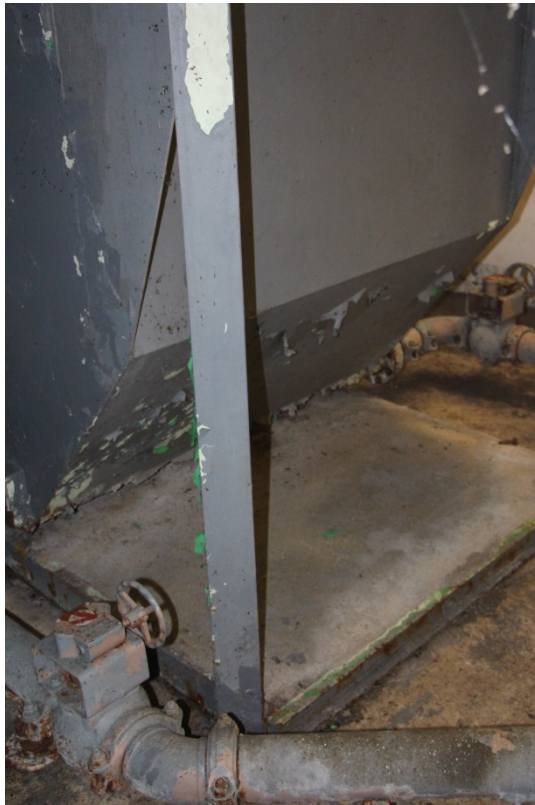
Lamella Clarifier Corrosion

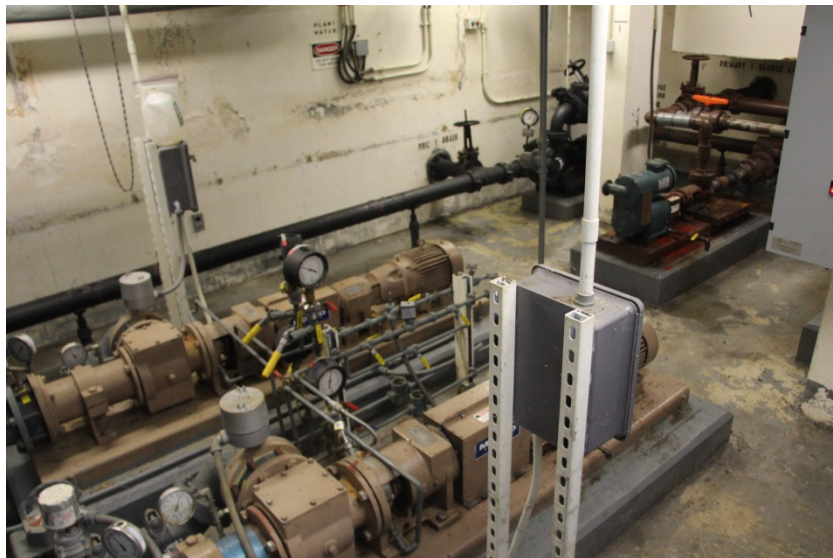
Original Lamella Clarifiers and Intermediate Pump Station - The facility was originally supplied with Lamella clarifiers for clarification of RBC effluent. They were made redundant by the addition in 1995 of more conventional secondary clarifiers, however they still are part of the flow path of effluent from the RBCs to the newer secondary clarifiers. Facility staff has expressed concern regarding the structural integrity of the Lamellas. Should they fail, they would result in a complete loss of filtrate processing capability and the flooding of the area housing the intermediate pumps that lift flow to the newer secondary clarifiers. Not being part of the current treatment scheme, the Lamellas do not require replacement per se, however piping modifications should be made to bypass them and eliminate the consequences of a vessel failure. Additionally, one of the two intermediate pumps that lift flow to the secondary clarifiers needs to be rebuilt/replaced.

Intermediate Pumps Requiring Rebuild

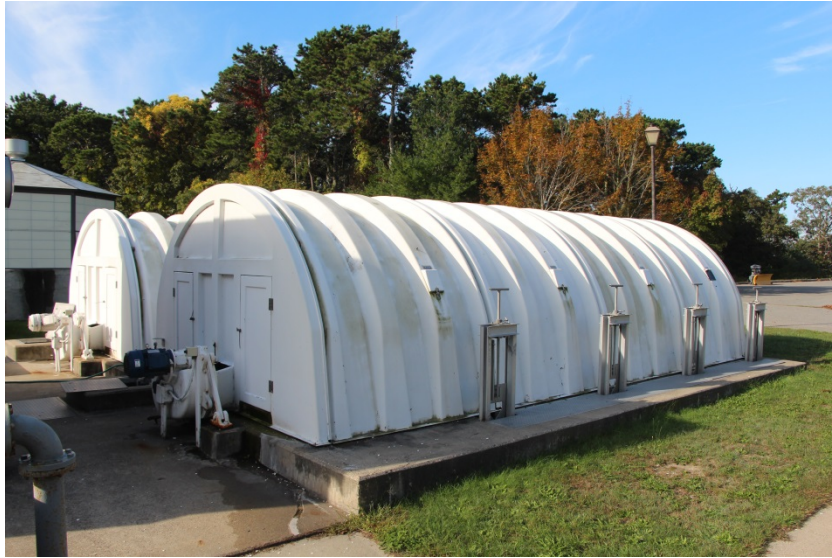
Rotating Biological Contactors (RBCs) - The four RBCs are the heart of the liquid train system. Two of the units have been rebuilt in the past 10 years. Three are currently needed to handle facility flow, with one of the older units being kept offline in reserve. In order to maintain facility capacity at rated levels, one unit will almost certainly need to be refurbished. Two options are available:

Four RBCs in Total – Two Original and at End of Life

- Replace both units or
- Refurbish just one of the older units with funds kept in reserve to refurbish a second unit should one of the duty RBCs fail. The standby unit will still be old and available for only limited service if one of the three duty units goes offline for any reason. The risk associated with this is the last remaining original unit failing before repairs could be made on one of the rebuilt units. Repairs might be expected to take up to three to four months.
