# TOWN OF ORLEANS

# FIRE STATION FEASIBILITY STUDY

August 11th, 2021

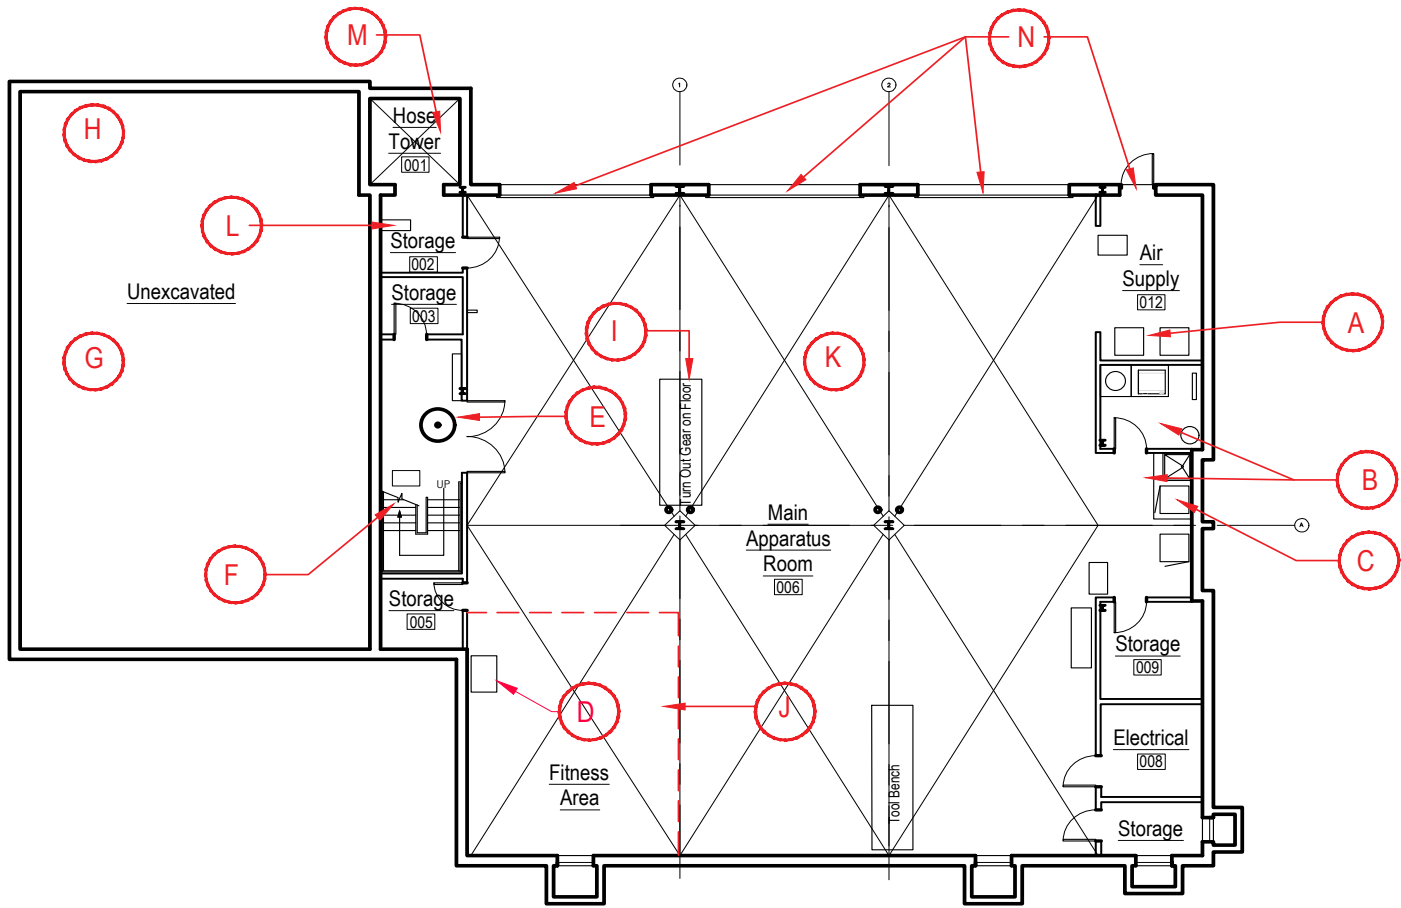
- C. Domestic washer/dryer in gear area - Hazardous chemical exposure to all occupants and bedding
- D. Ice Machine location - should be located in area safe from carcinogenic contamination. Currently piped to floor drain - tripping hazard

- G. EMS Supplies storage is not centralized and inadequate, on apparatus floor, in contaminated areas, near office and lobby areas
- H. Truck repair - inadequate space for repairs due to ceiling height

- I. Turn out gear stored in apparatus bay - NFPA violation
- J. Fitness area in apparatus bay - leading to carcinogenic exposure
- K. Apparatus floor drains clog and routinely back up, drains go to a septic leech pit, not a tight tank

- L. Plymovent system not designed for vehicles that must be turned around during winter storms due to grade. Installed 2009 - soot stained walls from pre-2009

- Lower floor Apparatus door height/Ceiling height - Inadequate for apparatus. Door height at lowest point is currently 11'6", contemporary standards require 14'-0" doors
- Very limited storage
- Electrical service will be insufficient for new service requirements
- Flooding and equipment loss on basement level - potential mold on walls where supplies are stored

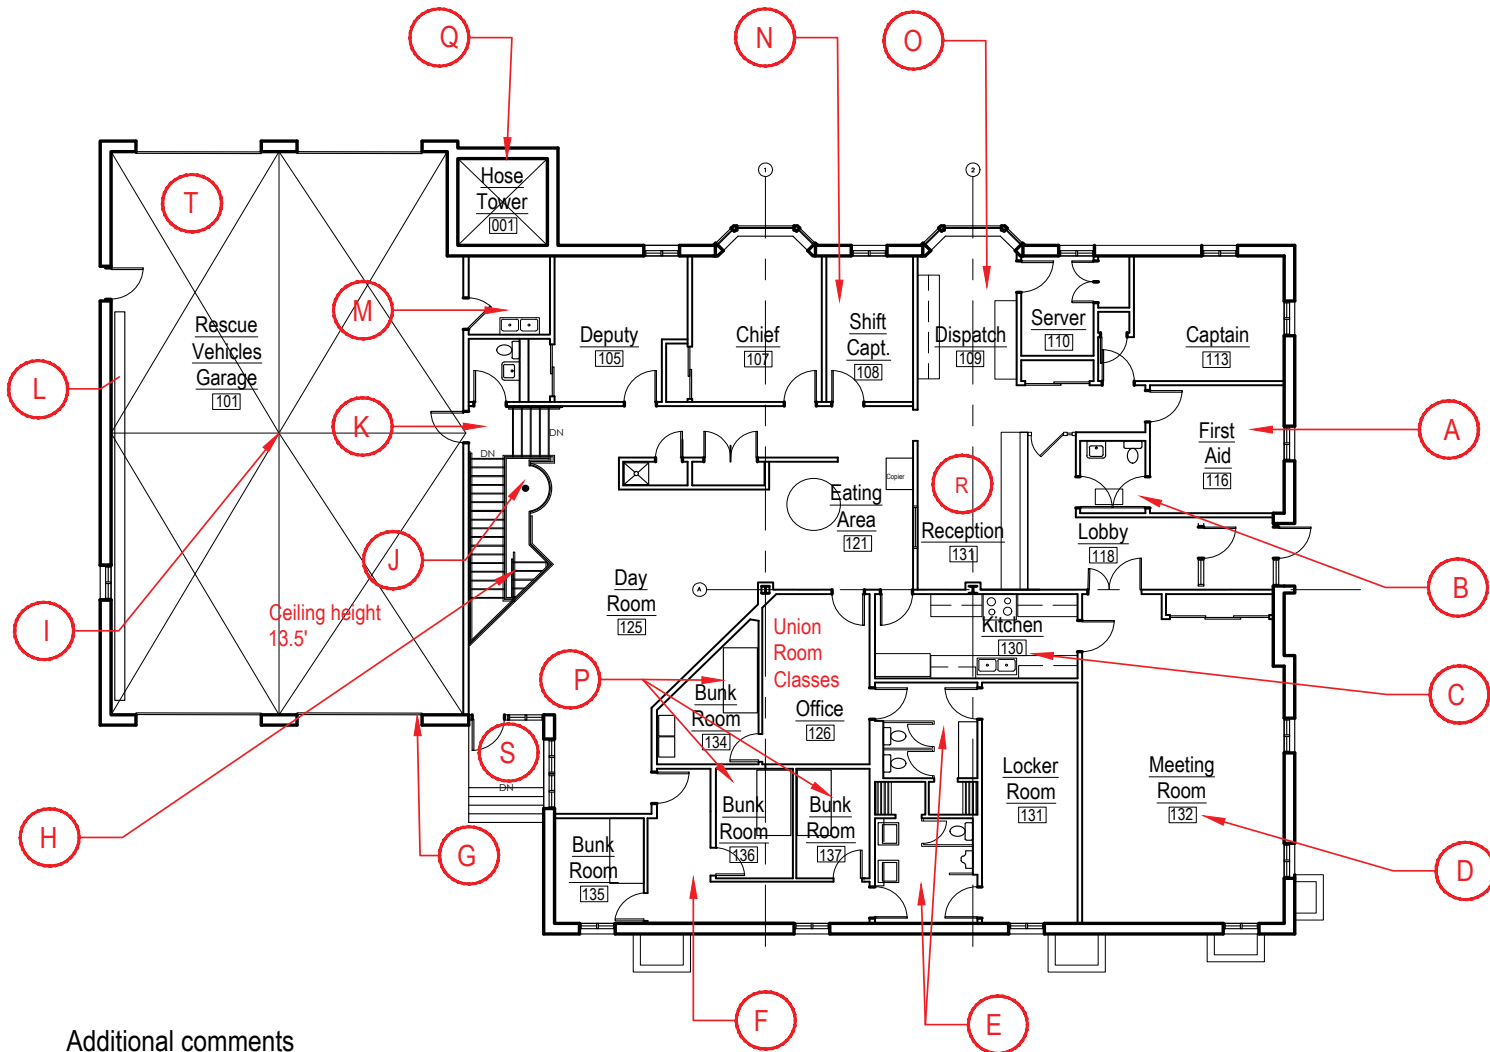
- B. Public restroom (MAAB Violation) - Unsecured location and privacy issues (odor, etc)
- C. Kitchen - Current facility has been outgrown, is outdated and inadequate for personnel. Not MAAB compliant

- D. Training/Meeting Room - Not large enough to accommodate 30+ station personnel, and to function as backup Emergency Operations Center. Temporary HVAC repair takes up space.

- F. Laundry facilities - No domestic laundry available leading to potential carcinogen transfer.
- G. First floor apparatus door height/Ceiling height - Inadequate for apparatus. Door height at lowest point is currently 10', ceiling height is 13.5' Contemporary standards require 14'-0" doors

- L. Turnout gear on apparatus floor - does not conform to NFPA standards
- M. EMS Medical Supply - Space inadequate  
Two bay sink blocks door swing
- N. Shift capt. office - Used for sleeping but was not designed for this. Poorly located

- O. Dispatch area - No longer used therefore inactive space
- P. Bunk rooms in violation of building codes. No natural light or ventilation. Too small as built.

- Q. Hose tower no longer used
- R. Reception desk not MAAB compliant
- S. No separation of the dayroom from the exterior - door not tight and cold air infiltrates

- T. Vehicles must be driven out of the back of the upper apparatus bay - can not back up the hill during minimal snow and ice (even with plowing and sanding)

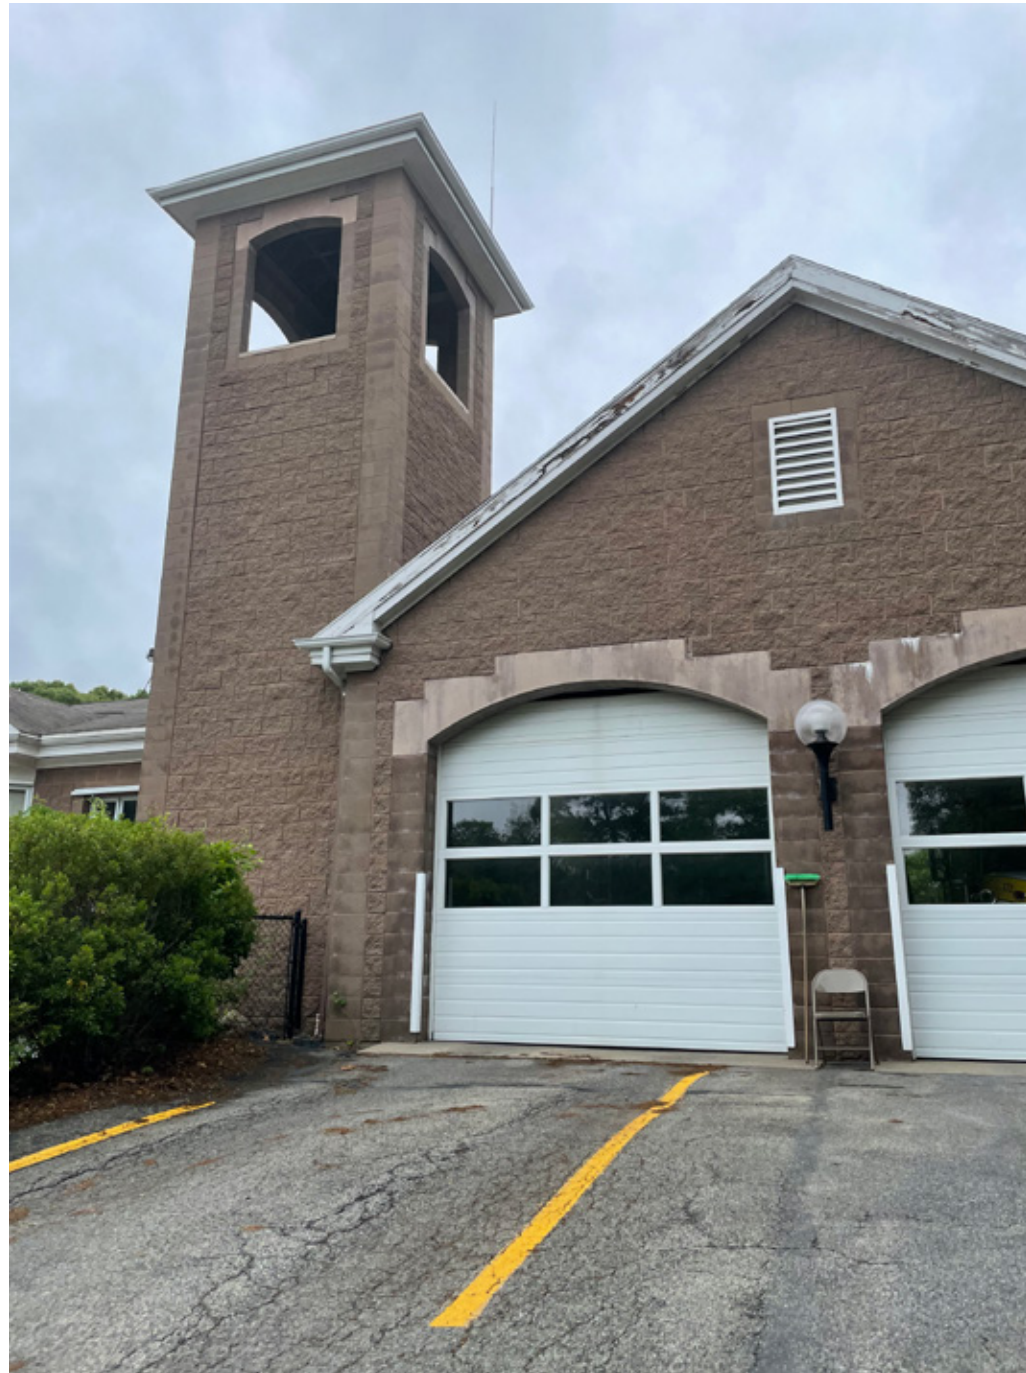
Apparatus bays lack a concrete apron, and asphalt is in poor condition. Precast arch shaped lintels limit effective overall height of doors which limits apparatus selection

**It is recommended that concrete aprons be incorporated into any future design thinking**

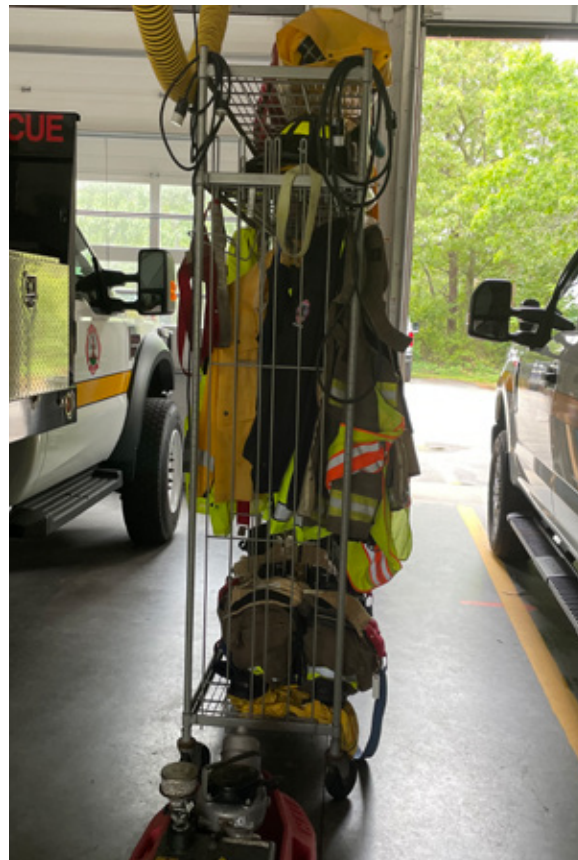
Turnout gear is stored in unsafe conditions in the apparatus bays and does not conform to NFPA standards

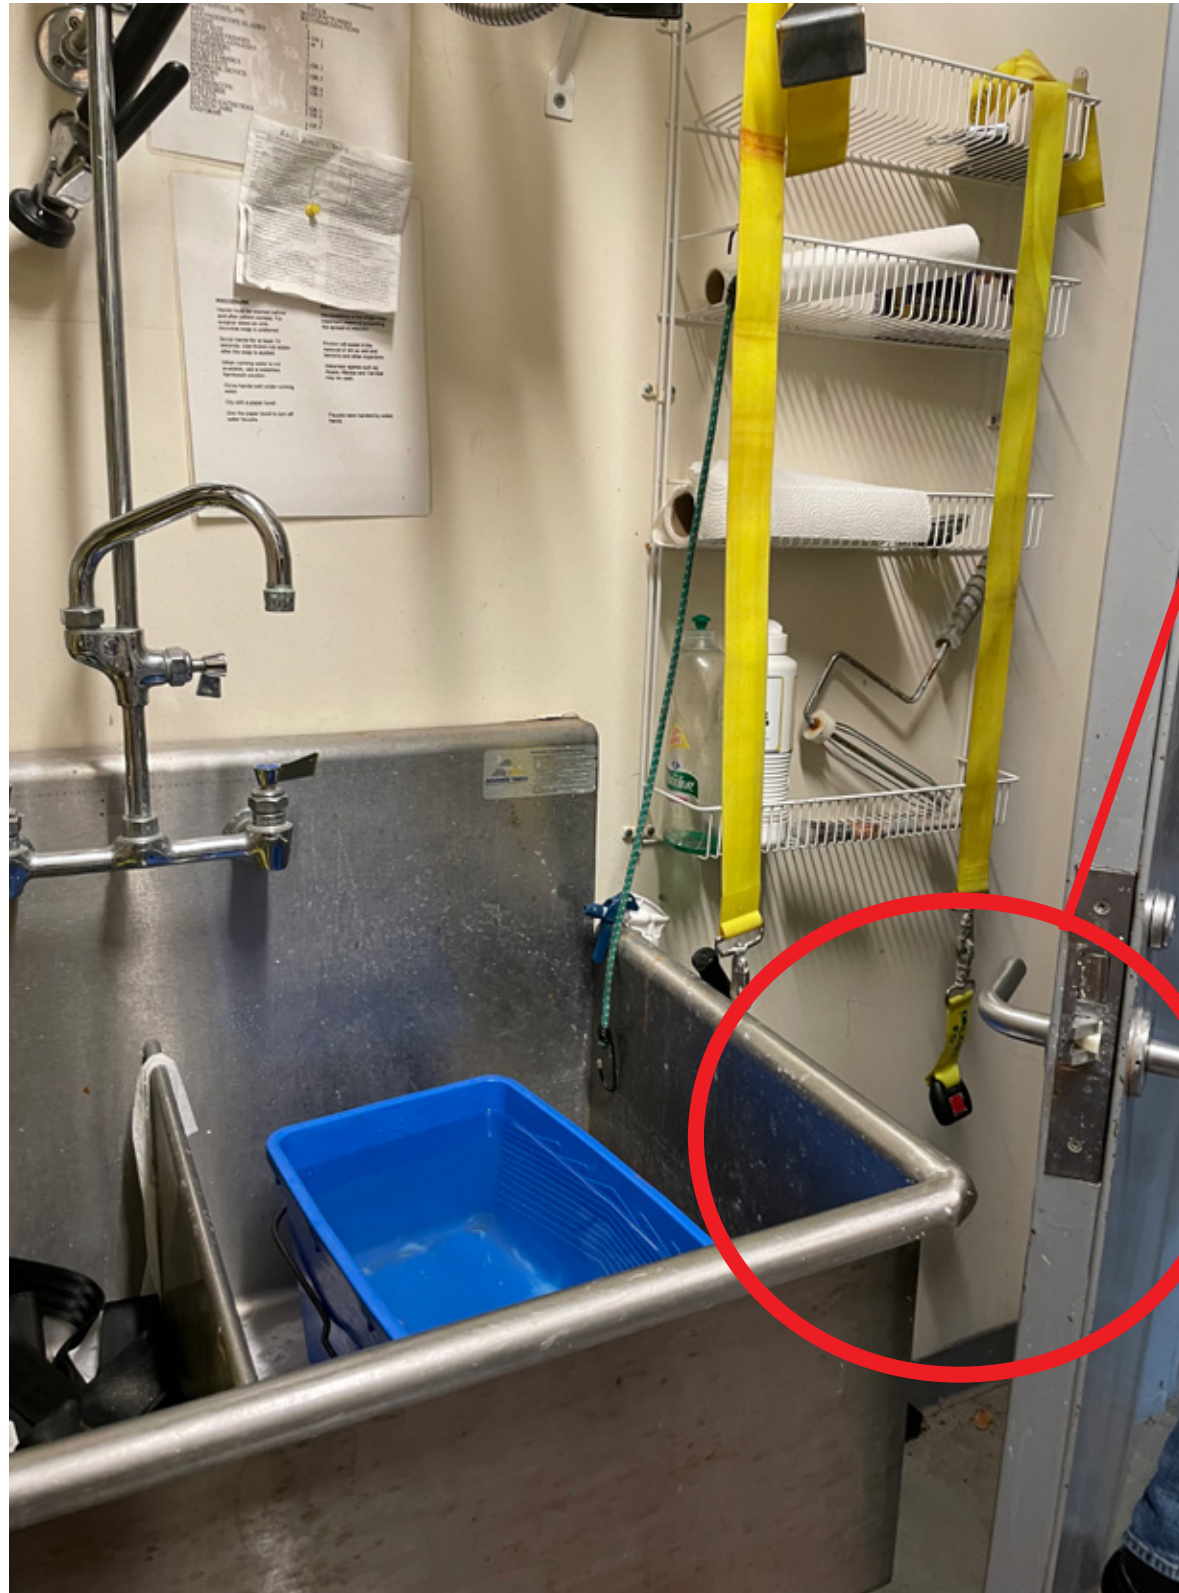
EMS Supply Room was retrofitted with a sink. Because of crowded conditions door can not fully open.

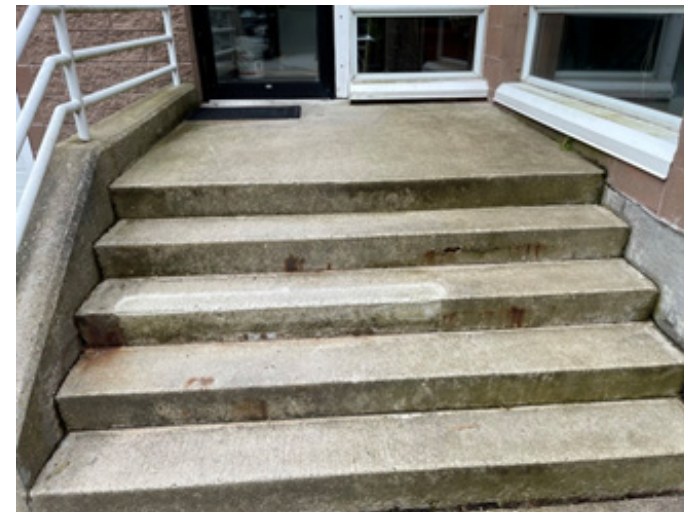
Photo #4 Building West Elevation  
Concrete steps with minor cracks and surface  
rusting observed

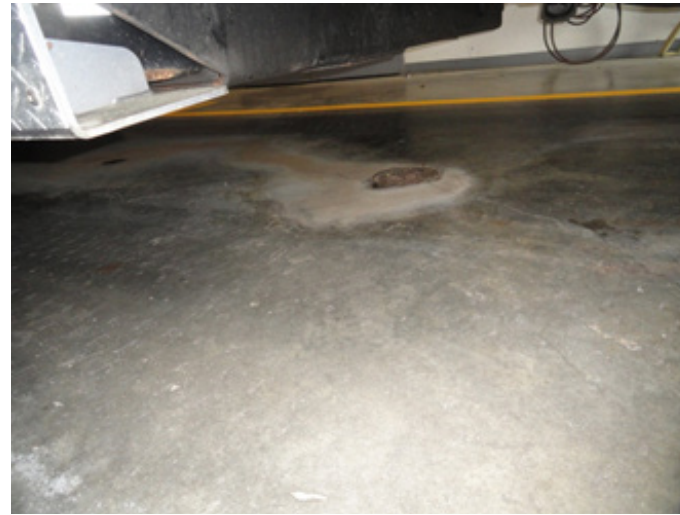
Photo #10 Basement Apparatus Room slab  
Shrinkage cracks at the front north bay

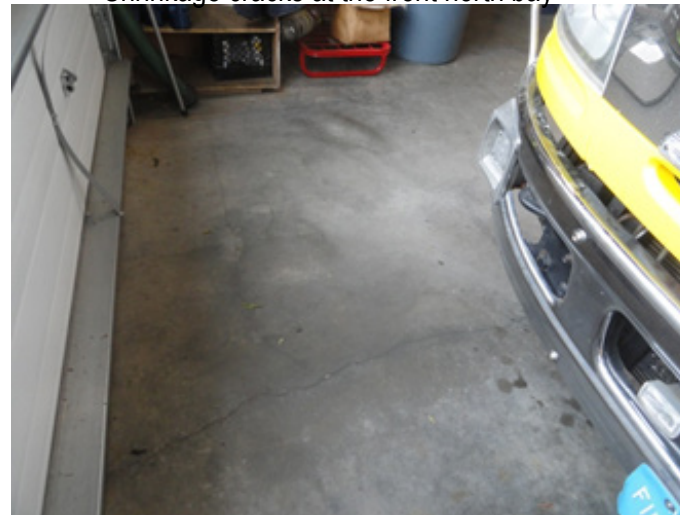
Photo #12 Basement Apparatus Room slab  
Shrinkage cracks at the front south bay

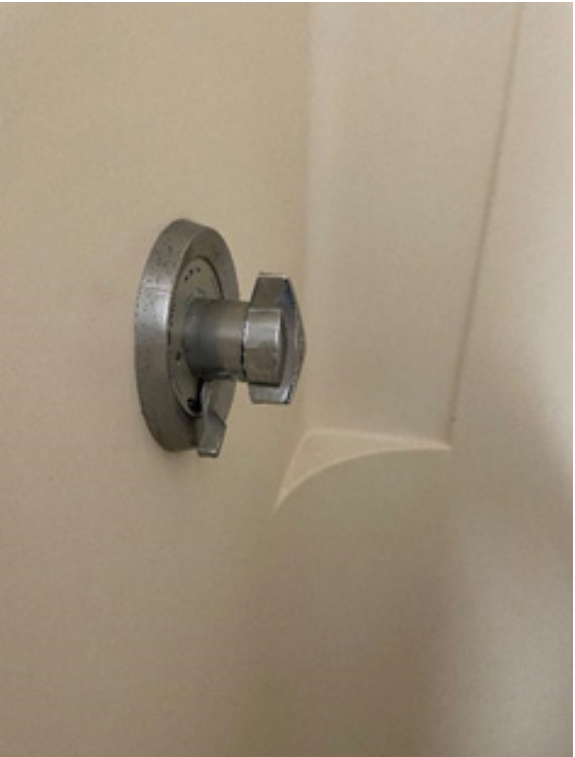
Existing Shower Valve

5. Showers: The two showers in the building are fiberglass units with integral thermostatic mixing valves. The showers appear to be in poor condition and it is recommended that these be replaced.

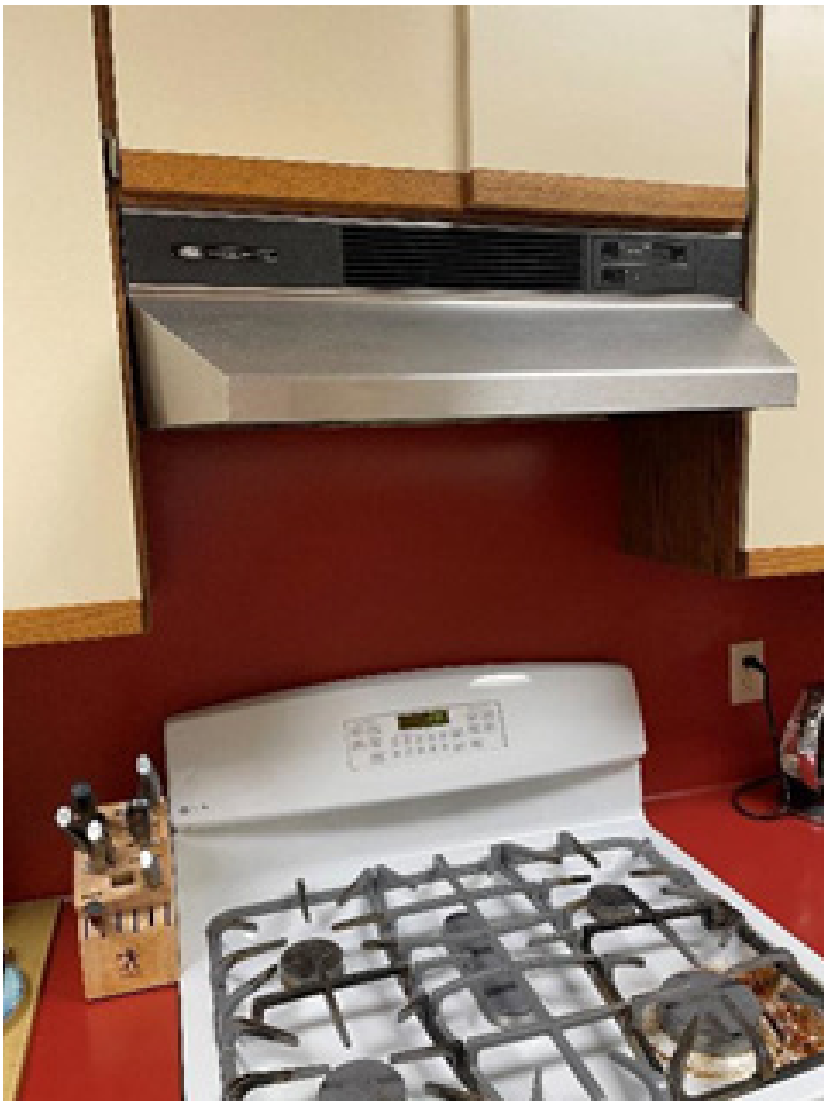
Kitchen Oven and Cooktop

7. Kitchen: The Kitchen is provided with a residential oven and exhaust hood. These appliances are both significantly outdated and not sufficient for a modern day fire station. It is recommended that these be removed and updated with commercial appliances and proper exhaust to meet MAAB requirements

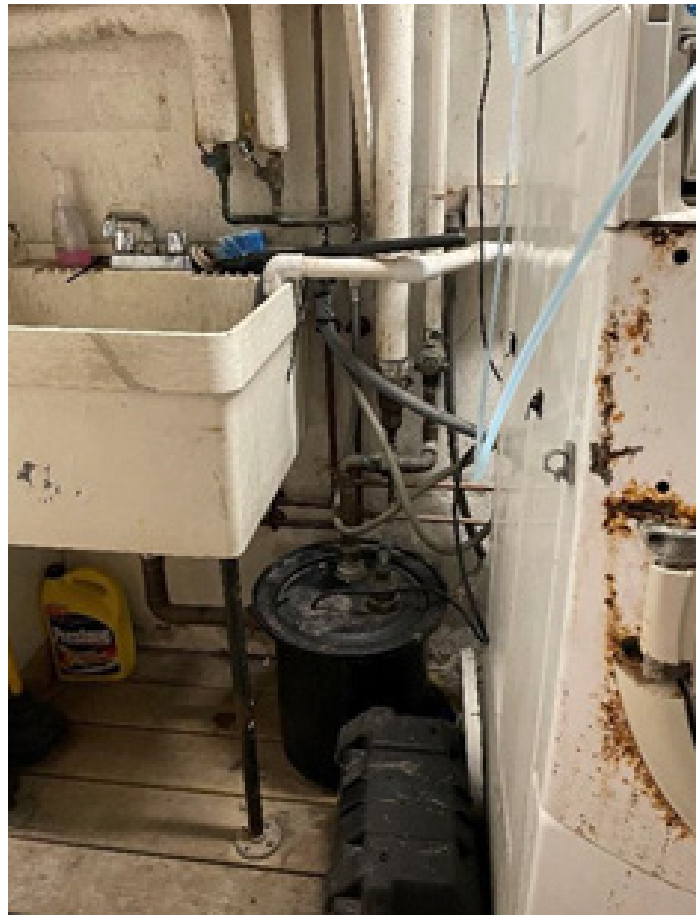
Ejector Pump for Laundry Tub

9. Extractor and Washing Machine Waste: The waste from the extractor and washing machine in the Apparatus Bay drain into a laundry tub sink. The waste from the sink is then pumped up via an ejector pump and taps into the gravity waste. It was brought to CES' attention that the sink routinely overflows onto the floor when the extractor and washing machine are running. This issue is likely caused by an undersized ejector pump which cannot handle the amount of water flow.

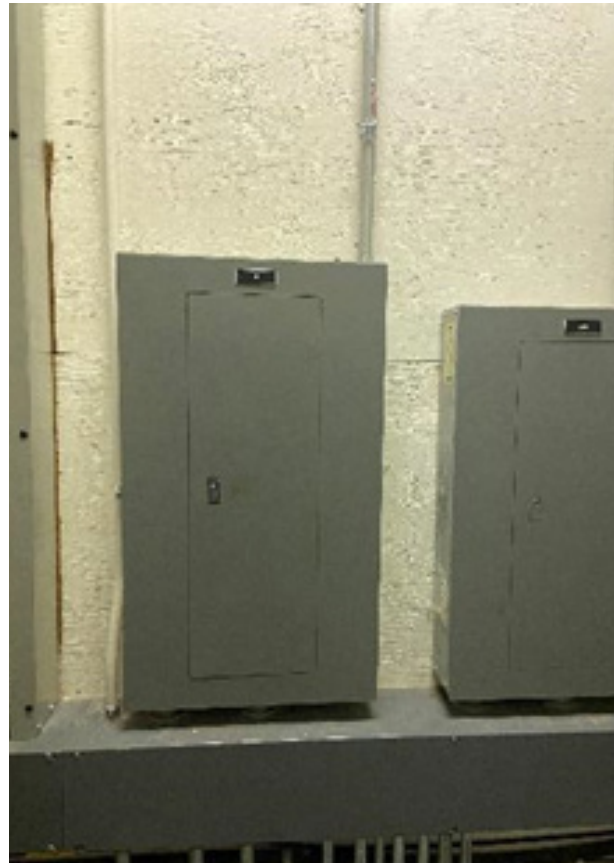
Older Electrical Panels

3. Panelboards: There are a number of branch circuit panelboards in the Main Electrical Room. These panelboards are original to the building and manufactured by Square D. There are missing blank-off plates in one panel. These original panelboards are in fair condition and have very limited spare capacity. There are also newer panelboards that were installed with the generator. These panels are manufactured by Siemens/I-T-E and are in good condition.
