Town of Orleans Stormwater Management Project

Orleans Fresh Water Ponds Committee Meeting

January 17, 2017

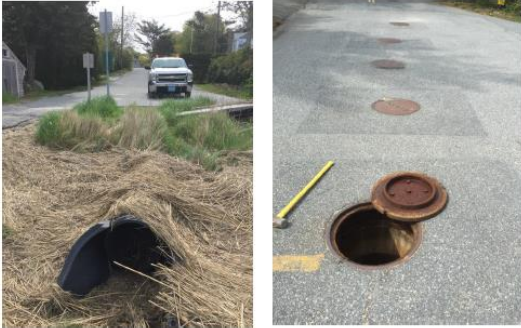
BMP ID: 11-BMP-1 Asa's Landing
Location: Asa's Landing

System Description:
Subsurface treatment - two deep sump catch basins with eight leaching pits and 18-inch outfall to Town Cove

Accumulated Sediment?
2-feet of sediment in catch basins

Condition of System:
4

Additional Notes:
System needs routine catch basin cleaning. Site has room for expansion. Installed in 1999.

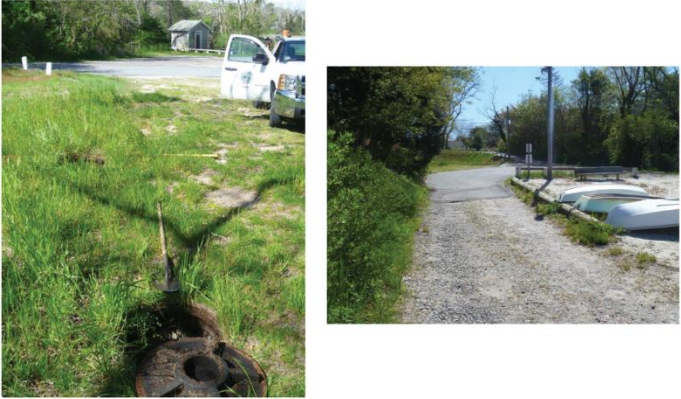
BMP ID: 43-BMP-1

System Description:
Two deep sump catch basins, eleven leaching pits, settling tank, headwall and outfall to Meetinghouse Pond.

Standing Water in Leaching Facility?
Yes, three feet of water.

Accumulated Sediment?
Yes, 6 inches.

Condition of System:
3,1

Additional Notes:
System regularly becomes inundated. Original design may be cause of inundation. In need of re-engineering. Site has room for expansion.
