Subject **Town of Orleans, MA
Water Quality and Wastewater Planning
Task Number 4 – Adaptive Management Plan – Deliverable 4.f.6 - Final Technical
Memorandum for Stormwater and Fertilizer Monitoring**

Project Number 60476644

From Thomas Parece, P.E., AECOM Project Manager

Date 05/25/16

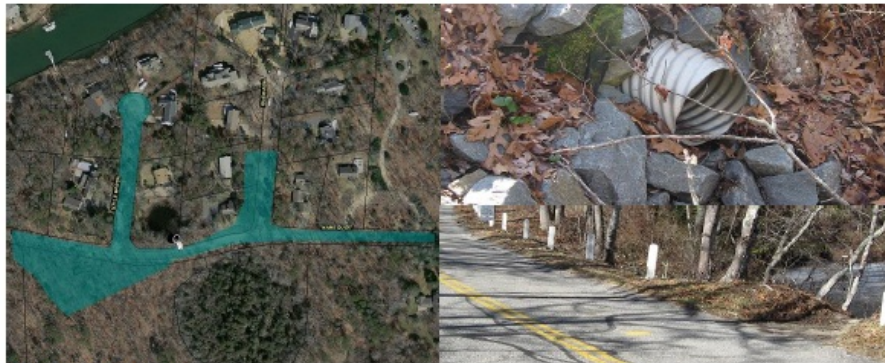
Seasonal residential with average 1/2 acre lots. Majority of runoff from Namequit Road and some from Little Marsh lane.

Abandoned outfall or old culvert observed near 69-OUT-1

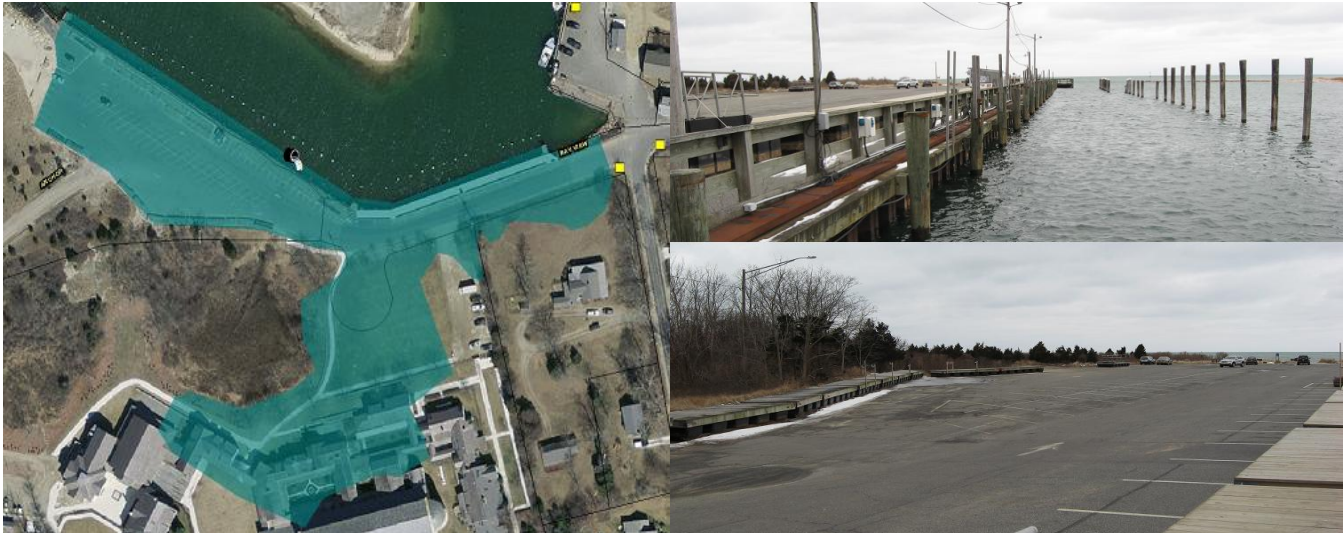
Actual outfall location was not observed. Assumed outfall located at drain manholes. No catch basins were observed and it was assumed that the parking area was included in the drainage area.

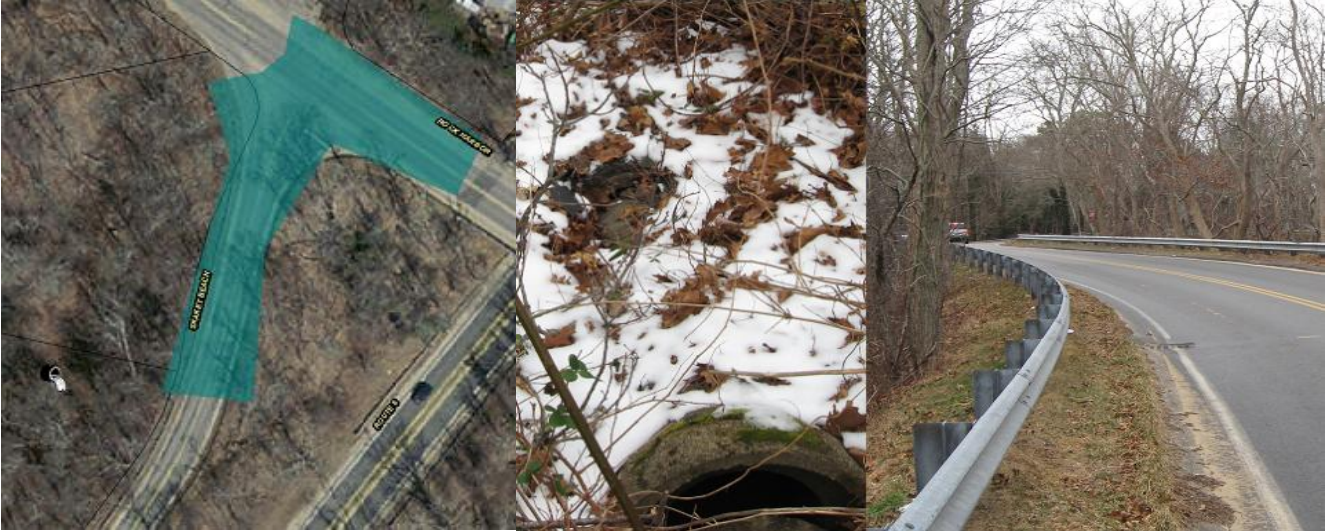
Observed multiple gaps in the concrete outfall pipe. Outfall pipe was partially submerged under dirt and brush.

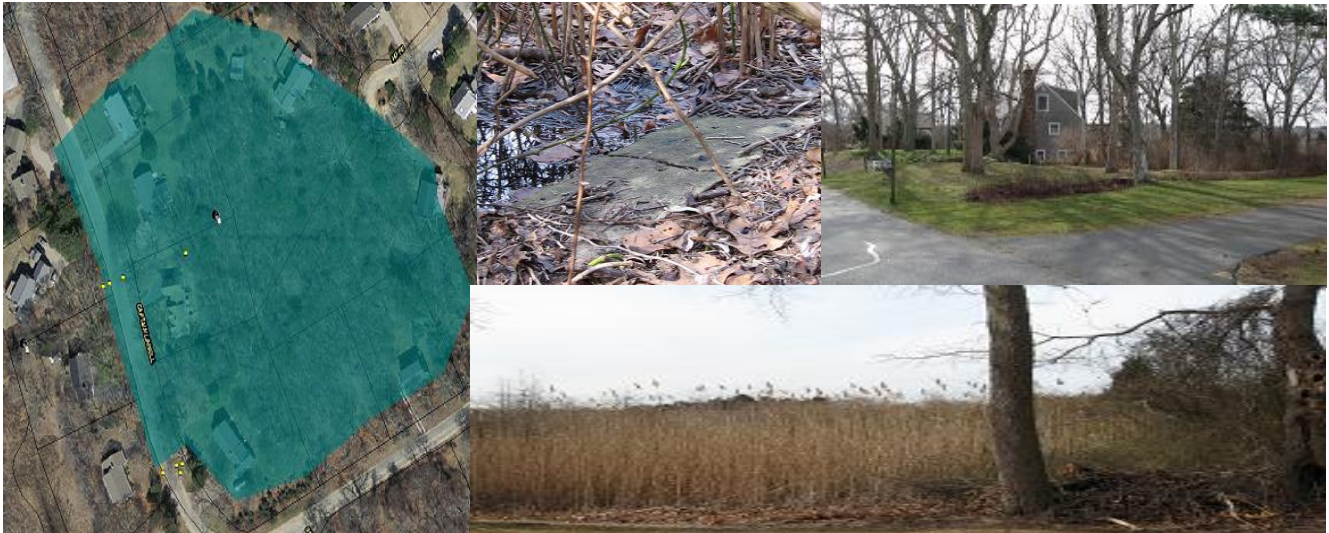
Outfall fully submerged. Cleaning recommended.

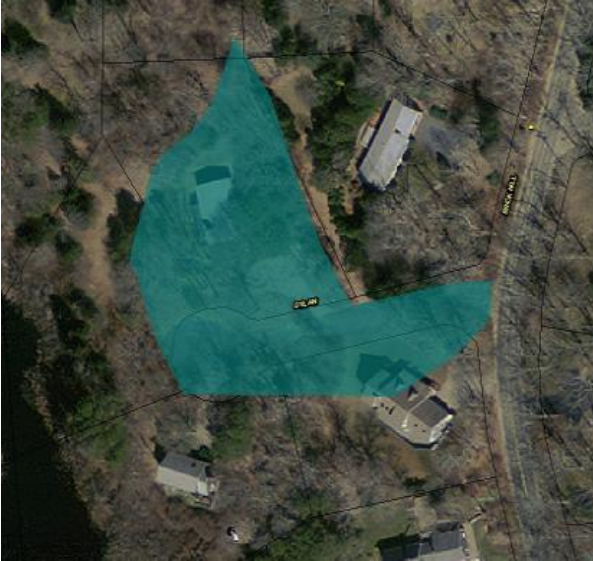
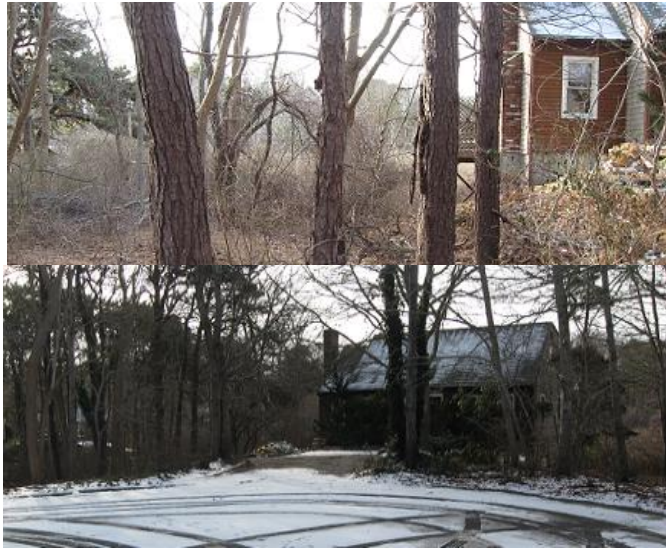
Unable to locate outfall or any drainage structures.

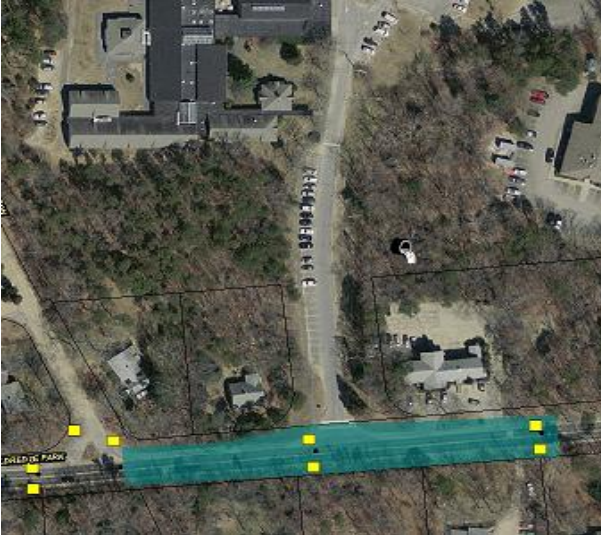
Manhole cover located in elementary school parking lot. No catch basins were found in the parking lot.

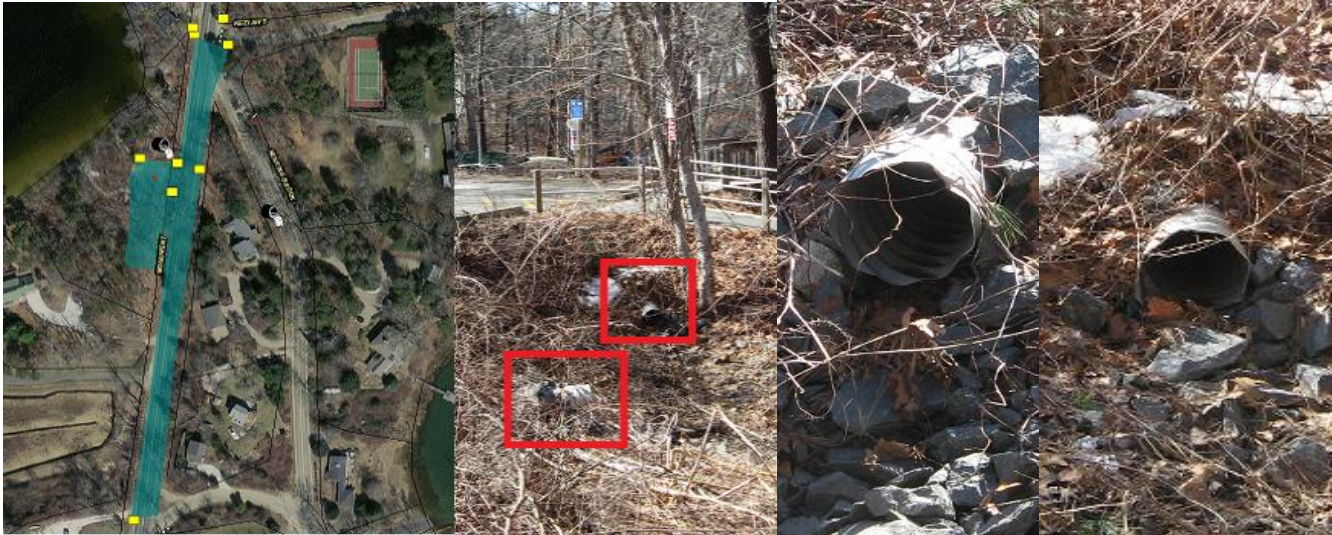
Includes runoff from Monument Road and Dickenson Conservation Area paved parking lot.

Two Outfalls were found and both drain into the same discharge area. Unable to determine which structures lead to each outfall.

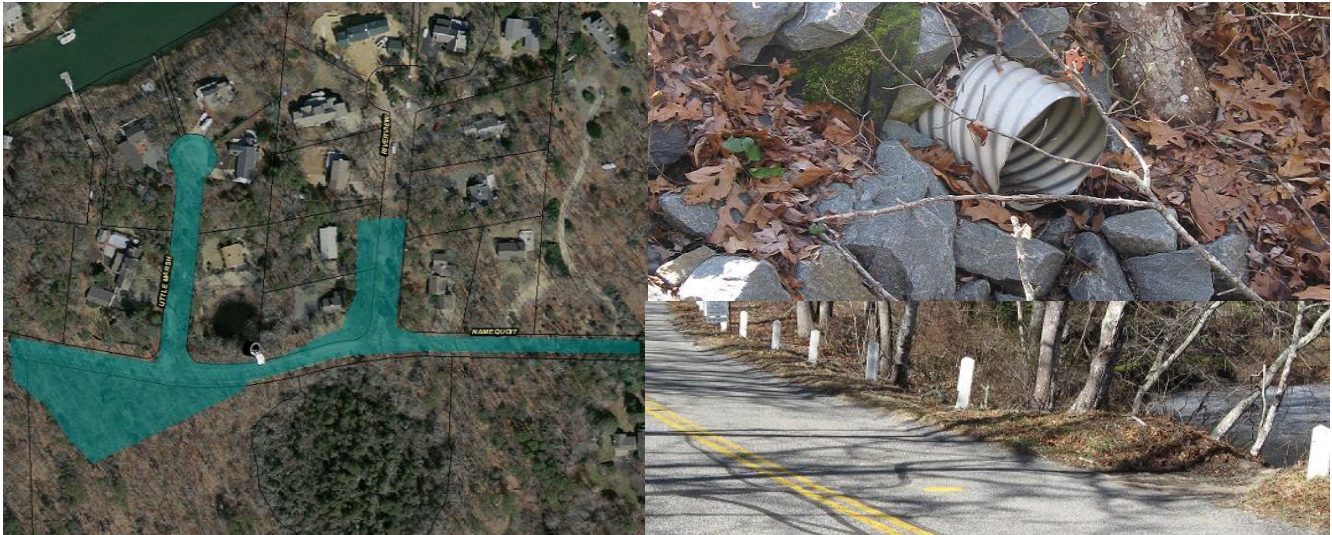
Seasonal residential with average 1/2 acre lots. Majority of runoff from Namequoit Road and some from Little Marsh lane.

Abandoned outfall or old culvert observed near 69-OUT-1
