# TOWN OF ORLEANS

# FIRE STATION FEASIBILITY STUDY

August 11th, 2021

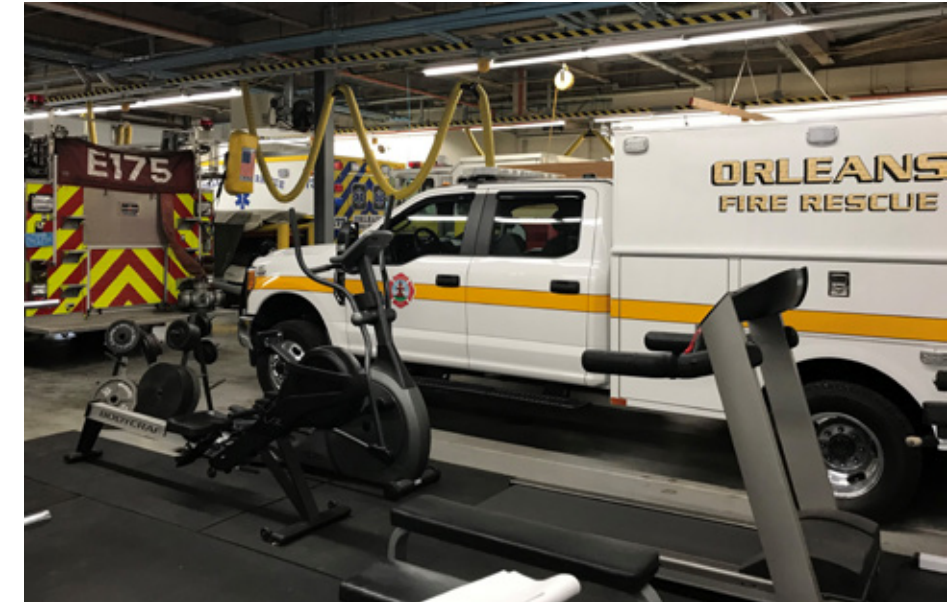
In Orleans, the fitness equipment is located directly on the apparatus floor – the biggest Hot Zone in a fire station – and the worst possible place for deep breathing caused by exercise. Anyone working out on an apparatus floor is breathing in the history of soot, but also potentially any current day carcinogens that return with the trucks and / or the diesel exhaust the trucks emit as they enter the building – even with the Plymovent system. This is a very big hazard and needs to be corrected.

**It is highly recommended that a building be planned and designed to take care of the town's first responders long-term health and welfare by protecting them from carcinogen transfer in the station.**

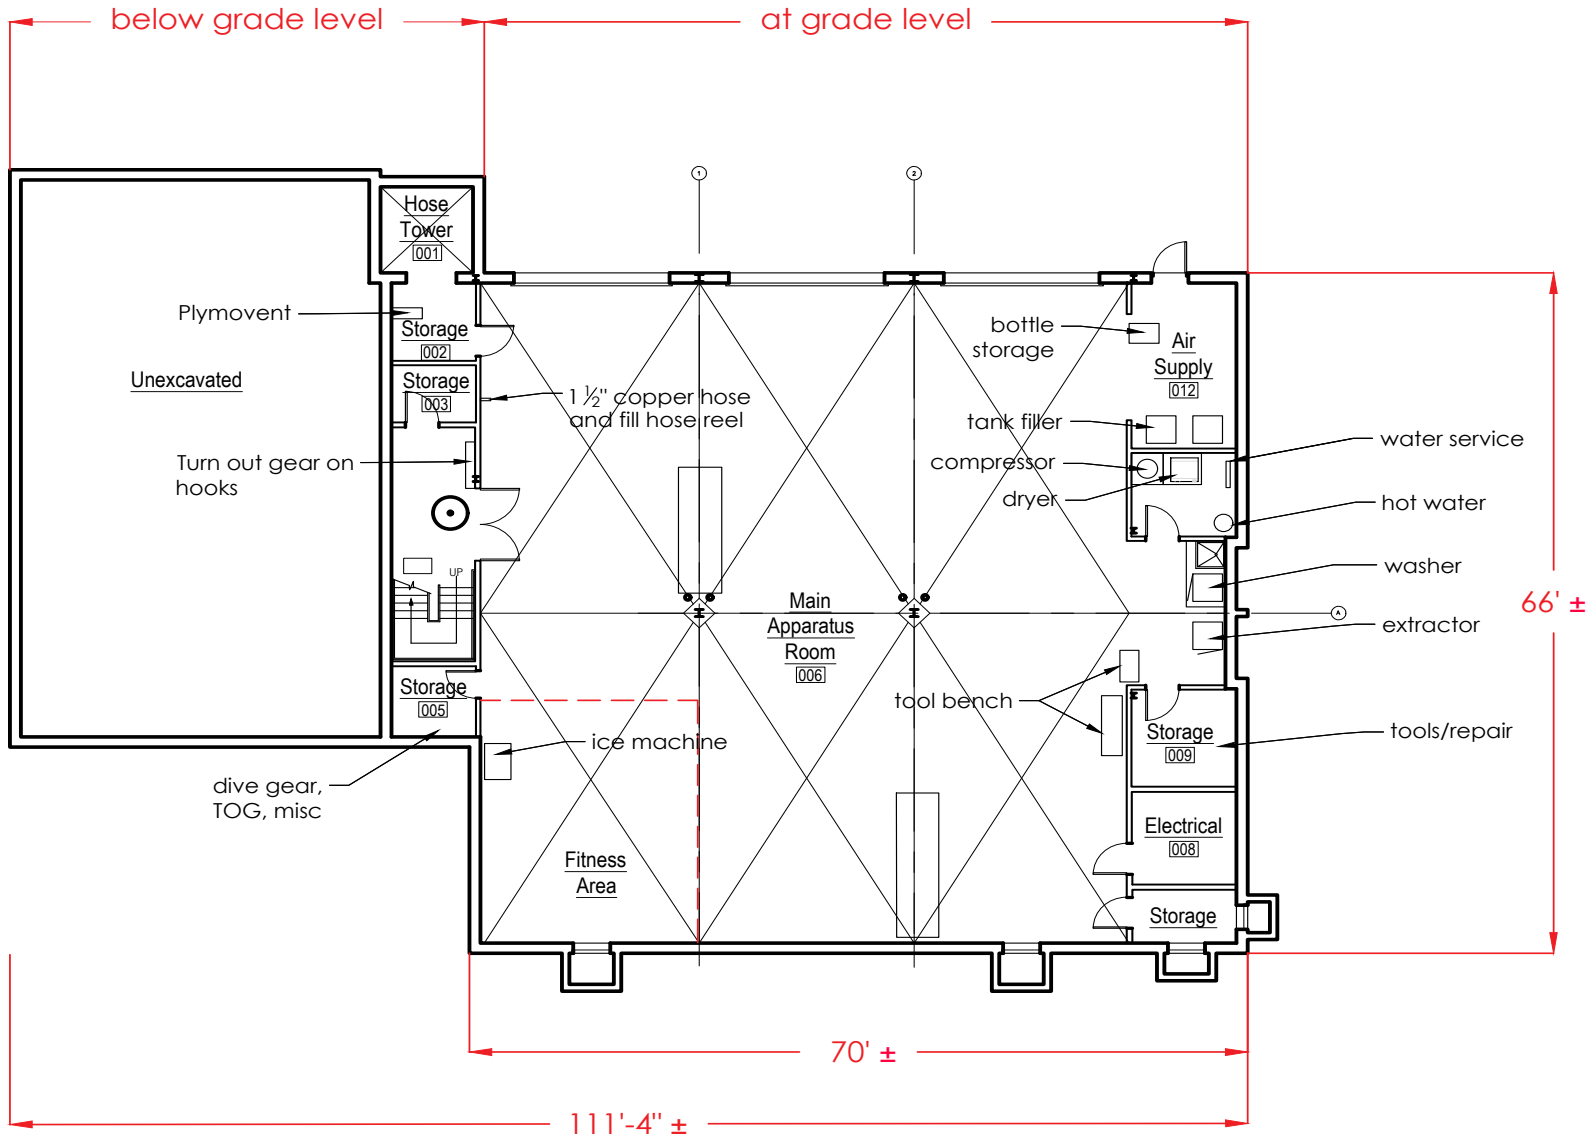
EX-101

- C. Domestic washer/dryer in gear area - Hazardous chemical exposure to all occupants and bedding
- D. Ice Machine location - should be located in area safe from carcinogenic contamination. Currently piped to floor drain - tripping hazard

- G. EMS Supplies storage is not centralized and inadequate, on apparatus floor, in contaminated areas, near office and lobby areas
- H. Truck repair - inadequate space for repairs due to ceiling height

- I. Turn out gear stored in apparatus bay - NFPA violation
- J. Fitness area in apparatus bay - leading to carcinogenic exposure
- K. Apparatus floor drains clog and routinely back up, drains go to a septic leech pit, not a tight tank

- L. Plymovent system not designed for vehicles that must be turned around during winter storms due to grade. Installed 2009 - soot stained walls from pre-2009

- Lower floor Apparatus door height/Ceiling height - Inadequate for apparatus. Door height at lowest point is currently 11'6", contemporary standards require 14'-0" doors
- Very limited storage
- Electrical service will be insufficient for new service requirements
- Flooding and equipment loss on basement level - potential mold on walls where supplies are stored

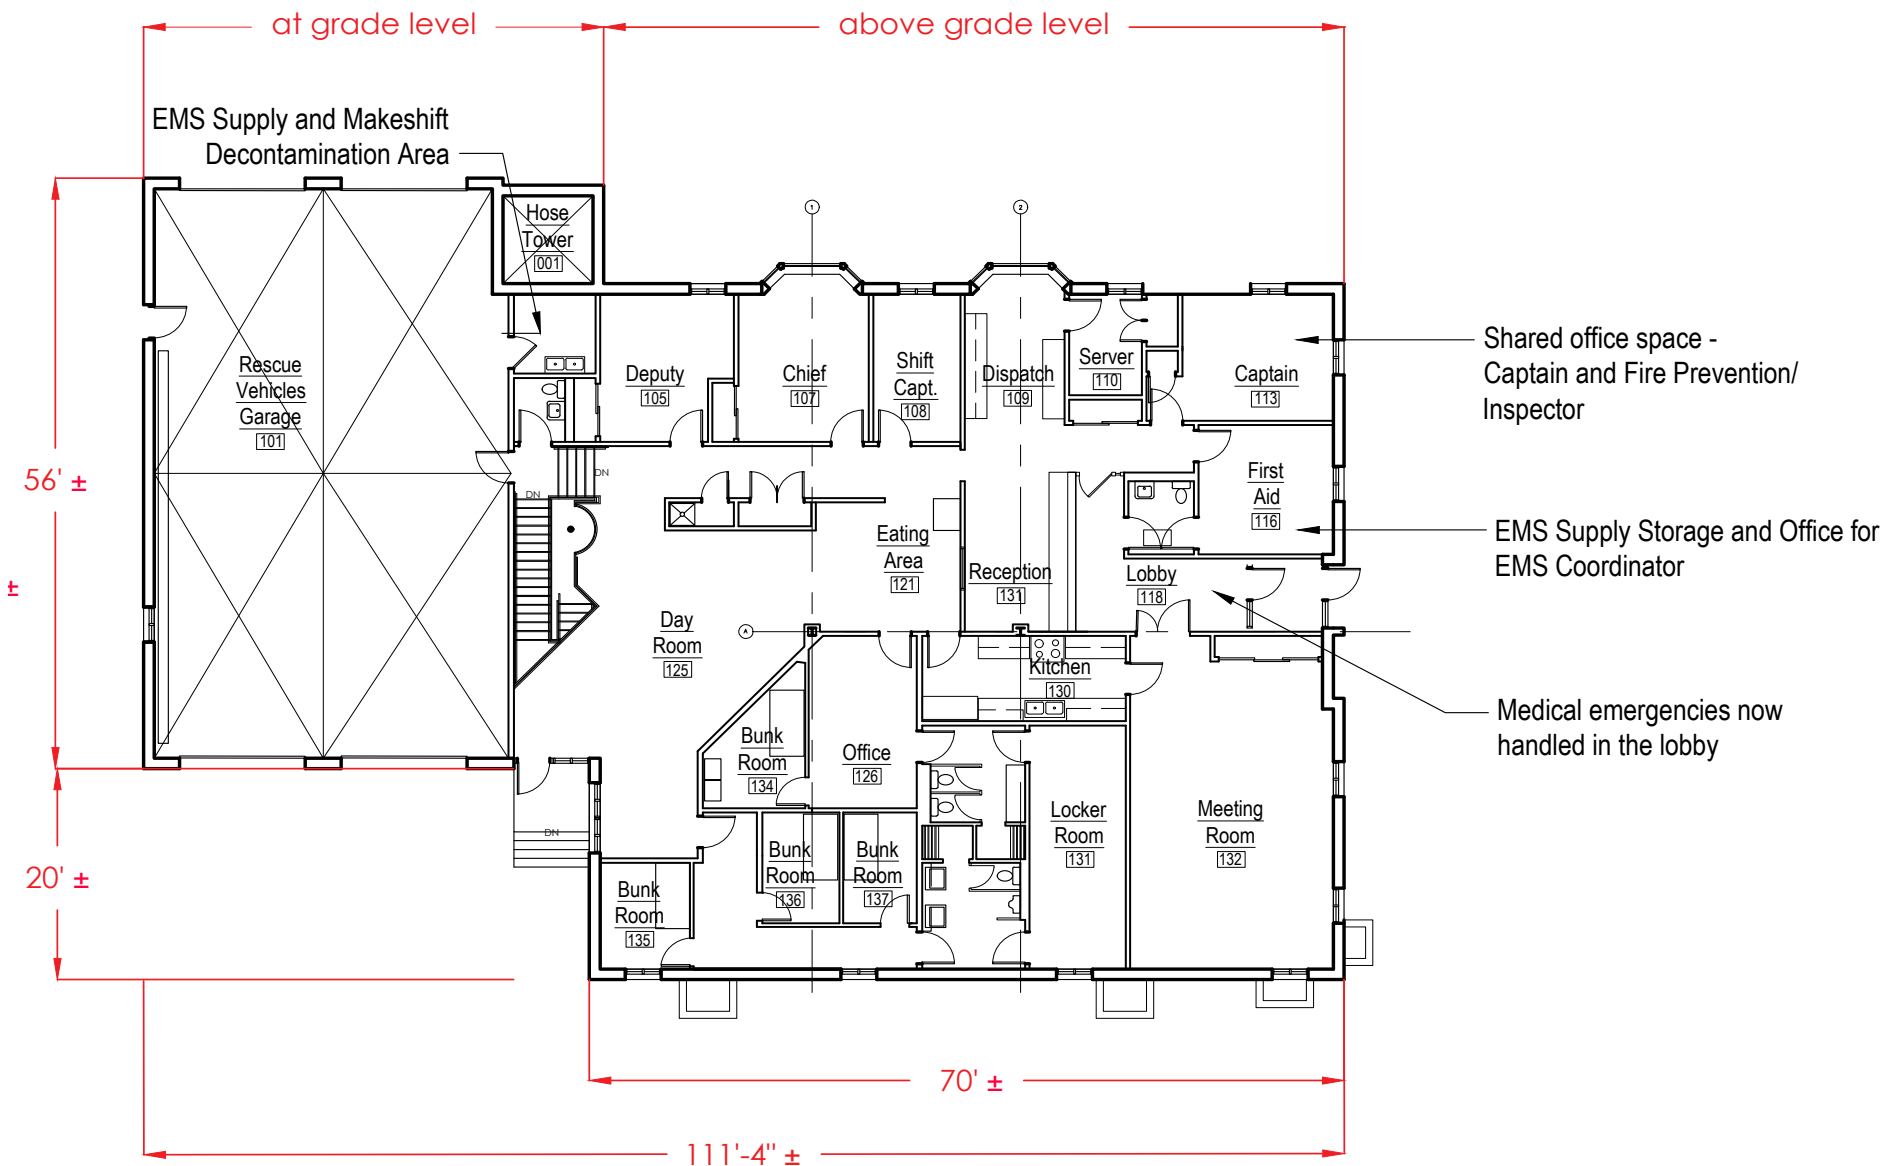
EX-102

- B. Public restroom (MAAB Violation) - Unsecured location and privacy issues (odor, etc)
- C. Kitchen - Current facility has been outgrown, is outdated and inadequate for personnel. Not MAAB compliant

- D. Training/Meeting Room - Not large enough to accommodate 30+ station personnel, and to function as backup Emergency Operations Center. Temporary HVAC repair takes up space.

- F. Laundry facilities - No domestic laundry available leading to potential carcinogen transfer.
- G. First floor apparatus door height/Ceiling height - Inadequate for apparatus. Door height at lowest point is currently 10', ceiling height is 13.5' Contemporary standards require 14'-0" doors

- L. Turnout gear on apparatus floor - does not conform to NFPA standards
- M. EMS Medical Supply - Space inadequate  
Two bay sink blocks door swing
- N. Shift capt. office - Used for sleeping but was not designed for this. Poorly located

- O. Dispatch area - No longer used therefore inactive space
- P. Bunk rooms in violation of building codes. No natural light or ventilation. Too small as built.

- Q. Hose tower no longer used
- R. Reception desk not MAAB compliant
- S. No separation of the dayroom from the exterior - door not tight and cold air infiltrates

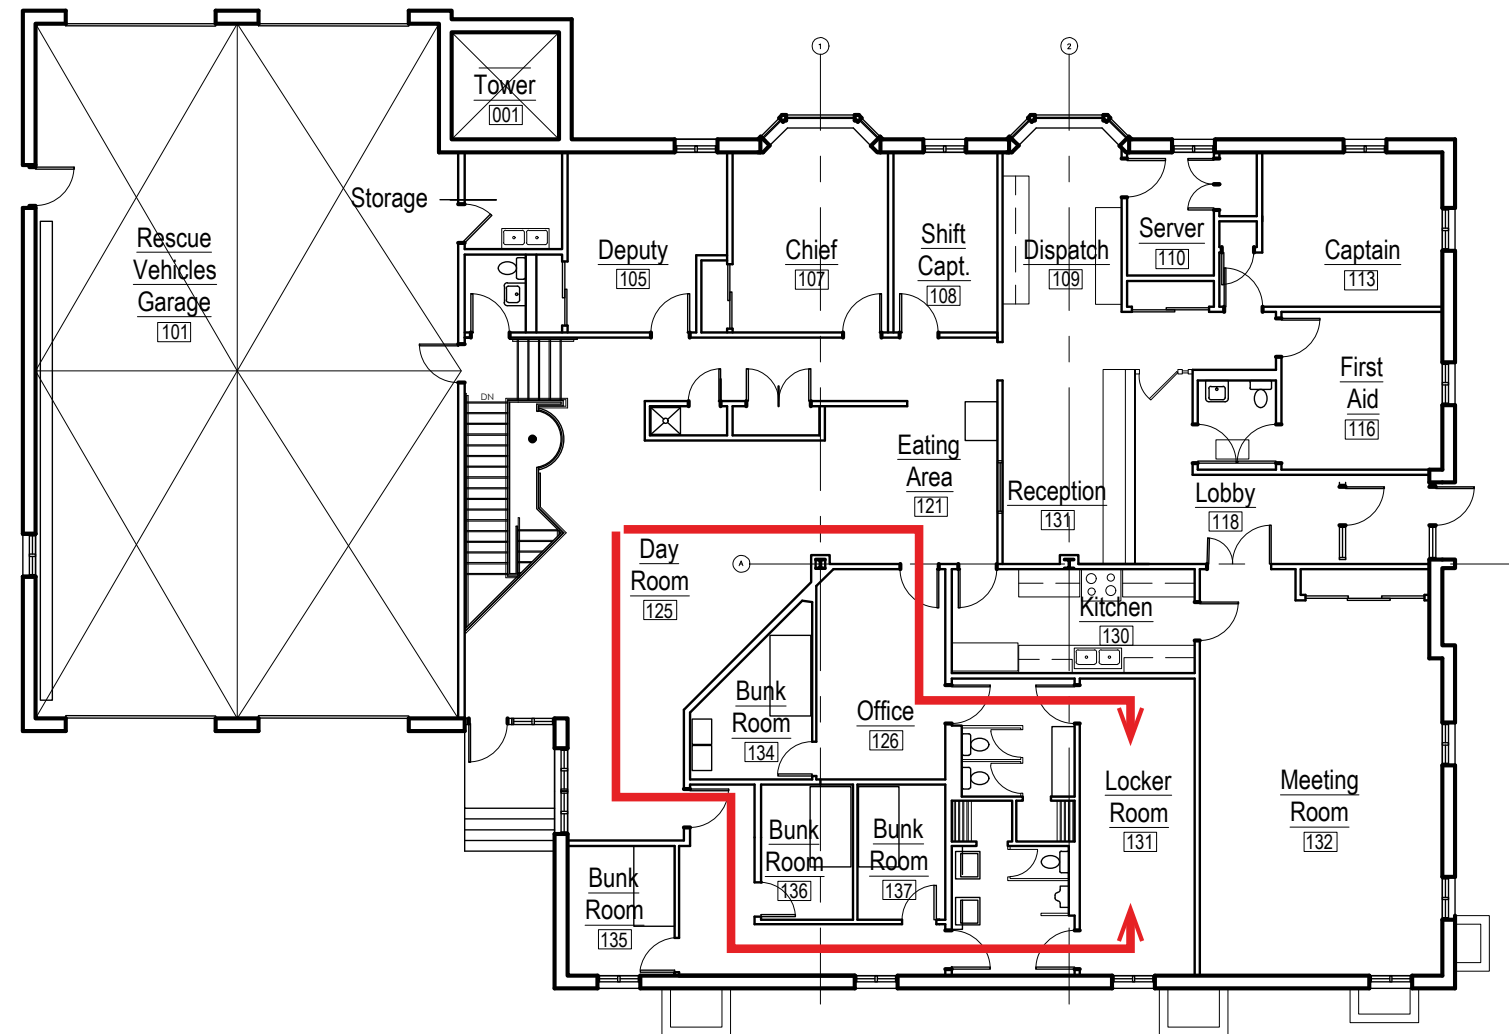
Locker room - path is through the male/female bathrooms. Poor circulation path

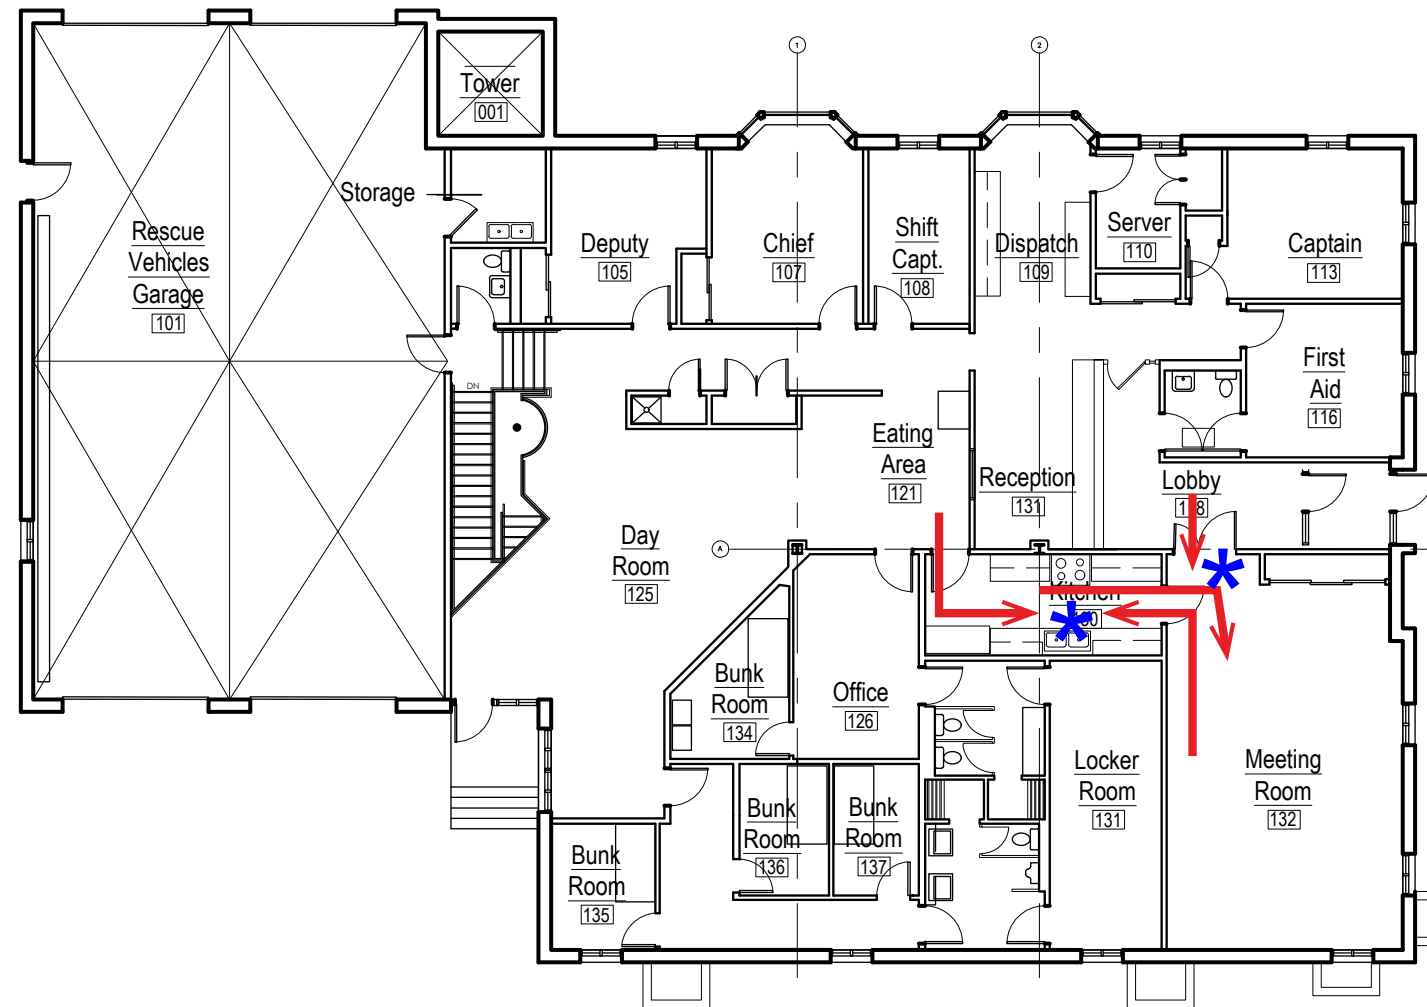
Kitchen - Path in/through kitchen is problematic

Dayroom/eating area is the main circulation hub - Inadequate for station personnel

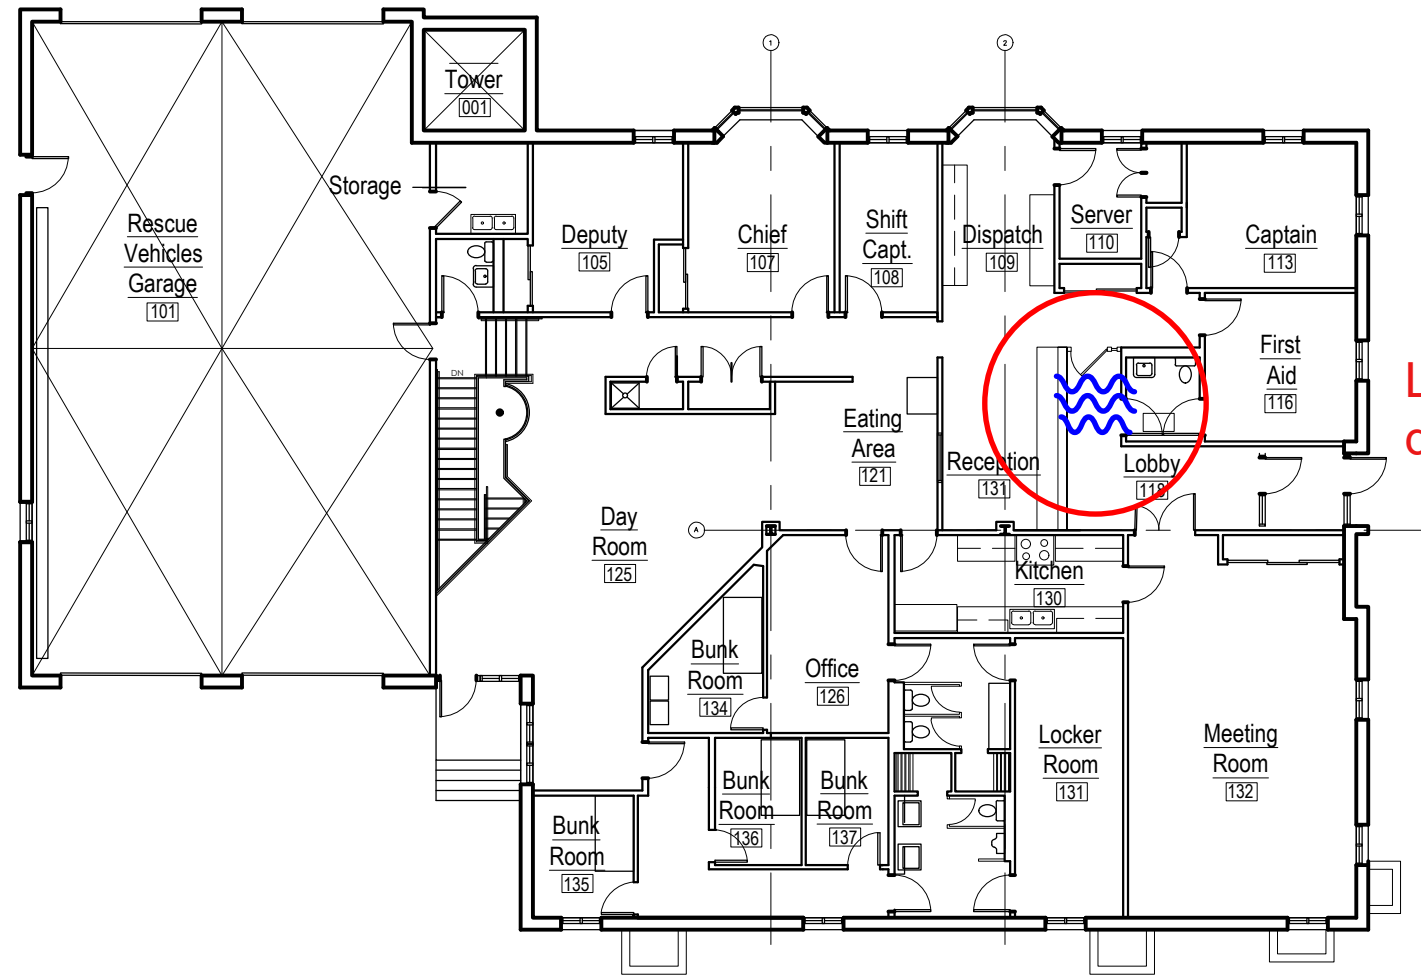
Location of restroom -  
distracting/odors

Re-purposed  
bunkroom too close to  
offices and eating area

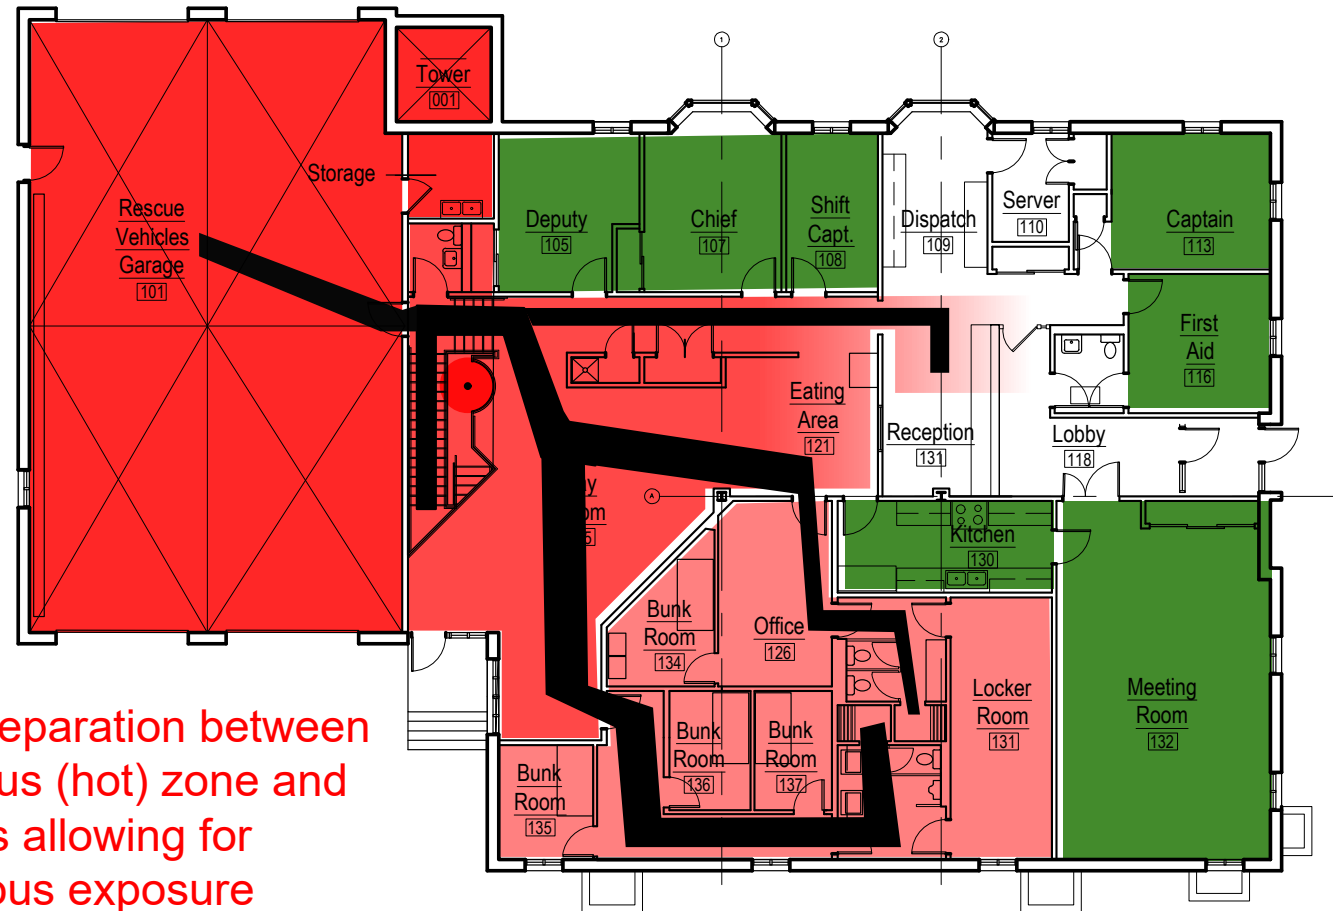
No air separation between  
apparatus (hot) zone and  
showers allowing for  
dangerous exposure  
in the living quarters

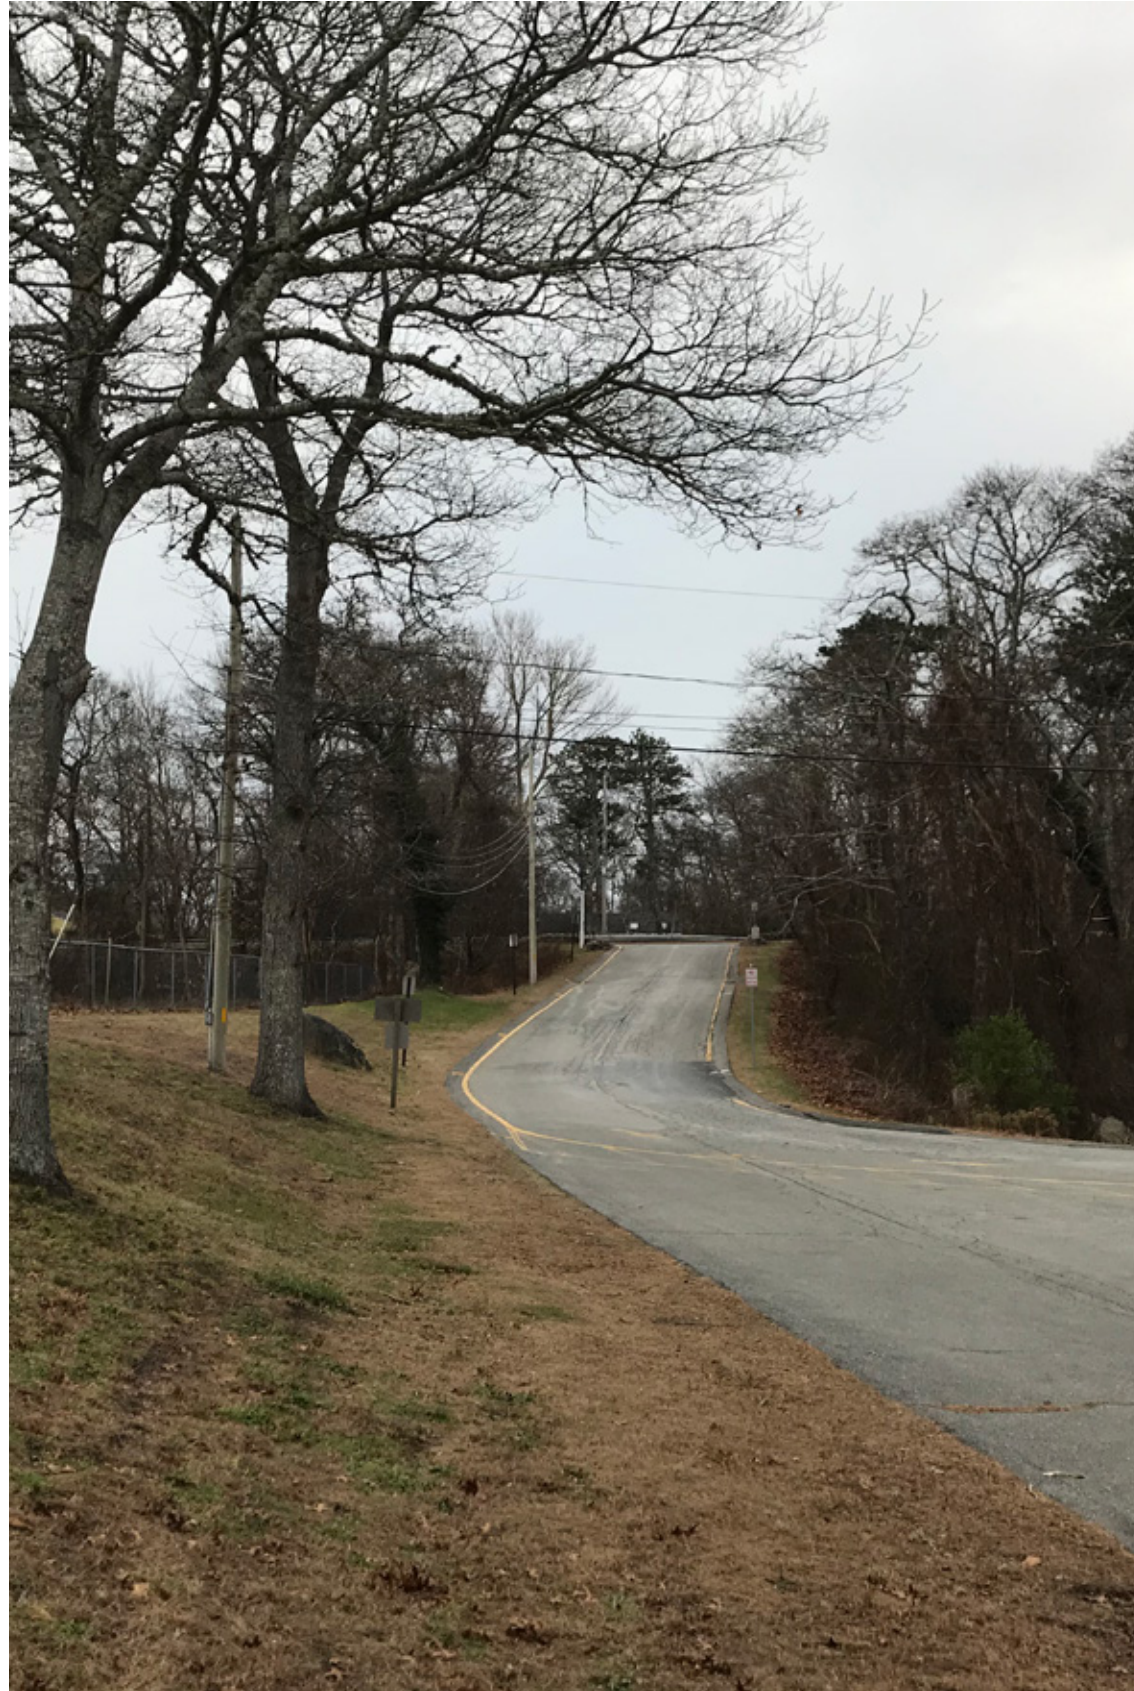
Significant grade changes causing slow turnout time in winter storms

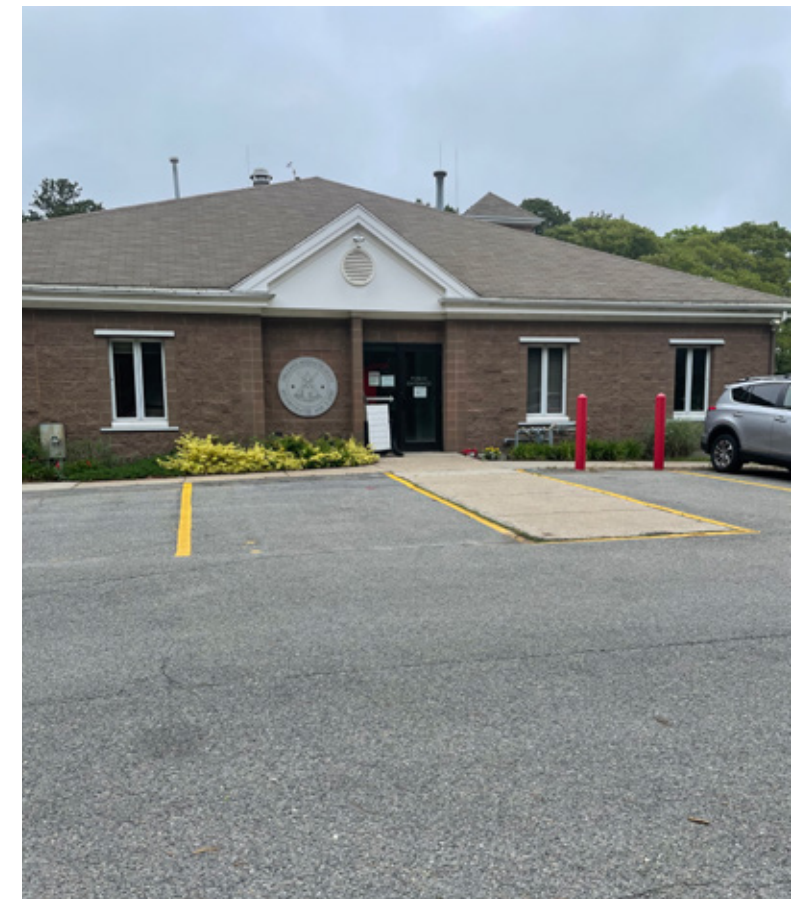
Main Entry to building is not clear, and access has non-compliant slope

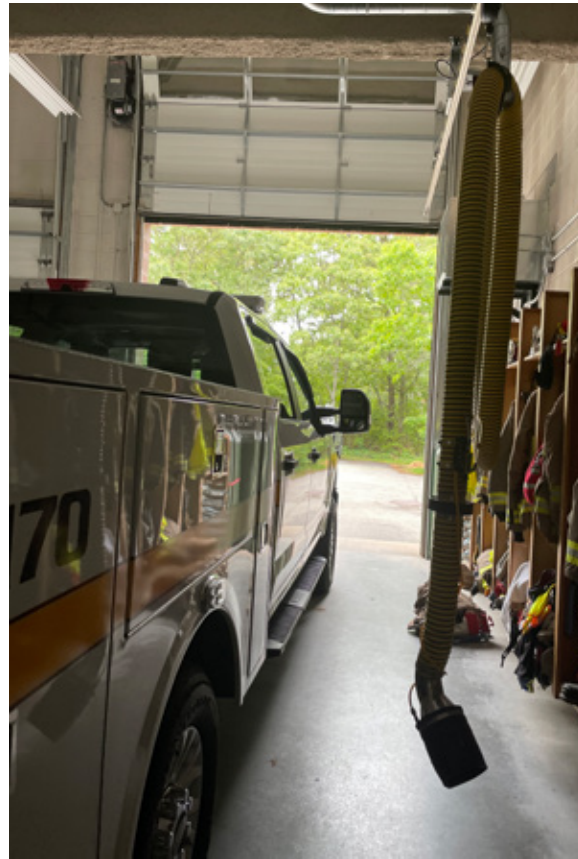
Apparatus bays are too small for current fire-rescue vehicles

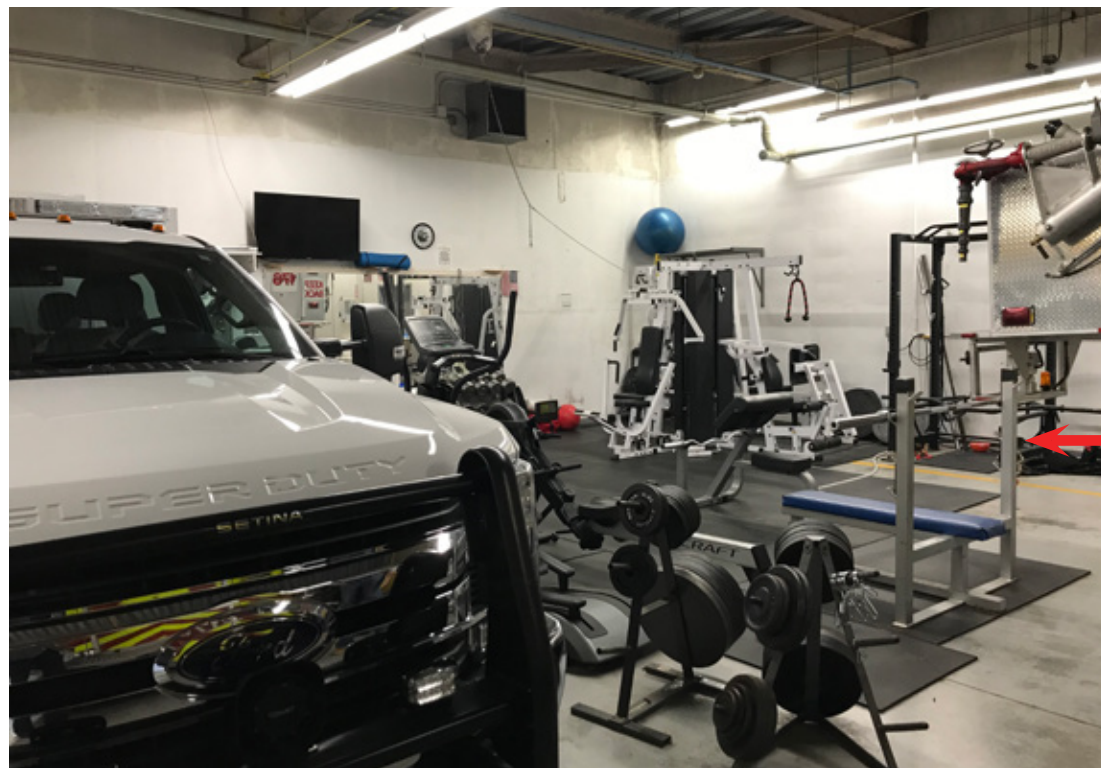
Fitness area in the apparatus bay  
puts personnel at risk of constant  
carcinogenic exposure

No janitor's closet so cleaning supplies  
are continually exposed too

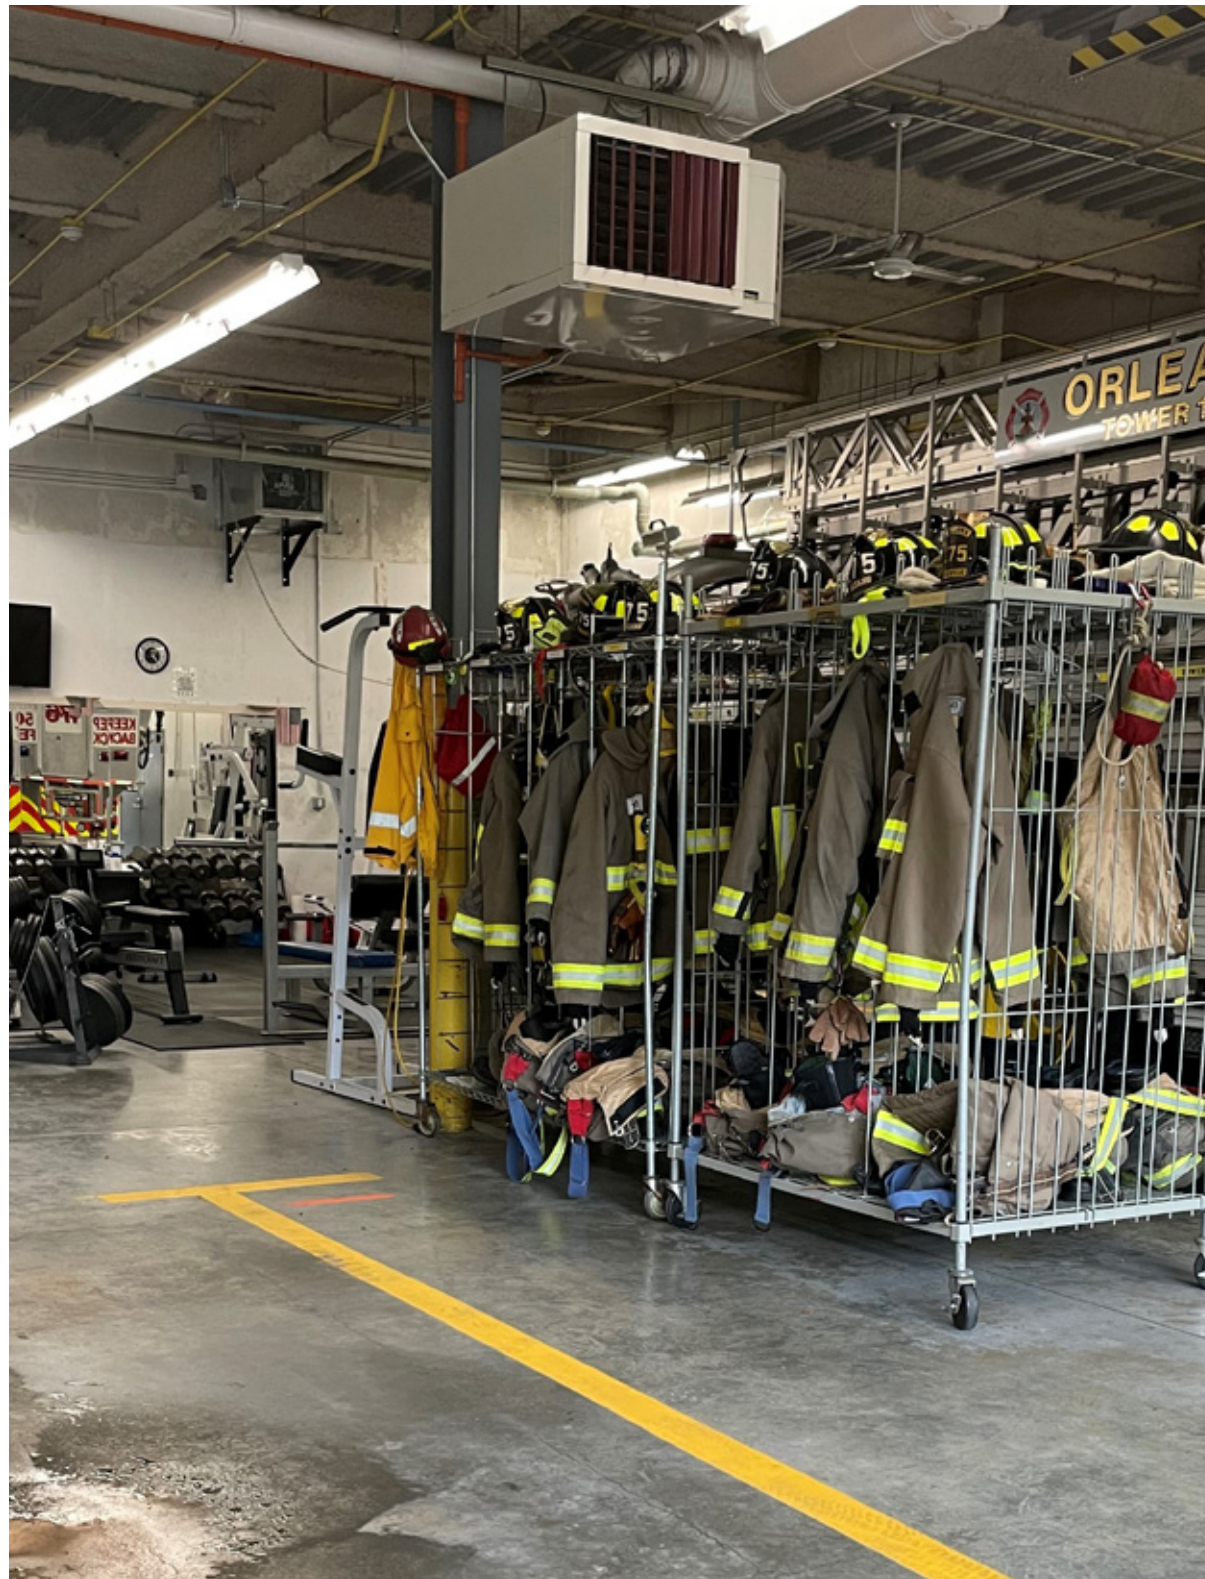
Lower Apparatus Bay

Lacks designated storage for turnout gear - not compliant with NFPA standards

Protective gear is often dried in apparatus bay or outdoors

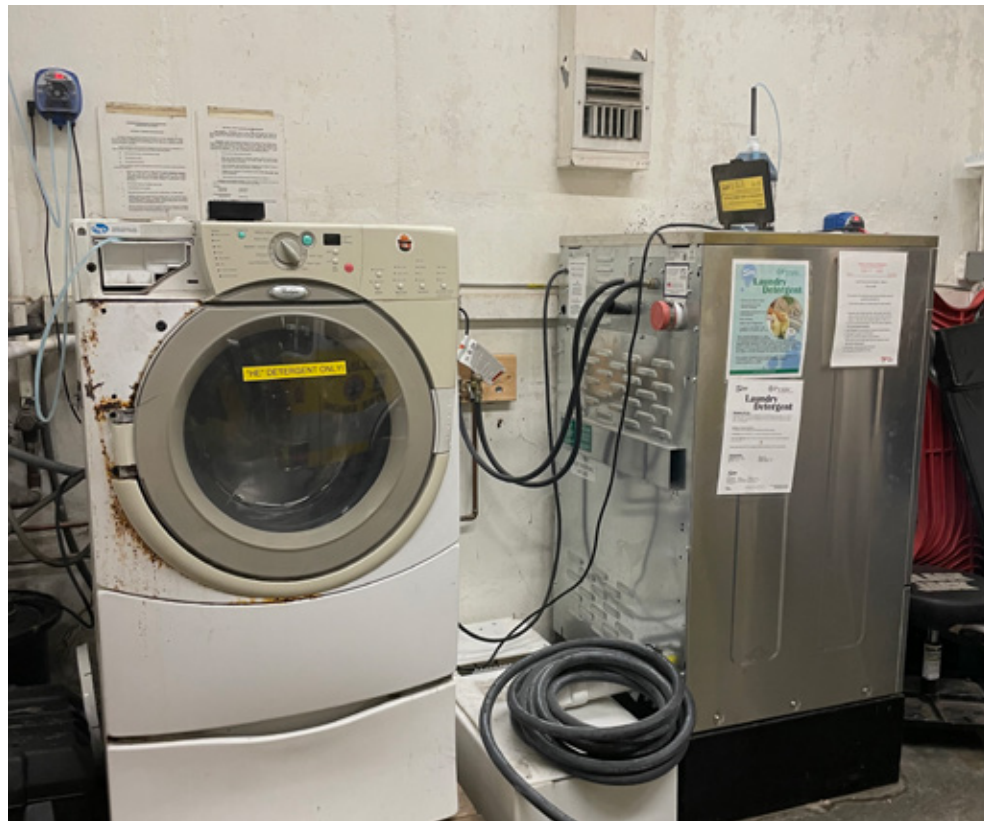
## Lower Apparatus Bay Issues

- Inadequate and not isolated laundry facilities
- Inadequate repair space
- No proper ventilation
- Inadequate plumbing services

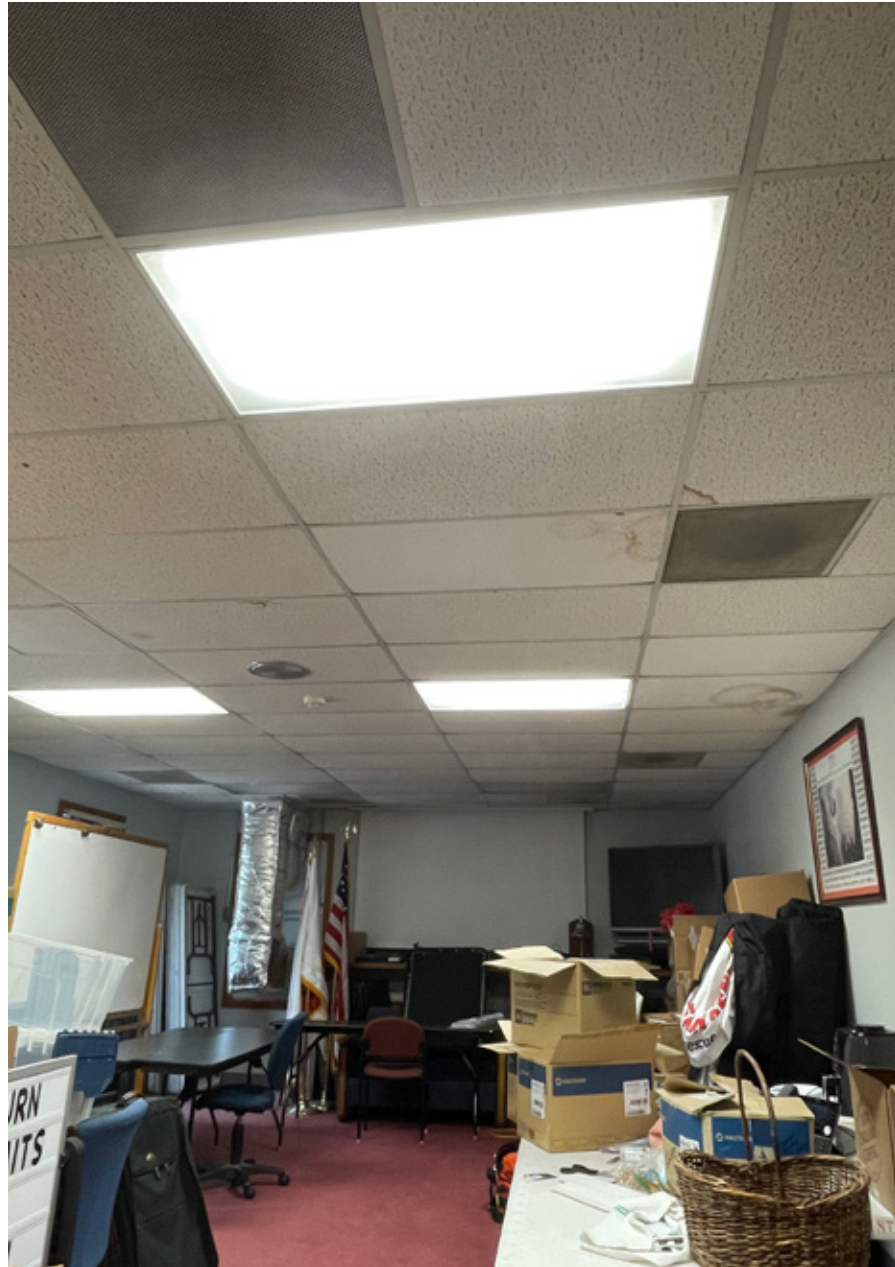
Training/Meeting Room  
currently serves primarily as  
storage. Space needed for  
station meetings/back up  
Emergency Operations Center

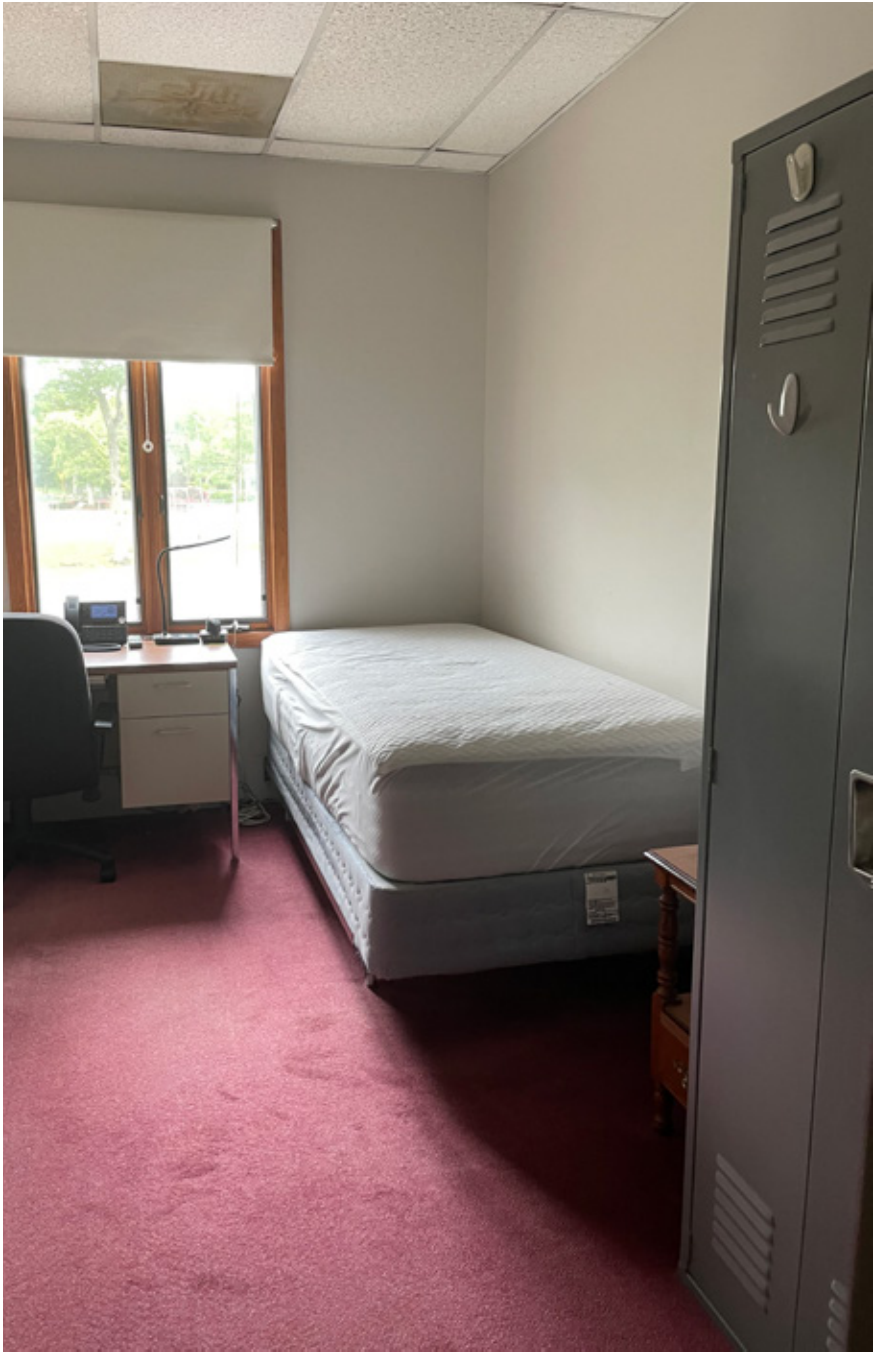
Office currently used as a bunkroom, poorly located

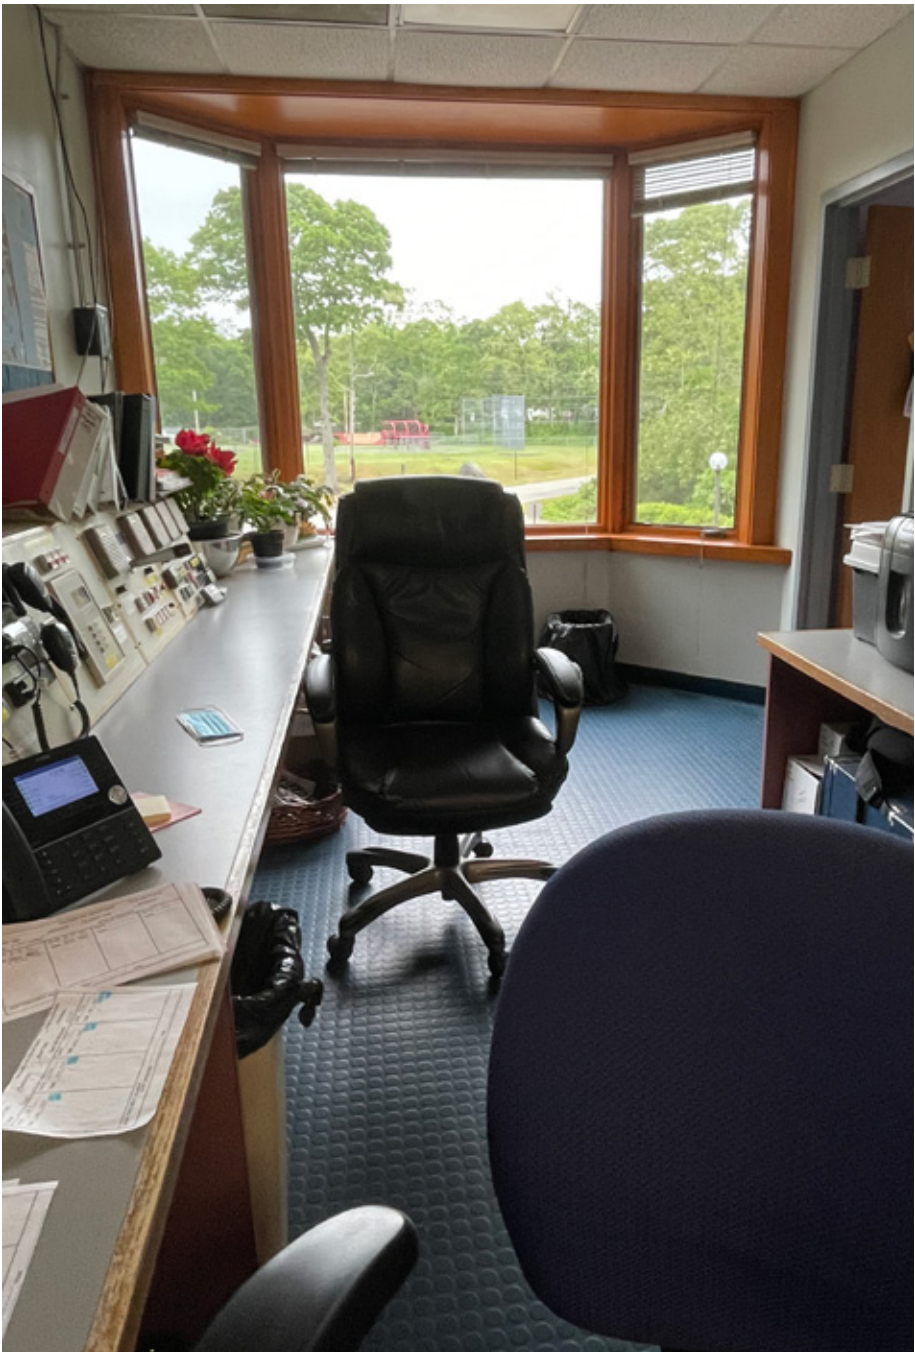
Dispatch area no longer used

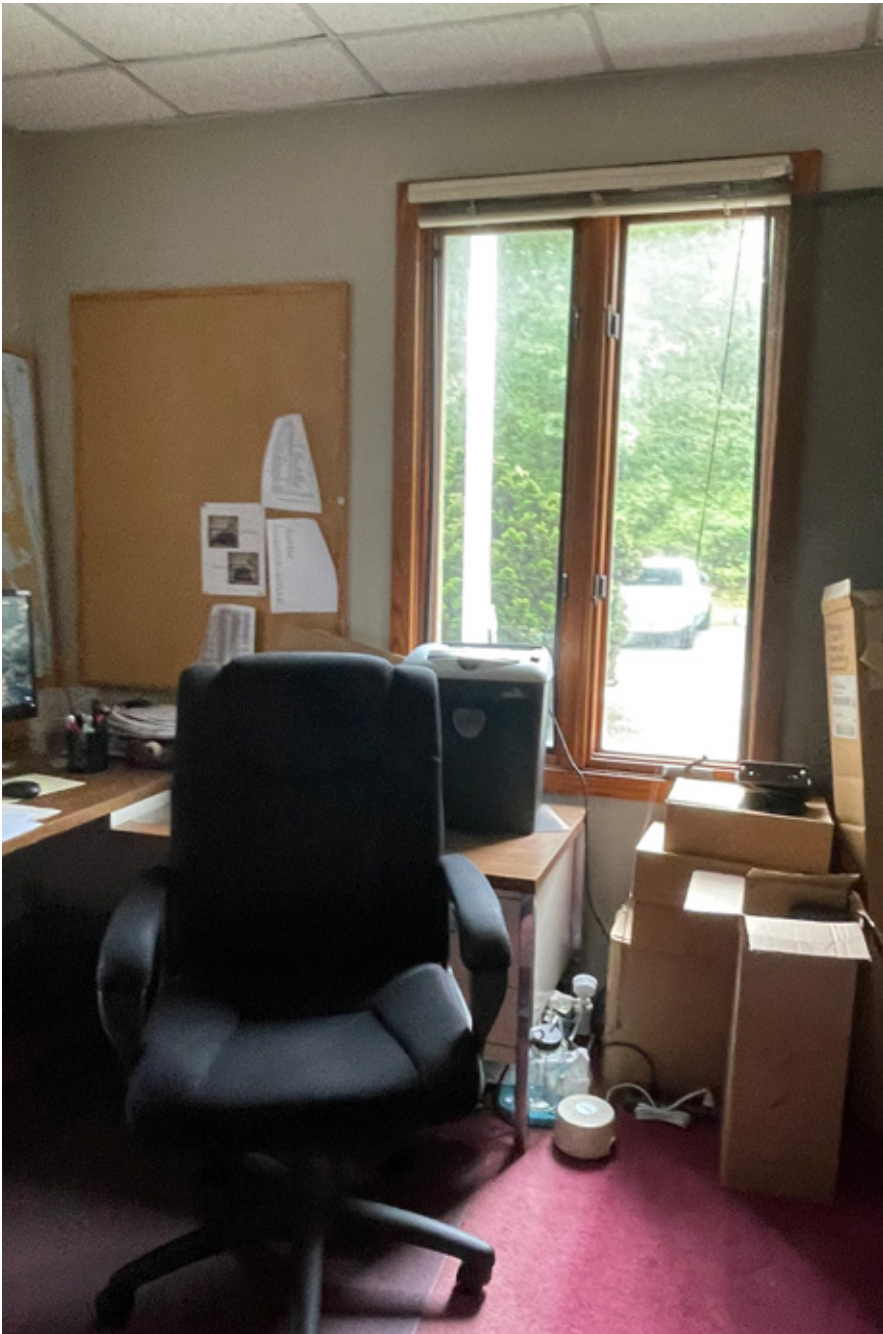
Office space crowded with stored equipment and supplies

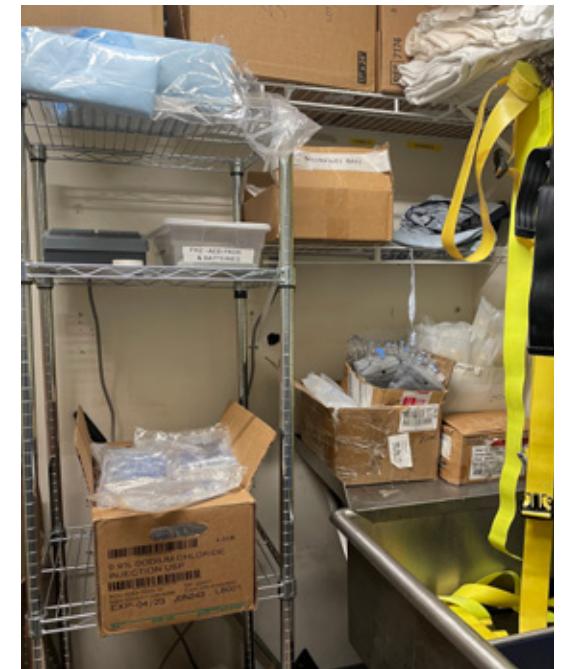
EMS Supply Room was retrofitted with a sink. Because of crowded conditions door can not fully open.

Throughout the station there is evidence of not enough storage.

No dedicated decontamination space
