# TOWN OF ORLEANS

# FIRE STATION FEASIBILITY STUDY

August 11th, 2021

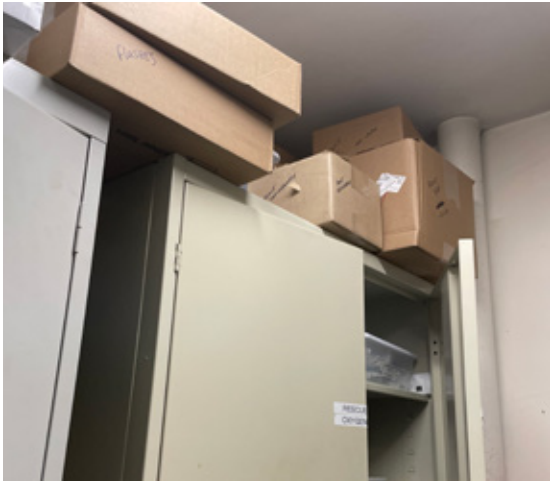
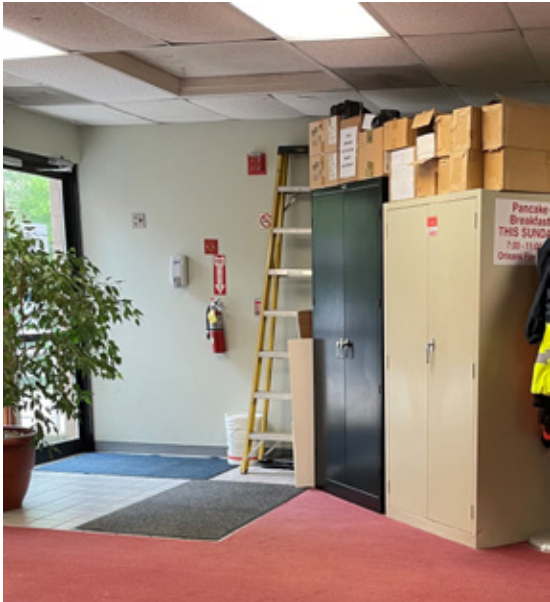
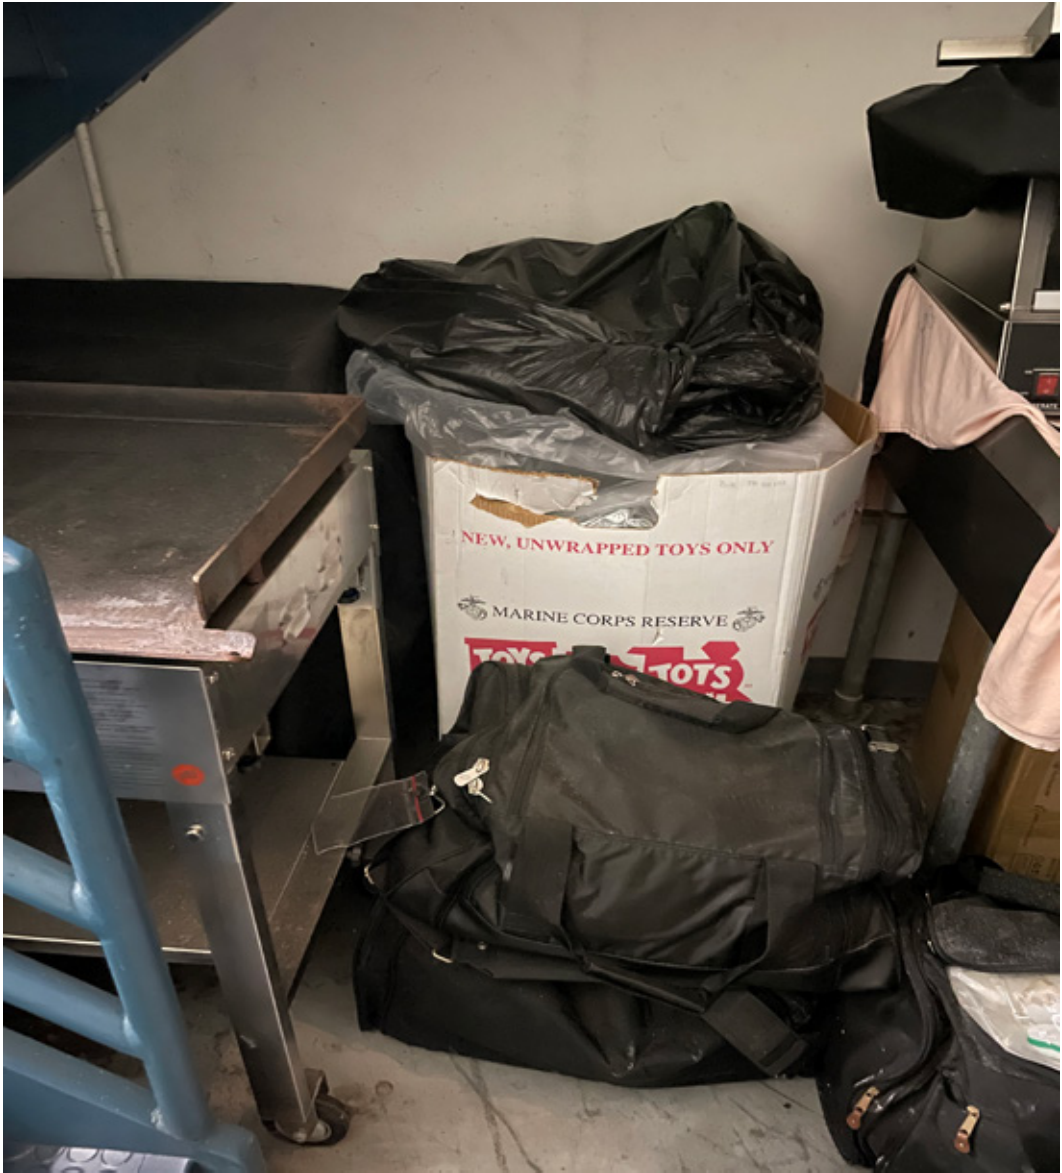
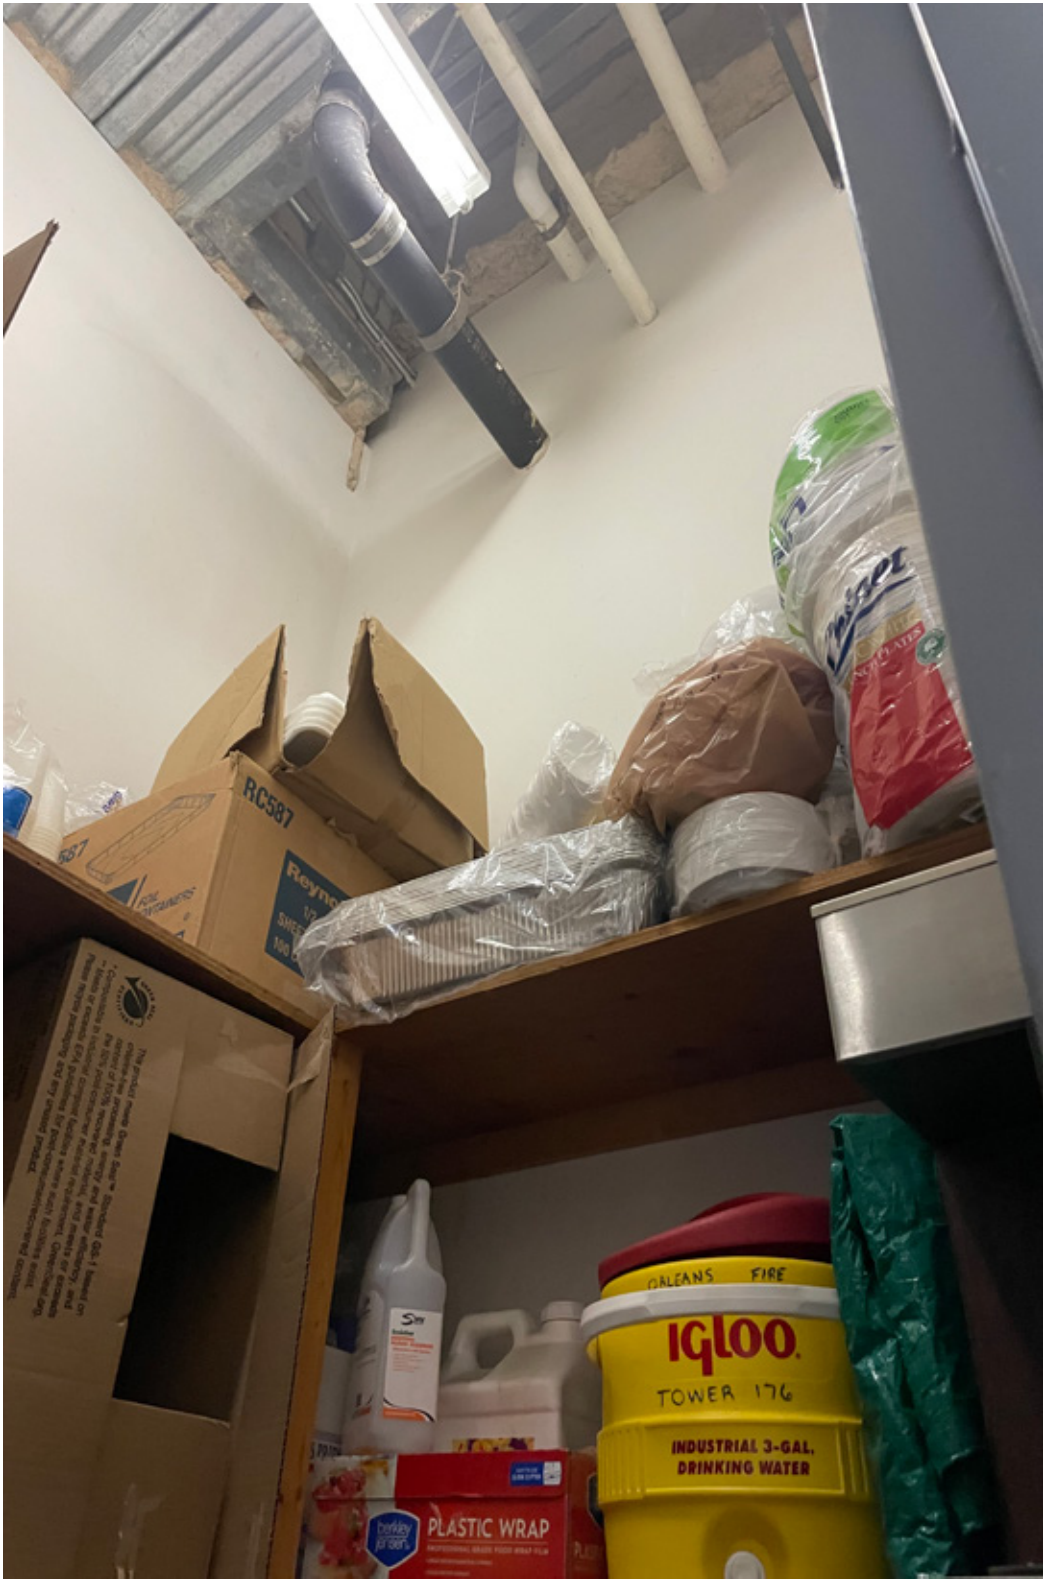
Storage found throughout the building in non-designated areas including in the dayroom, under stairs, and on top of cupboards

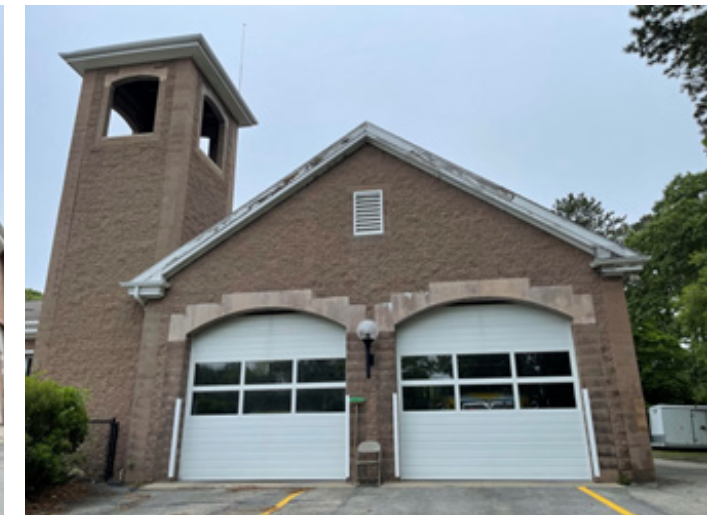
- a. The exterior masonry was generally in good condition with some minor efflorescence.
  - b. Some efflorescence and hairline cracks observed at the precast concrete lintels above the 5 overhead doors at the building east elevations to access the main apparatus room and the rescue vehicles garage.

Photo #6 Building East Elevation  
Rescue Vehicle Garage Doors are at the 1st floor  
near the northeast corner

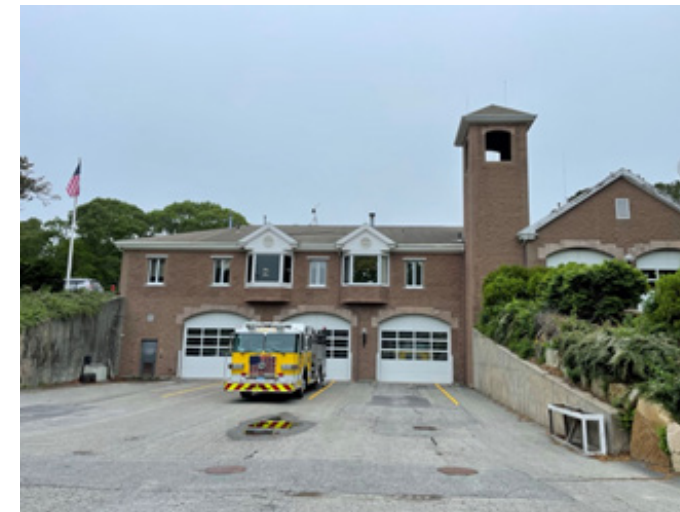
Photo #7 Building East Elevation  
Hose Tower and the Main Apparatus Garage  
Doors at the basement level

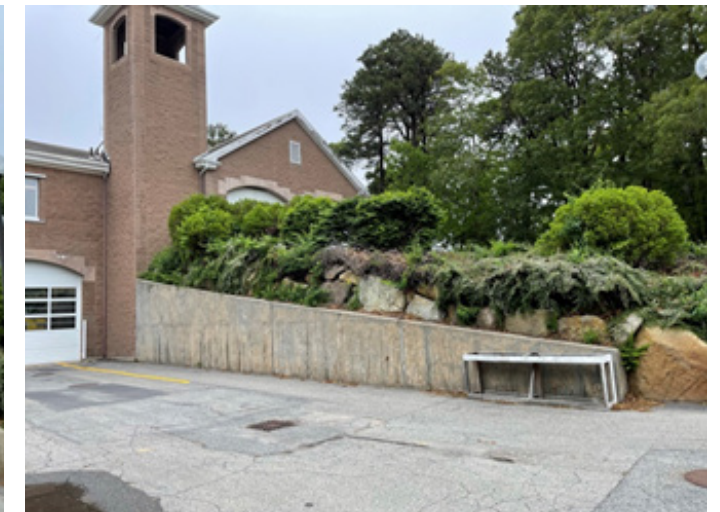
Photo #8 North Retaining Wall

- c. No surface erosion observed around the base of the building and soil line.
  - d. Both retaining walls in front of the main apparatus room entrance were generally in good condition with some hairline cracks but no sign of movement or settlement.

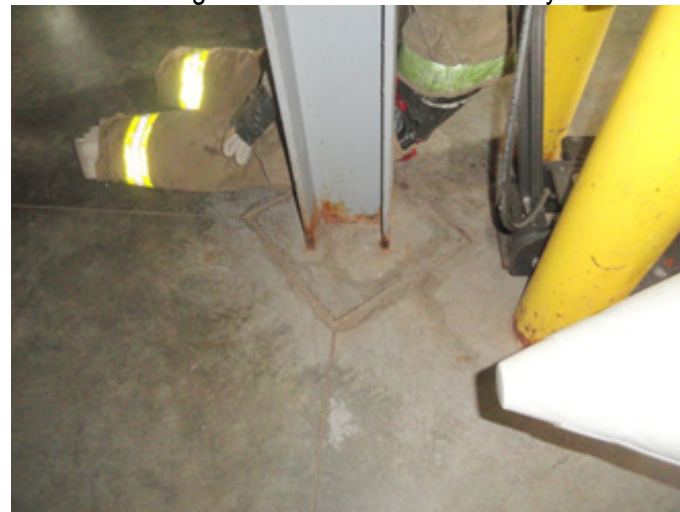
- c. The first floor steel framing and deck is in good condition with some surface rusting observed at the base of the steel columns and minor rusting at the underside of the steel deck and around the floor penetrations observed at the main apparatus room.

Photo #14 Basement Apparatus Room Surface rust is  
observed at the bottom of the steel column

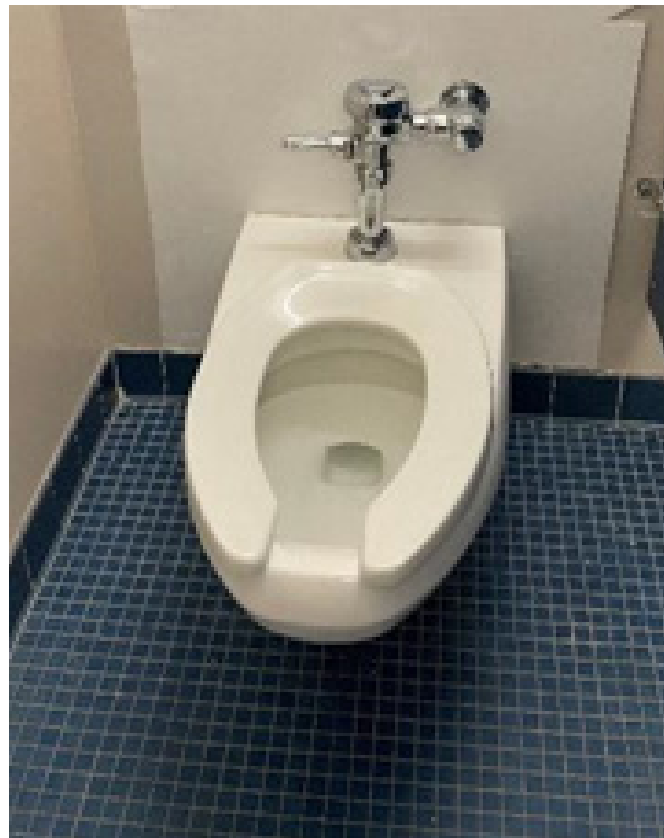
Existing Water Closet

1. Water Closets: Water closets are wall mounted flush valve vitreous china fixtures. These fixtures do not have low-flow water usage and do not meet current code. It is recommended that these be upgraded to current plumbing code standards for water usage.
2. Urinal: Urinal is a wall mounted vitreous china fixtures with manual flush valves. These fixtures do not have low-flow water usage and do not meet current code. It is recommended that these be upgraded to current plumbing code standards for water usage.

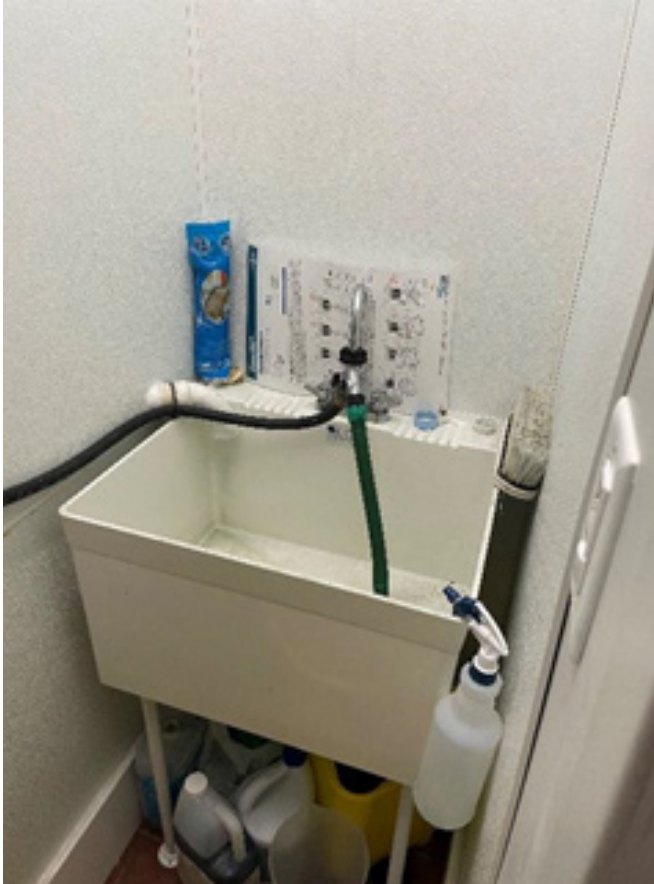
Janitor Sink

4. Janitor's Sink: The janitor's sink is a laundry tub style with two lever faucets. The sink is in good condition but space is tight inside the room with number of chemicals and cleaning supplies. The sink is provided with a cleaning chemical dispensing unit mounted on the wall. There is no testable backflow preventer installed between the unit and the water supply in order to protect the water supply from contamination. It is recommended to install a testable backflow preventer.

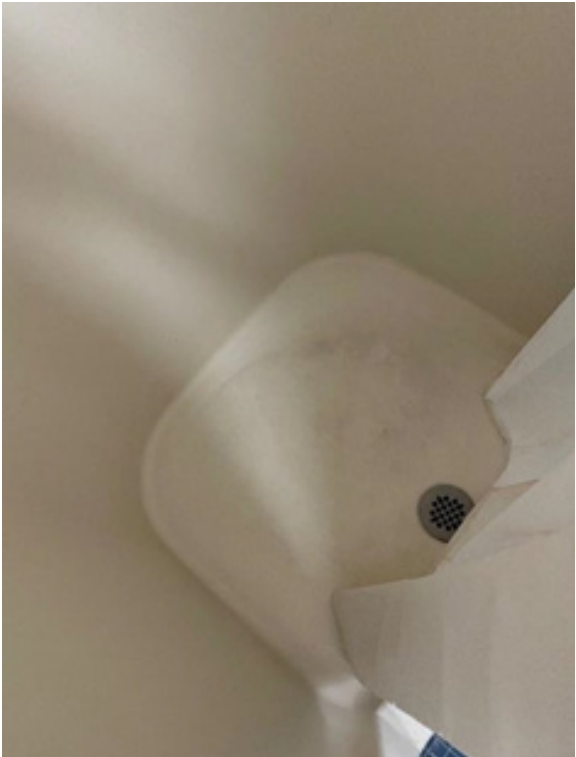
Existing Shower Drain

5. Showers: The two showers in the building are fiberglass units with integral thermostatic mixing valves. The showers appear to be in poor condition and it is recommended that these be replaced.

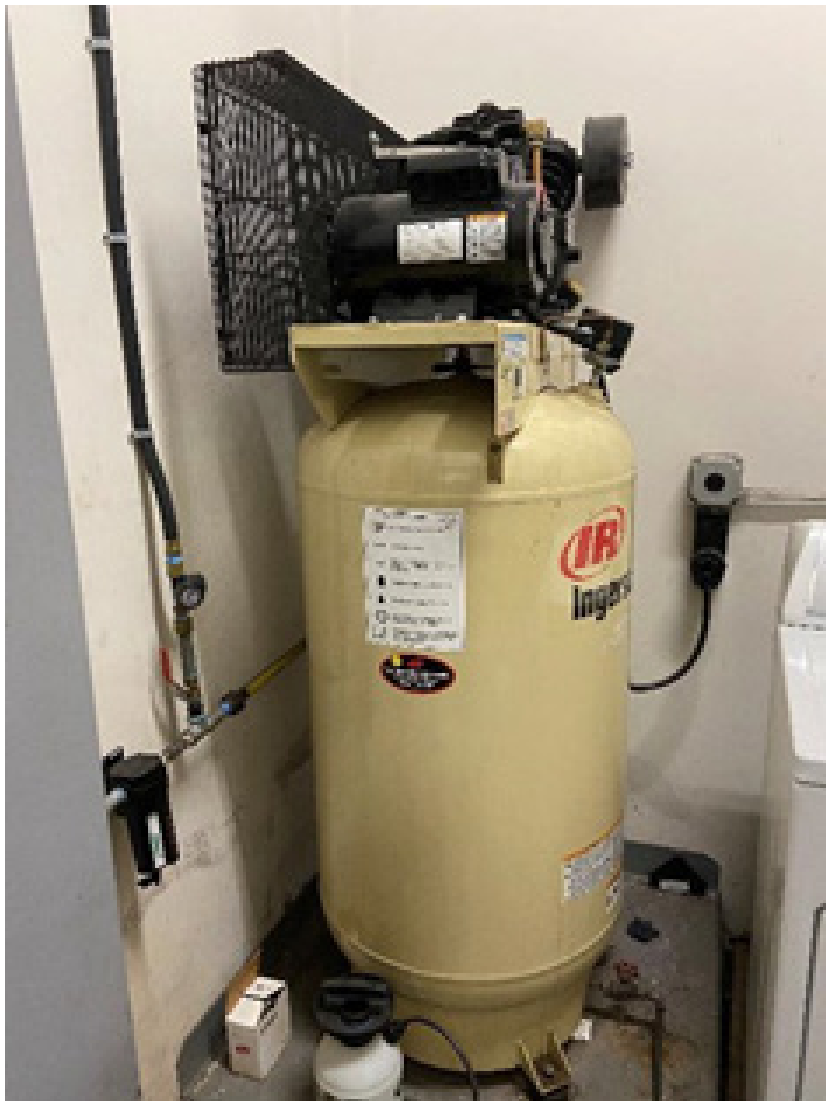
6. Air Compressor: An air compressor is provided for compressed air throughout the facility. The air compressor appears to be in good condition but there are no acoustical barriers between the compressor and washer/dryer room

Air Compressor

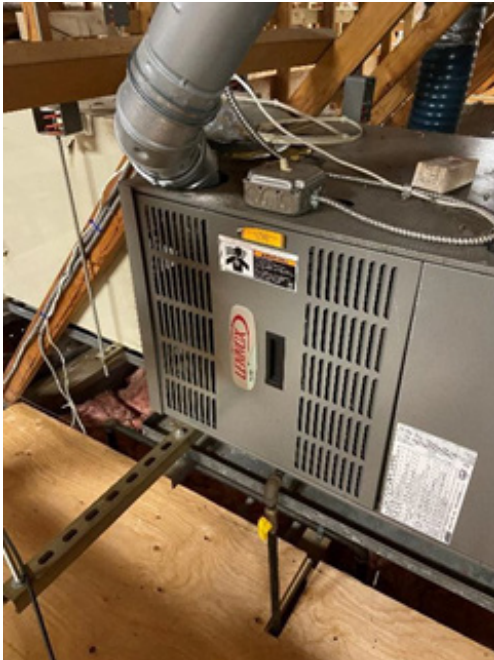
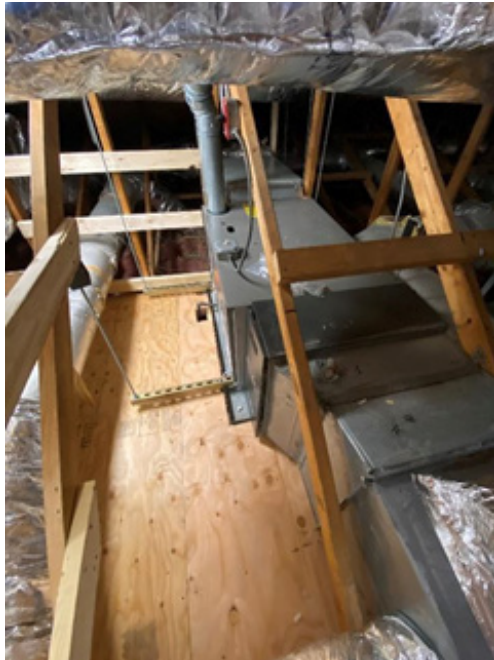
1. Heating and Cooling System: Heating and cooling is provided for the non-apparatus bay portions of the building via gas furnaces with duct mounted DX cooling coils. These units are located in the attic space of the building and ductwork is distributed to each space. The furnaces are at the end of their useful life and only in fair condition.

Furnace Unit in Attic Space

- Upgrade the HVAC control system to a new electronic system with energy management capability.
- Relocate temporary ERV system and ductwork.
- Replace existing furnace units in attic space.
- Add general space exhaust for the Gear Laundry Room.

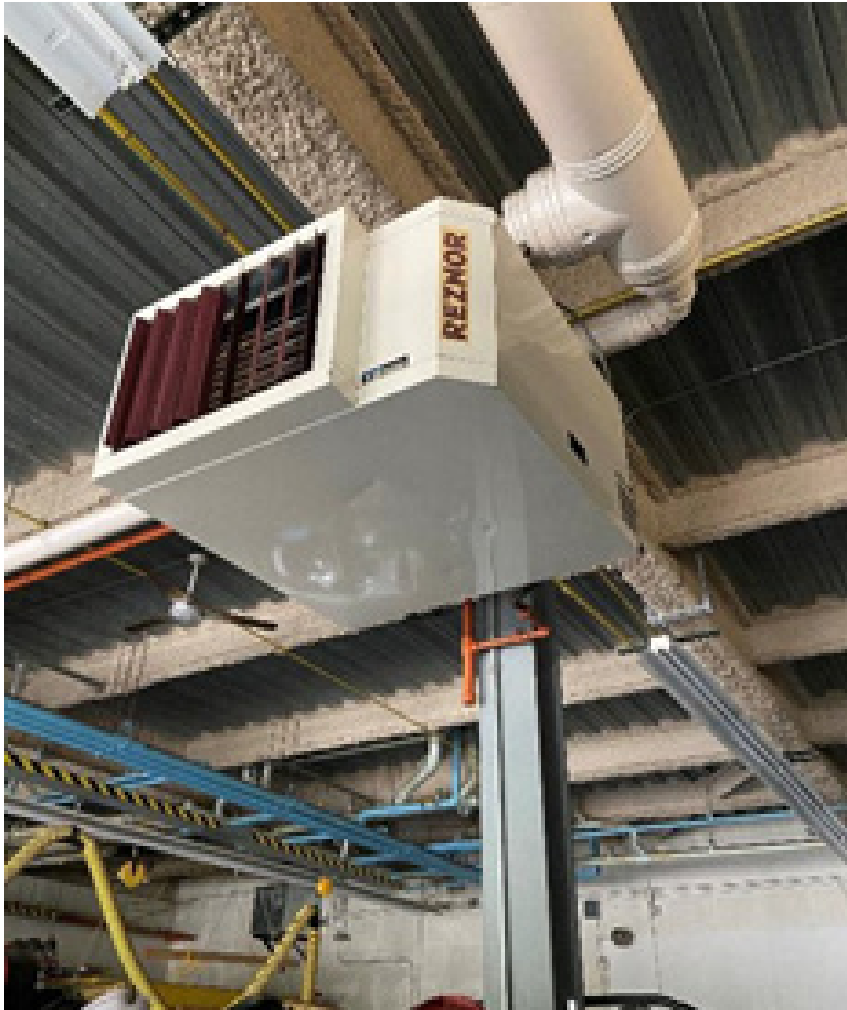
2. Gas-Fired Unit Heaters: The apparatus bays are provided with gas-fired unit heaters. These units appear to be relatively new and are in good condition.

Gas Fired Unit Furnace

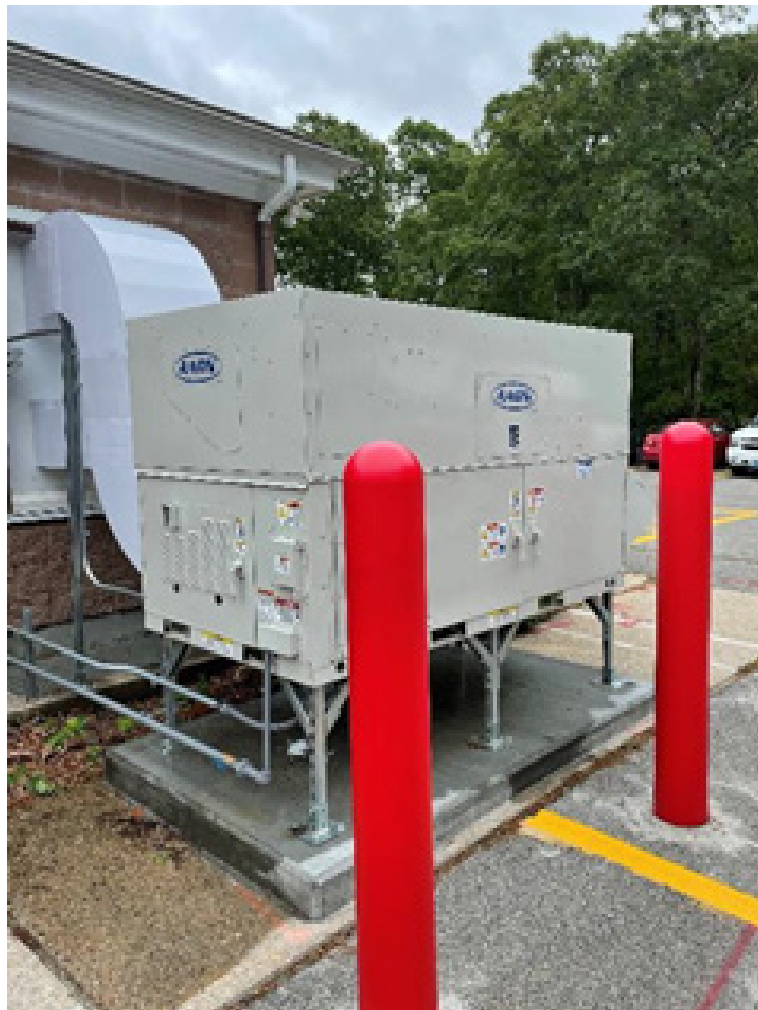
1. Energy Recovery Ventilator: Ventilation is provided to the building via an energy recovery ventilator (ERV) mounted outside on the ground and ducted into the building attic space. The outdoor air is ducted into the return mains of the furnace units and the exhaust air is ducted directly to the spaces. The ERV is new and is in good condition, however, the unit is located in order to minimize the amount of structural penetrations. The unit's ductwork enters the building in the conference room, protruding into the space and taking up floor area.

Outdoor Energy Recovery Ventilator (ERV)

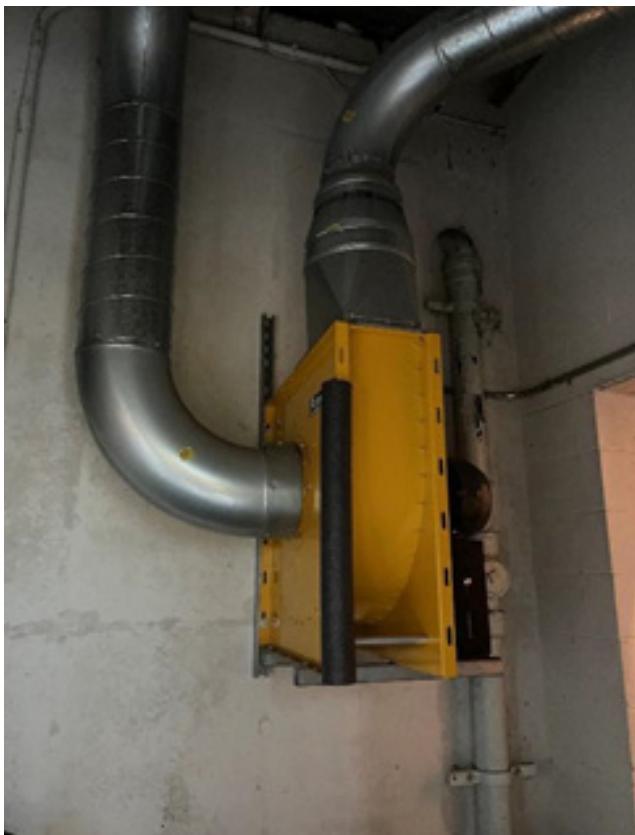
2. Plymovent System: A Plymovent vehicle exhaust extraction system is utilized to capture and release vehicle exhaust outdoors. The exhaust extraction system consists of hose reel assemblies with pneumatic grabbers and a central exhaust fan. This equipment is in good condition. The hose grabbers locations are not designed for vehicles to enter the apparatus bay in reverse. It was brought to CES' attention that this is a common issue during the winter months when vehicles have to back into the apparatus bay. The fumes from vehicles in the bay that aren't able to be connected to the Plymovent system can reach dangerous and toxic levels to individuals.

Plymovent Exhaust Fan

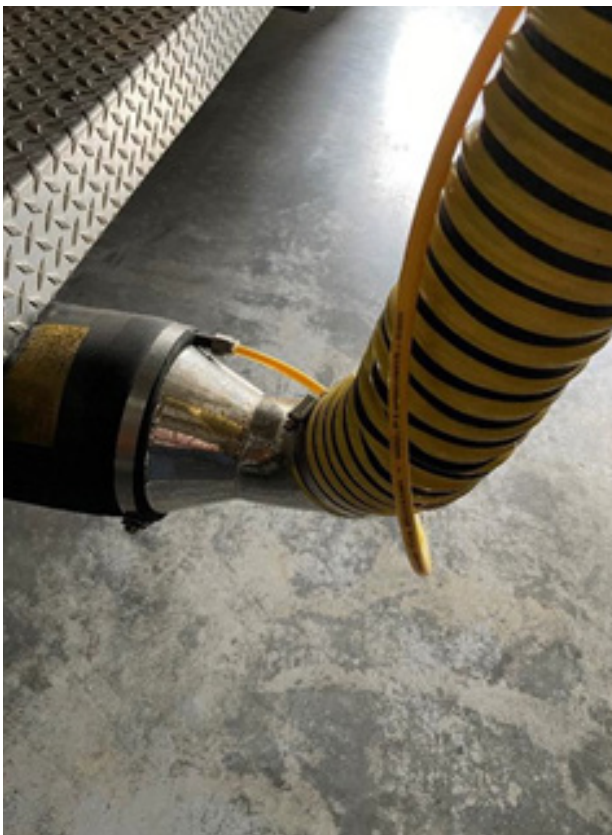
Vehicle Exhaust Pneumatic Grabber

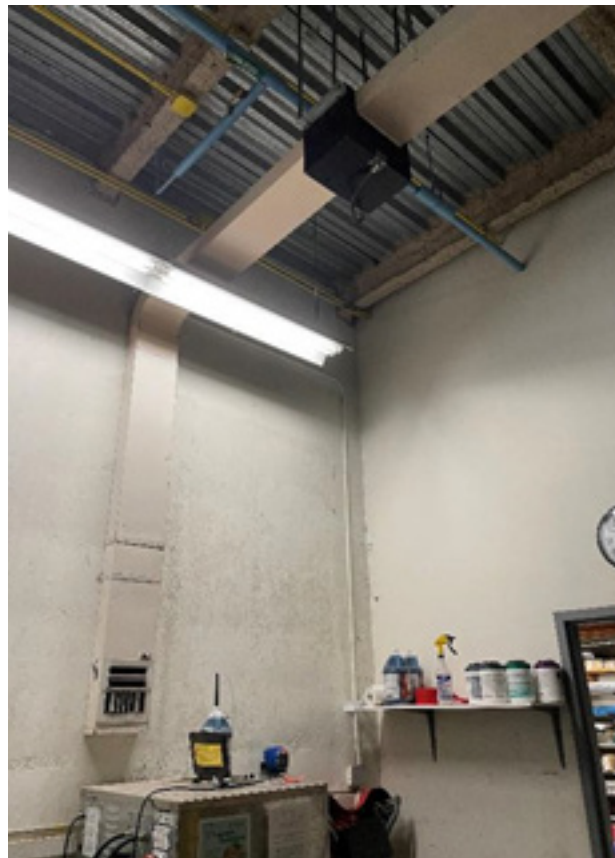
3. Laundry Area Exhaust: The Gear Laundry area is provided with exhaust ductwork for the dryer and makeup air. This room does not have any general space exhaust which is recommended for the gear that is currently being stored in this room. The adjacent extractor/washing machine space is provided with an exhaust fan and grille mounted on the wall behind the equipment. CES did not verify the amount of airflow from this fan because of the location of the fan and the need for a flow hood.

Washing Machine Area Exhaust Fan

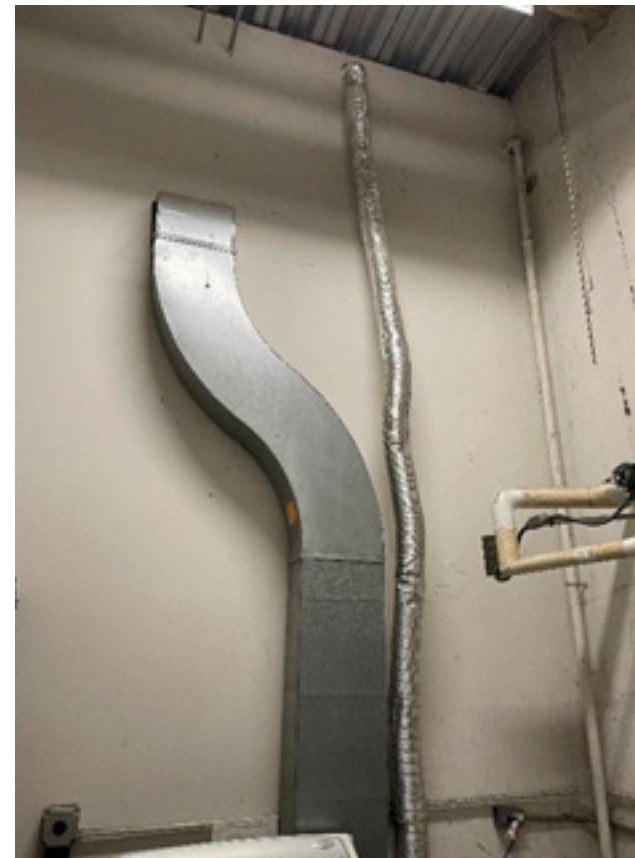
Dryer Exhaust and Relief Ductwork

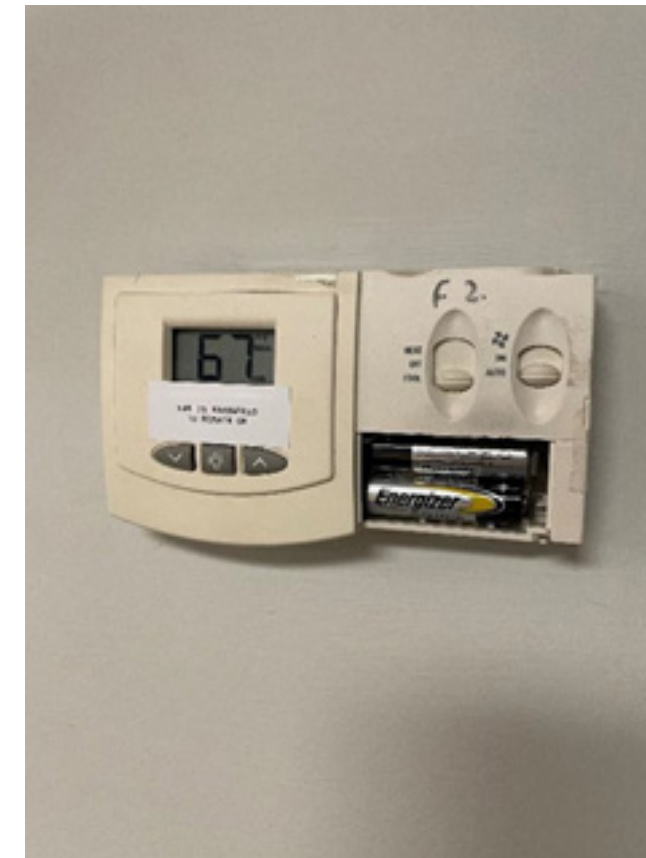
1. Each furnace is provided with local thermostats in the space. There is currently no centralized building management system at the facility. Thermostats do not appear to have energy saving controls. It is recommended that these be replaced with programmable thermostats at a minimum. The ideal solution is to bring in a building management system (BMS) for the overall building for better control and energy efficiency.

Existing Thermostat

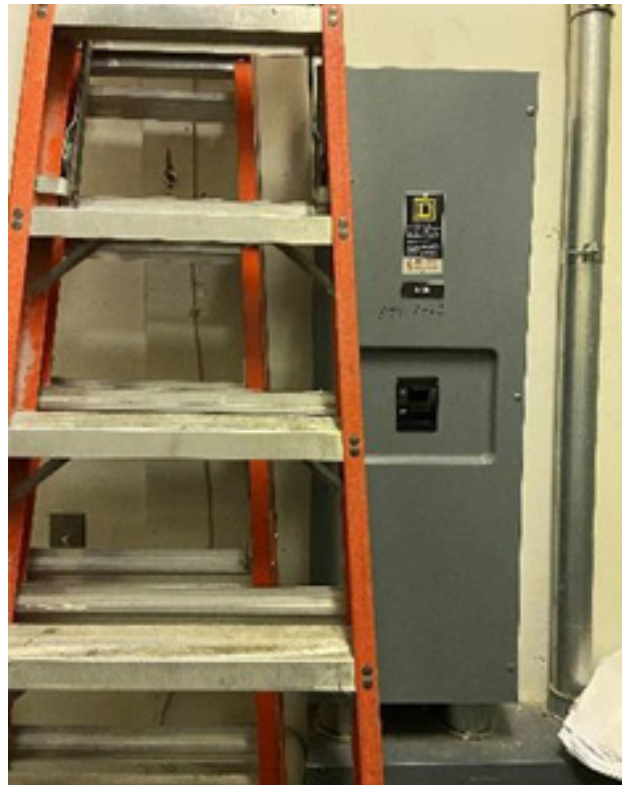
1. Electrical Service: The existing electrical service is a 400 amp, 240/120volt, 1-phase, 3-wire service that consists of a main disconnect switch and distribution panelboards. The main disconnect switch is manufactured by Square D. The distribution panelboard is manufactured by Siemens/I-T-E. This equipment is in good condition. If the building is renovated or expanded, the current service size would not be adequate. It is recommended that a 3-phase service with higher amperage be brought to the building. Single phase power is not adequate for the electrical needs of a modern day fire station.

Electrical Service Equipment

- Upgrade the existing fire alarm system with one that can support ADA compliant devices. The existing system will not support ADA compliant devices and additional devices are required for proper coverage. This will include pull stations, ADA compliant horn/strobe units, smoke and CO detectors, power supplies, and electrical wiring from a local power source.
- Repair damaged wiring devices, including occupancy sensors.
- Upgrade the lighting control systems with a new state-of-the-art system.
- Upgrade the data/technology systems with a new state-of-the-art system.
- Upgrade the security system with a new state-of-the-art system.
- Upgrade the electrical service and replace older panelboards and circuit breakers.

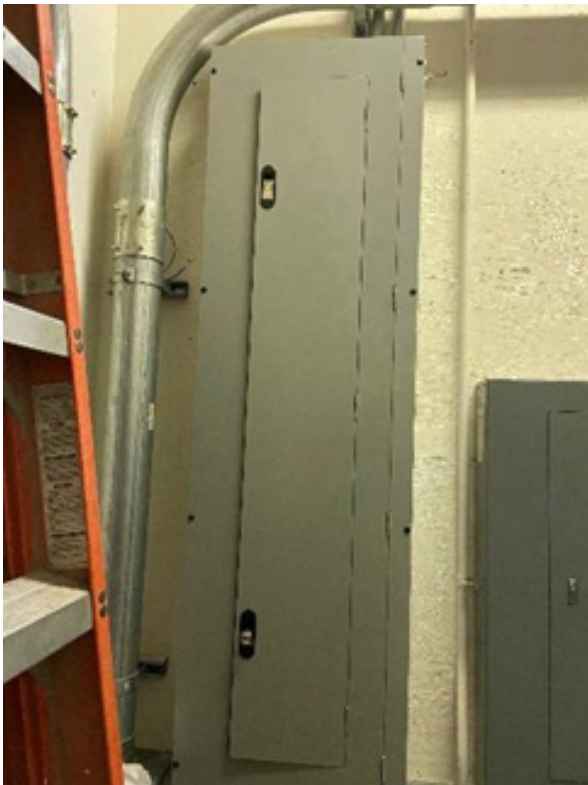
Distribution Panelboard

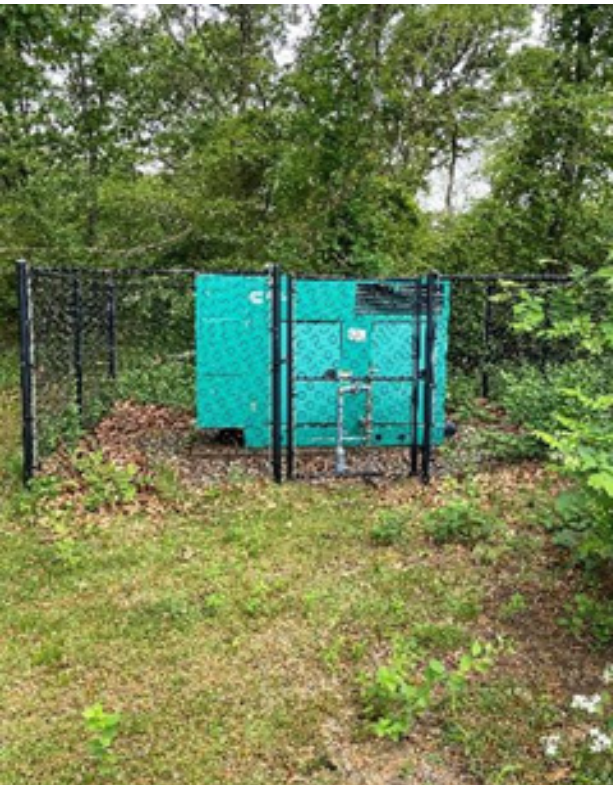
2. Generator: A 60kW natural gas fired generator is manufactured by Cummins and is approximately 9 years old. This provides back-up power to the entire building. This equipment is located outside of the building in a fenced-in enclosure. There is an automatic transfer switch located in the main electrical room. This switch is manufactured by Asco. This equipment is in good condition. This generator is not adequate to handle the additional load if the building is expanded and cannot be categorized by code as a life safety generator if it's not a diesel generator. Life safety generators must be sized for the entire load of the building without derating and must have 3-days' worth of diesel storage. The life safety equipment inside the building must be located in 2-hour rated enclosures.

Generator

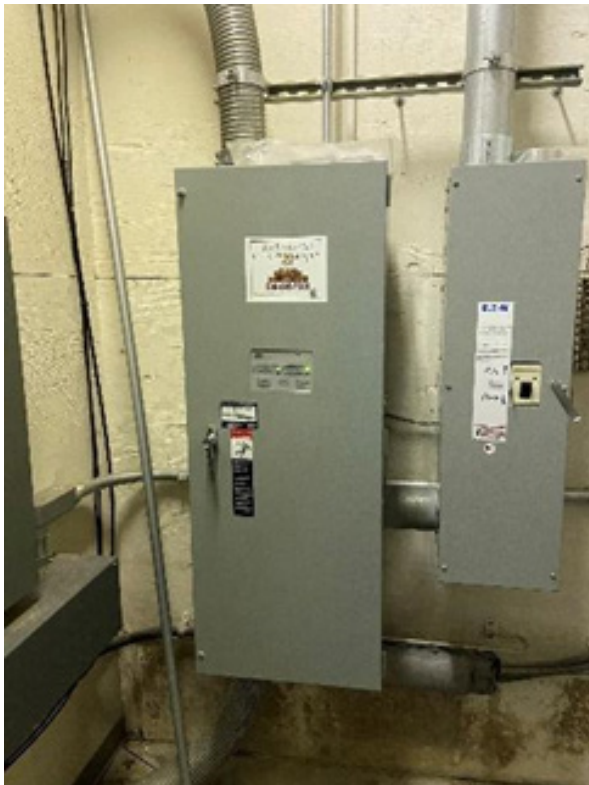
Automatic Transfer Switch

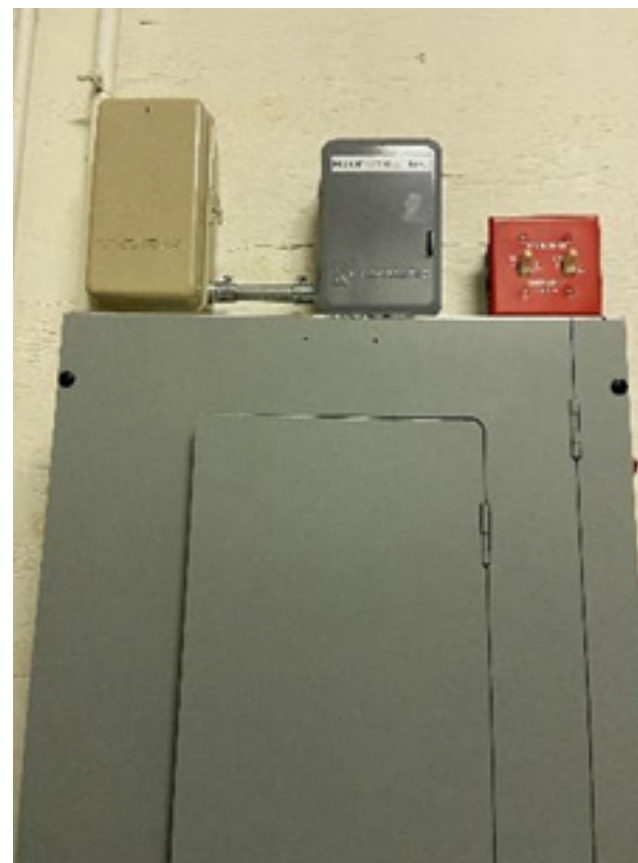
3. Panelboards: There are a number of branch circuit panelboards in the Main Electrical Room. These panelboards are original to the building and manufactured by Square D. There are missing blank-off plates in one panel. These original panelboards are in fair condition and have very limited spare capacity. There are also newer panelboards that were installed with the generator. These panels are manufactured by Siemens/I-T-E and are in good condition.

Newer Electrical Panel

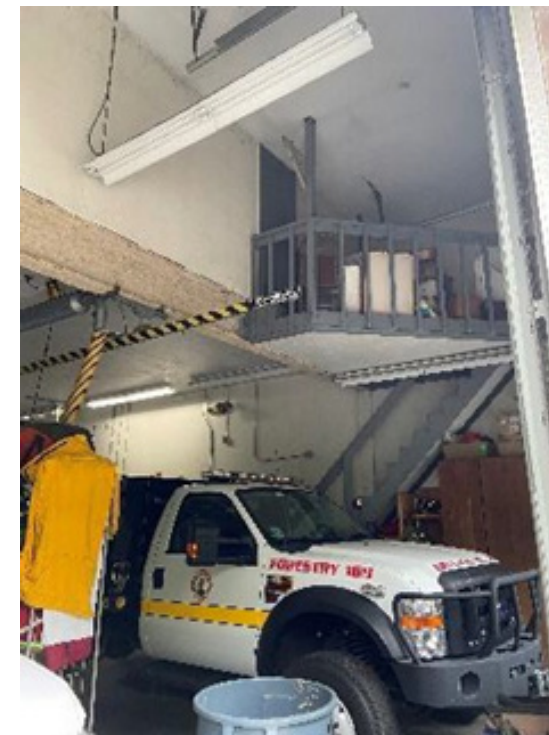
4. Lighting: Lighting throughout the facility consists of a number of type of light fixtures including but not limited to the following below. Fixtures are technologically outdated. There is a rudimentary Fire Station Alerting System that is tied to the building lighting systems. However, given the age of the lighting and wiring in the existing building, this type of Fire Station Alerting System cannot be used. It is recommended that the Fire Station upgrades their lighting systems to incorporate with the Fire Station Alerting System.

Pendant Industrial Fixture

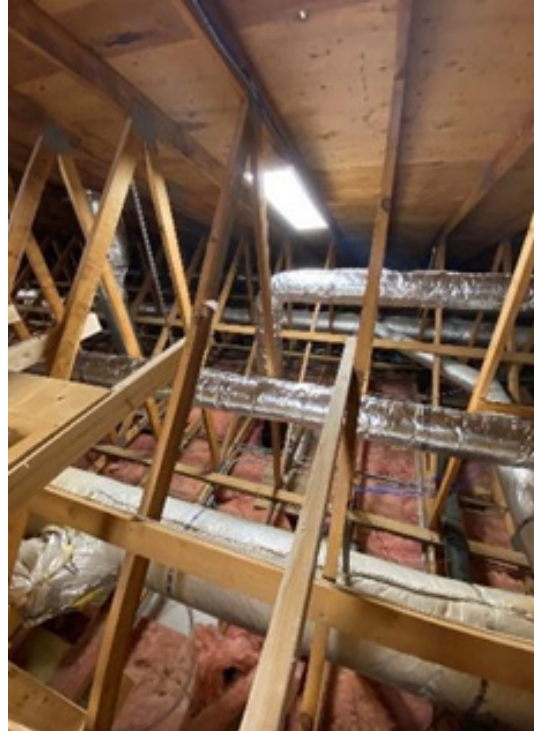
Surface Mounted Fixture

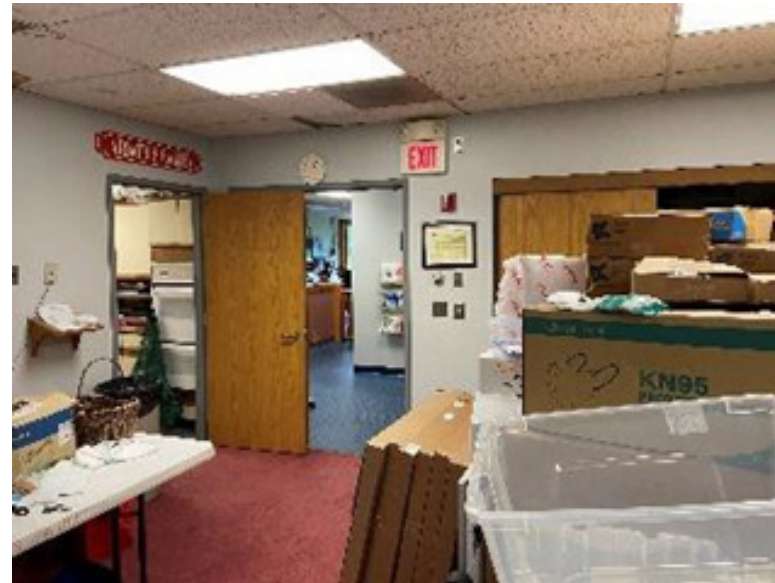
Recessed Fixtures
