Orleans Old Firehouse Project – Part A

Historic Building Survey

April 2014

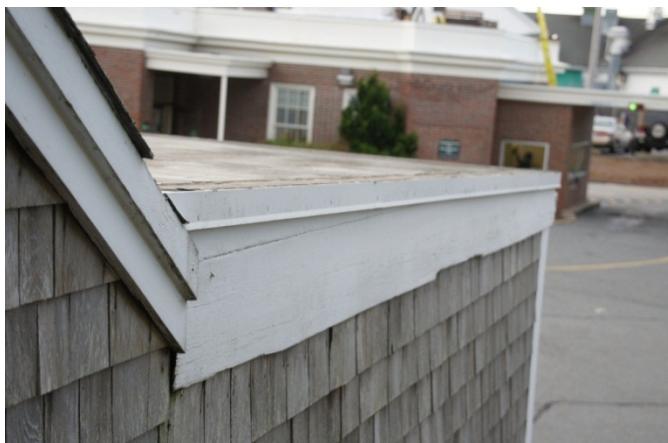
Fig. 4.2. Painted wood trim and standard metal drip edge.

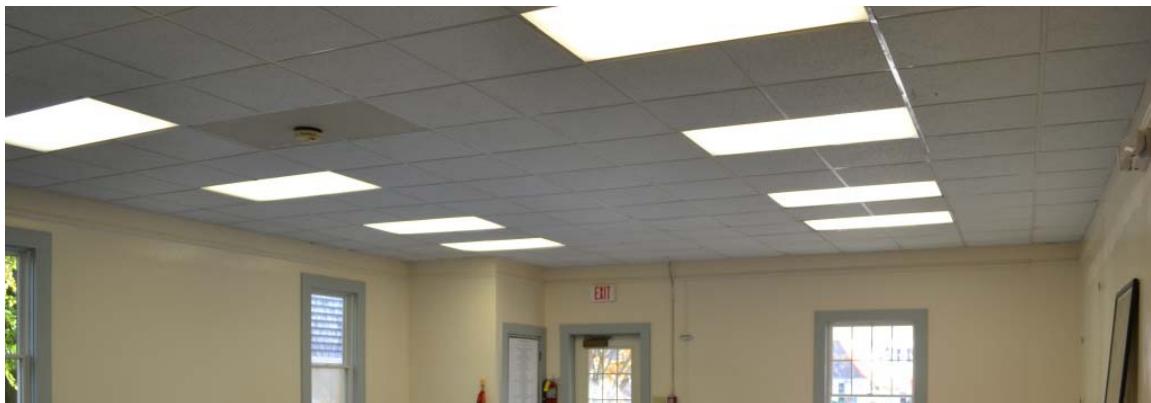
Fig. 5.4. Suspended acoustic ceiling tile ceiling at function room.

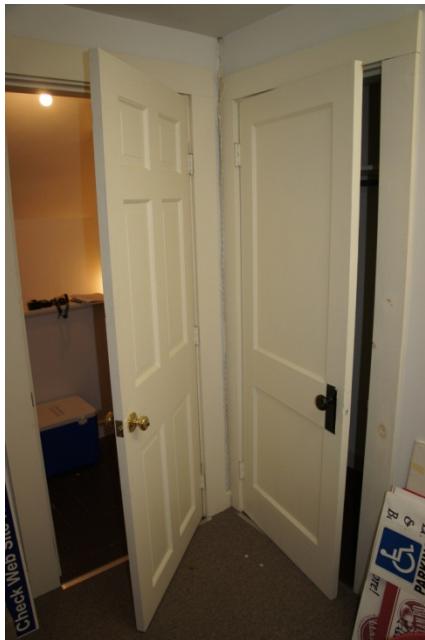
Fig. 5.12. Second-floor doors; 2-panel closet door (right) is probably original.

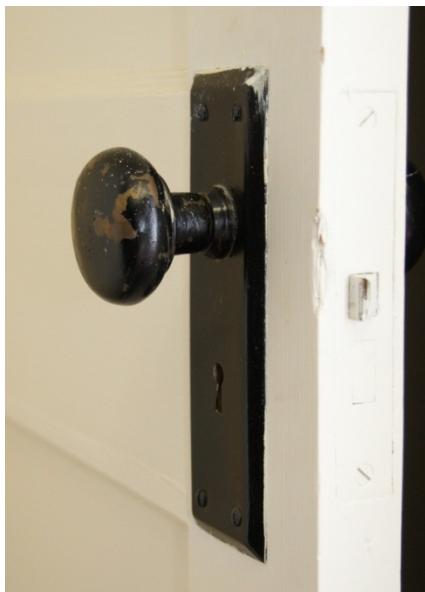
Fig. 5.14. Original door hardware at the second-floor closet.

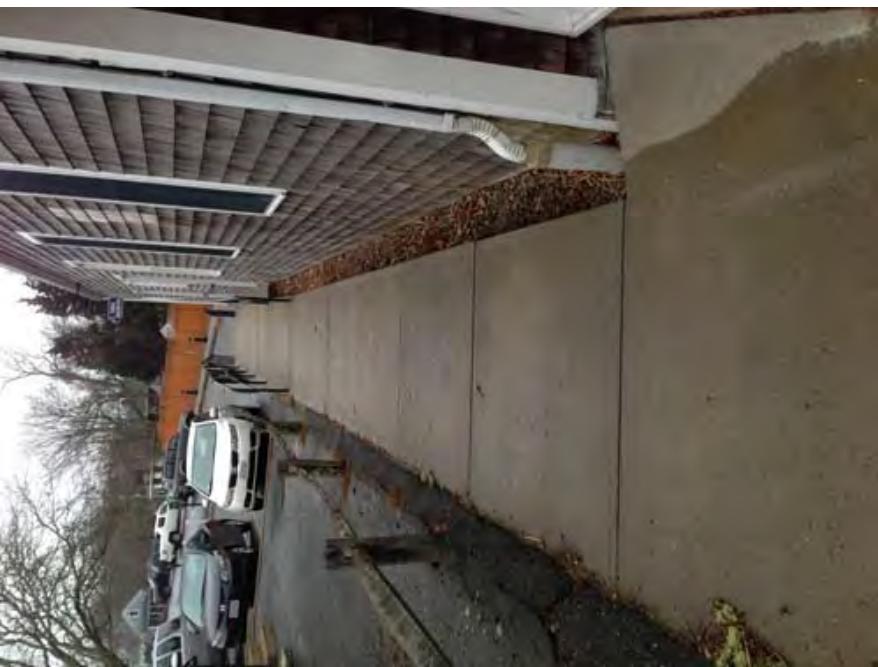
Photo #2

Roof runoff flows off the northerly (left), westerly (front), and southerly (right) sides of the building. Our site inspection found that only the northerly side of the building has a gutter and downspouts to control roof runoff [Photo #2]. The downspouts are located at the front and rear corners of the building, with the rear downspout discharging onto the ground and the front downspout discharging into the ground via a PVC pipe. We do not know where the PVC pipe leads. Runoff from the front roof discharges onto the brick courtyard and runoff from the right-side roof discharges onto the ground, where it has caused scour, erosion, and loss of vegetative cover. It is apparent [Photo #3] that the uncontrolled roof runoff and runoff from the brick courtyard discharge onto the property to the south (46 Main Street – Orleans Whole Food Store).
